# AIR ACCIDENT INVESTIGATION SECTOR

## ACCIDENT INVESTIGATION REPORT

### SEVERE TURBULENCE ENCOUNTER

Boeing 777-300

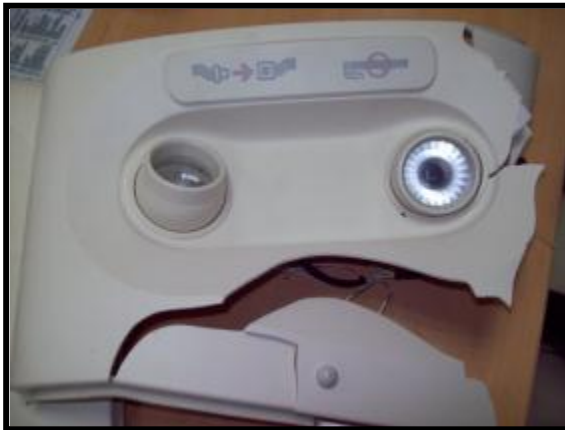
Figure 2 PSU Damage

During the turbulence event several passengers contacted the passenger cabin overhead panel Passenger Service Units (PSU's), resulting in injury and significant damage to the tertiary structure cabin panels.

During turbulence, four other passengers who were seated in between the seat rows 51-55 at the aft section of the aircraft hit the PSU's<sup>15</sup> above their seats in the cabin. According to the cabin crew statements, the passengers had their seatbelts loosely fastened at the time of an event. Several masks were deployed and the PSUs were damaged due to the impact with the passengers.

The affected panels were replaced in the hanger with all other associated post-accident inspections.

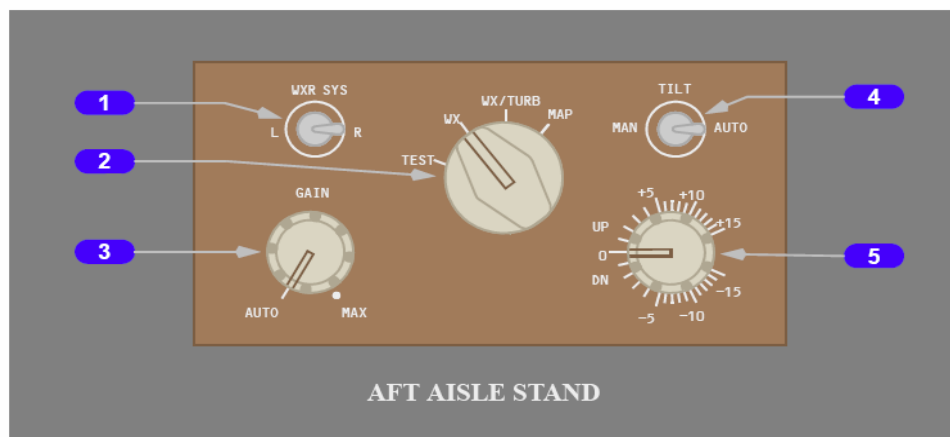
Figure 5 : Weather Radar Panel A6-ETC

The TILT selection remained in the AUTO mode throughout the flight. The PF stated that it is advised by the operators training establishment to keep the TILT switch to AUTO. According to the crew statements, the crew did not consider putting the TILT to MAN.

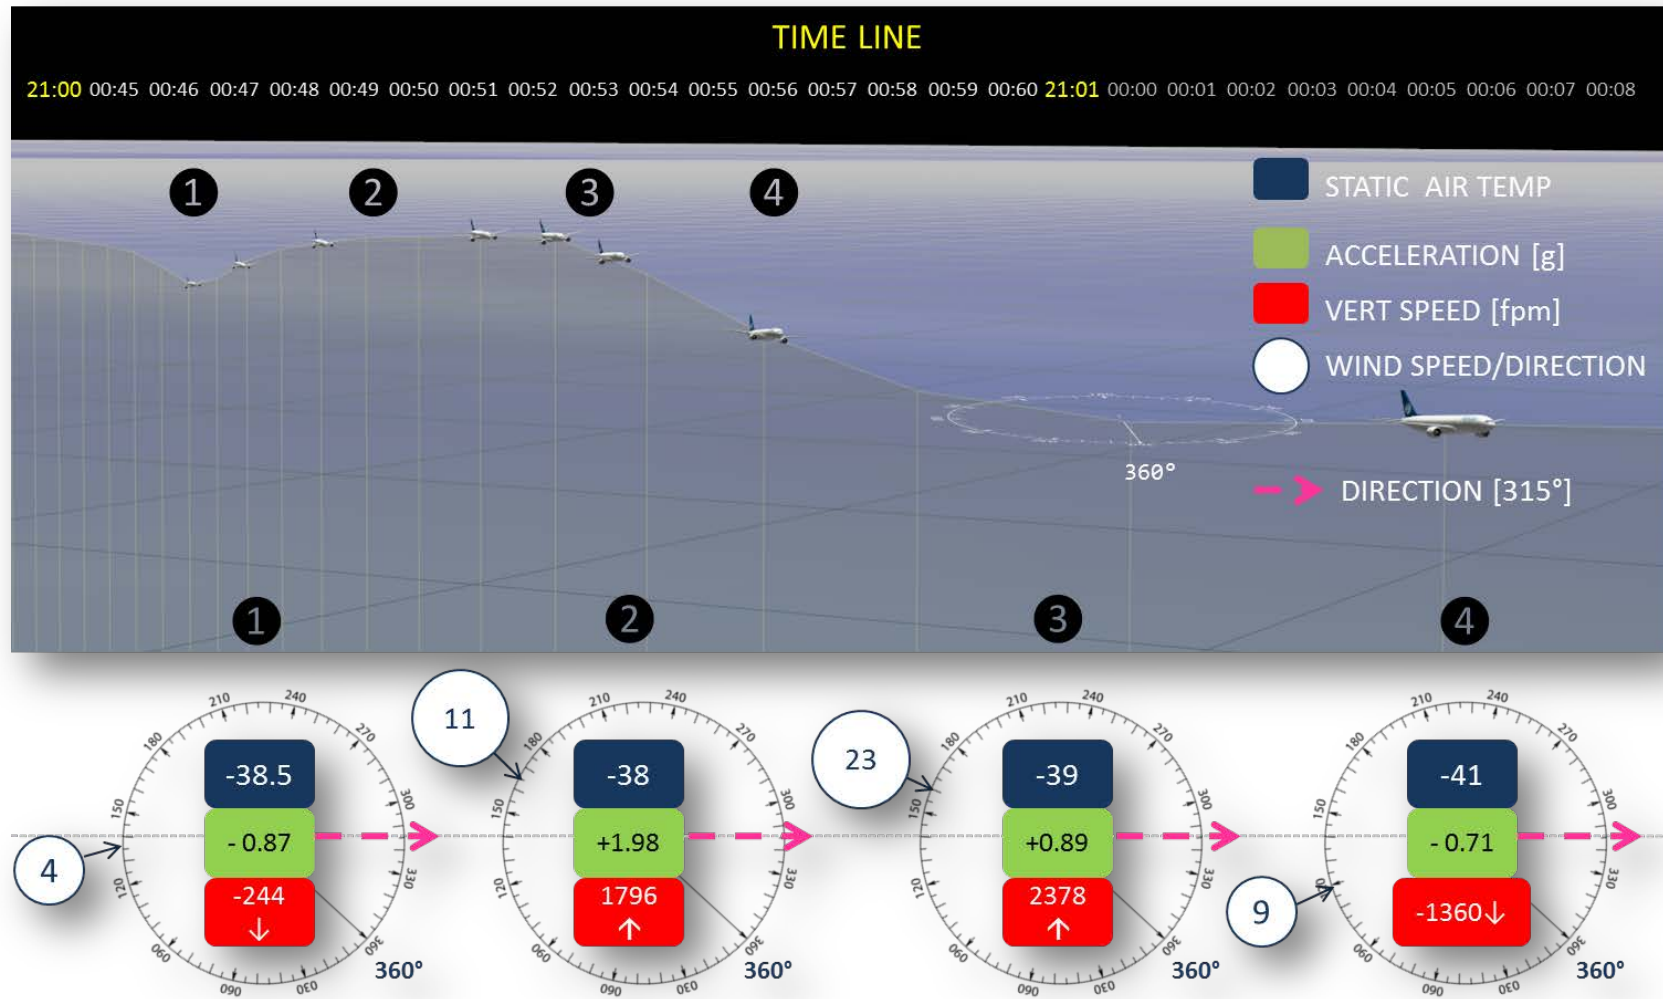
Figure 9 SEVERE TURBULENCE DATA –EVENT SEQUENCE

The crew altered track to 315°, laterally off set to the right from the airway to avoid the Cb, the flight passed the Cb and when abeam the cell approximately 7 nm laterally off set, the airplane encountered severe turbulence for approximately 45 seconds.

During the severe turbulence encounter, the autopilot disconnected, the aircraft climbed approximately 600 feet and the stick shaker activated.

The vertical acceleration(g) maximum loads were +1.98 and -0.68<sup>5</sup>

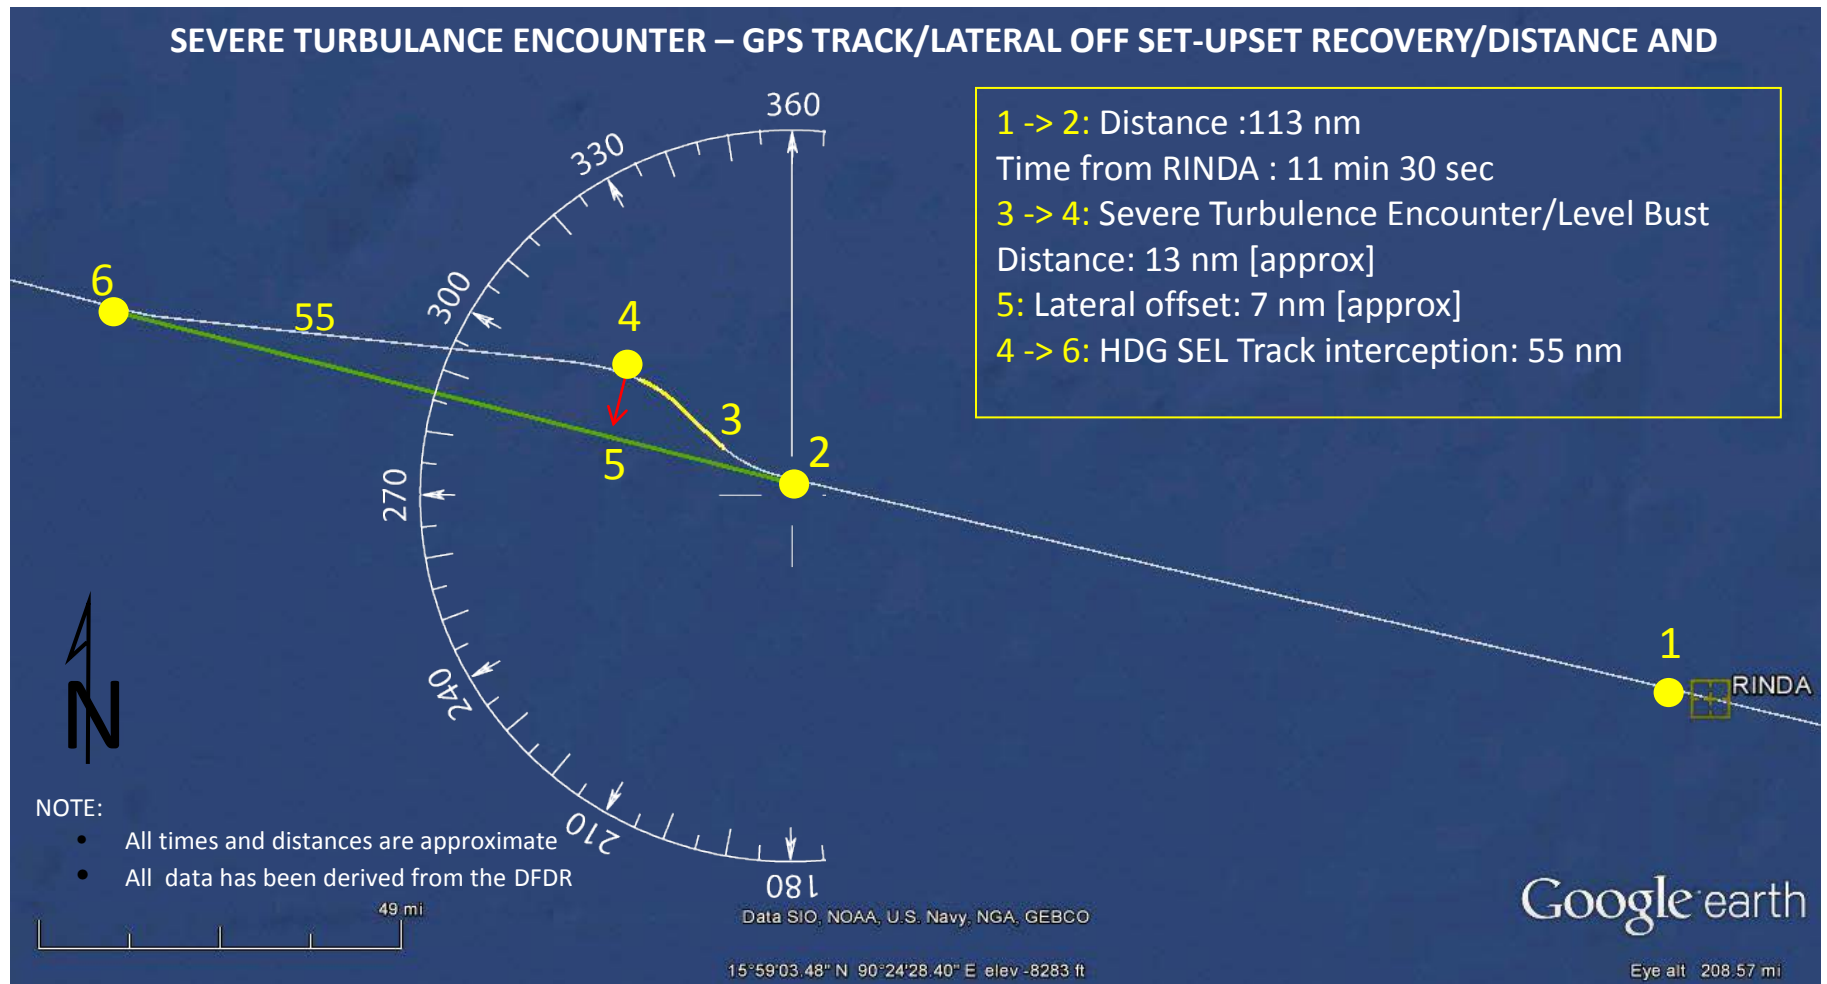
Figure 10 Track Deviation Overview [DFDR derived track data]

During this deviation from track to avoid adverse meteorological conditions, the aircraft deviated approximately 7 nm laterally off track from the 285° heading to 315° when the turbulence occurred. After this event, the aircraft returned to the flight plan track (285°) and did not make any more weather deviations for the rest of the flight.
