**ATSB TRANSPORT SAFETY INVESTIGATION REPORT**

Aviation Occurrence Report – 200404589

**Aircraft Loss of Control  
Lake George, NSW  
21 November 2004**

**VH-TAG  
Fairchild Industries SA227-AC Metro III**

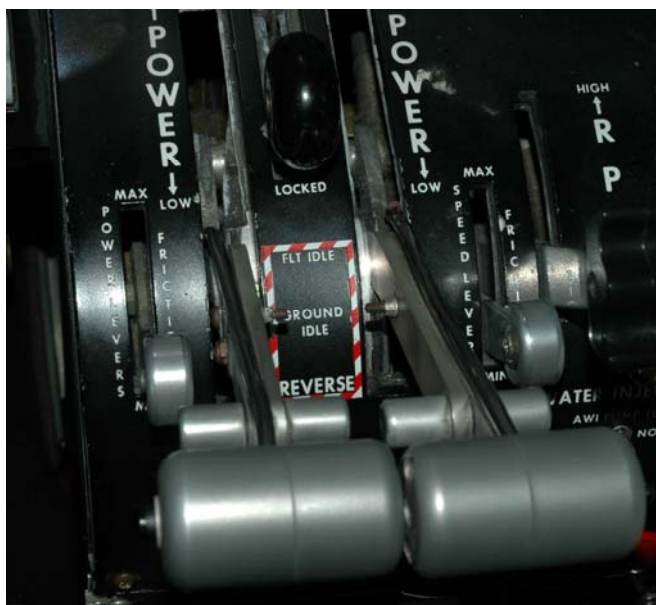
**Figure 1: Power levers and markings**

In order to prevent inadvertent selection of beta range in flight, the power levers were fitted with a supplemental latch mechanism that required the lifting of toggles (located below the power lever handle) to allow the lever to move through a detent from flight idle into the beta range.

Placing the power lever at the flight idle position with the landing gear retracted activated the 'landing gear warning' horn. No additional auditory warning was provided if the power lever was moved further rearward of the flight idle gate into the beta range. The 'Pre Planned Engine Airstart – SRL On' procedure called for the power lever to be brought back to the flight idle gate and then moved forward about ¼ inch until the landing gear warning horn was silenced. The CVR data indicated that the landing gear warning horn sounded four times during the occurrence sequence; the first time (lasting 14 seconds) was when the instructor initially brought the left engine power lever into the beta range.

Following the occurrence, the left propeller was found to be fixed in the 9 degree start-locks position. After release of the start-locks, the left engine and propeller operated normally during all ground testing and a subsequent in-flight engine shutdown and airstart. No problems were identified with the detent on the power lever between the flight idle and beta range.

The Australian Transport Safety Bureau recommends that the United States Federal Aviation Administration consider revising Title 14 Code of the Federal Regulations, Part 23.1155, to require a positive means to prevent operation of the propeller in the beta mode while in flight (regardless of pilot action), unless the aircraft is certified for such use.
