**Department of Transport and Regional Development
Bureau of Air Safety Investigation**

INVESTIGATION REPORT

9501246

**Israel Aircraft Industries
Westwind 1124 VH-AJS
Alice Springs, NT
27 April 1995**

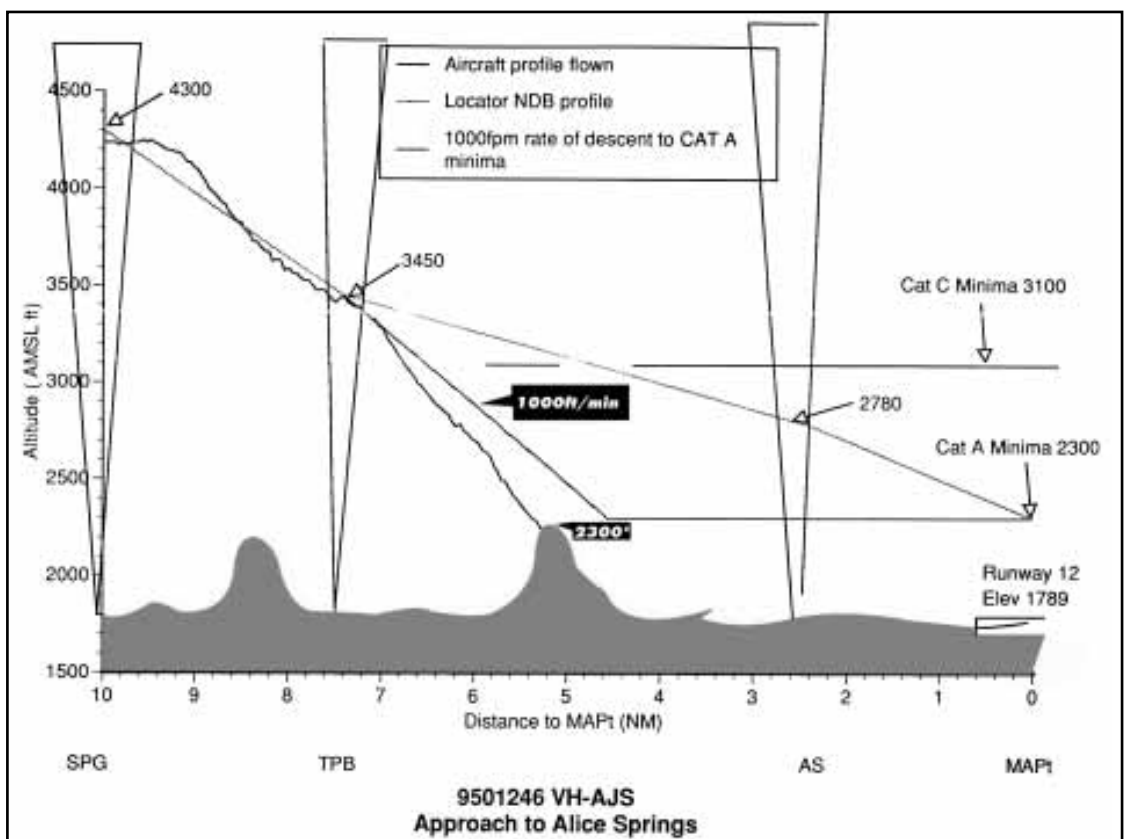
Figure 3. Side view showing vertical profile of the approach by VH-AJS.

The crew had descended to the incorrect minimum descent altitude before reaching the appropriate sector of the approach.

Approaching Simpson's Gap, the aircraft descended through 4,300 feet to about 4,000 feet before climbing back to 4,300 feet. It maintained this altitude to overhead Simpson's Gap before commencing a steady descent at about 1,100 feet per minute. The aircraft reached 3,500 feet a few seconds before passing Temple Bar and levelled briefly before descending again. The aircraft's descent rate was about 670 feet per minute for 18 seconds after passing Temple Bar and then increased to average about 1,500 feet per minute until levelling at 2,250 feet just before impact. The final 3 seconds of data recorded indicate that the aircraft was level at about 2,250 feet for 2 seconds before climbing some 12 feet, at which point the recording ended.
