**INCIDENT**

<b>Aircraft Type and Registration:</b>	Airbus A320-232, G-EUUR
<b>No &amp; Type of Engines:</b>	2 International Aero Engine V2527-A5 turbofan engines
<b>Year of Manufacture:</b>	2003
<b>Date &amp; Time (UTC):</b>	26 November 2008 at 0820 hrs
<b>Location:</b>	Approx 10 miles north-east of Glasgow Airport
<b>Type of Flight:</b>	Commercial Air Transport (Passenger)
<b>Persons on Board:</b>	Crew - 4                      Passengers - Not known
<b>Injuries:</b>	Crew - None                      Passengers - None
<b>Nature of Damage:</b>	None
<b>Commander's Licence:</b>	Airline Transport Pilot's Licence
<b>Commander's Age:</b>	49 years
<b>Commander's Flying Experience:</b>	14,750 hours (of which 5,400 were on type) Last 90 days - 150 hours Last 28 days - 82 hours
<b>Controller's Experience</b>	The controller had qualified in 1973, had been an approach radar controller since 1980 and employed at Glasgow since 1994

<b>Information Source:</b>	AAIB Field Investigation

**Synopsis**

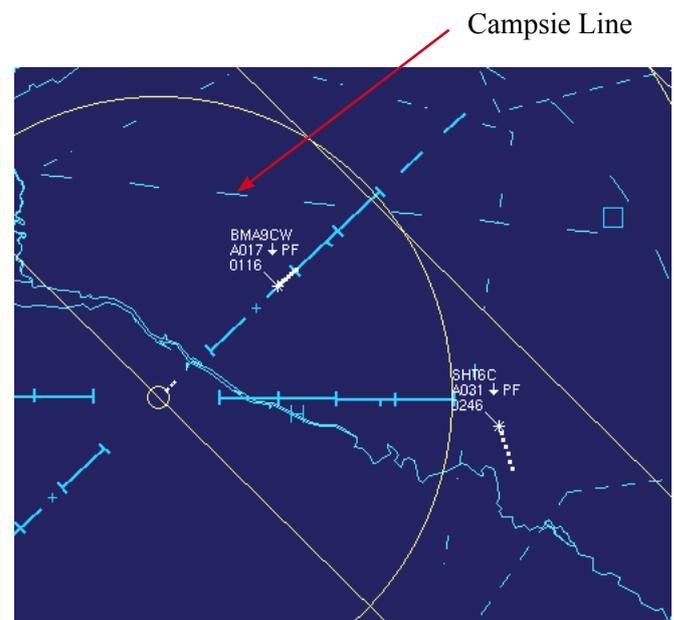
**Figure 1**

The controller had become involved in an exchange with an air ambulance flight and when he next looked at the radar G-EUUR was crossing the ILS centreline, but north of the 'Campsie Line' (Figure 1) and below the minimum altitude for that area. The controller had decided that, if he turned the aircraft further towards the ILS, it might still successfully intercept the localiser.

Radar 'screen grab' - Campsie Line & G-EUUR (SHT6C)

Glasgow airport is located six miles west of the city of Glasgow. The airport is in the River Clyde valley with a field elevation of 26 ft. The terrain along the approach to Runway 23 is generally low-lying (150-300 ft elevation) out to a distance of 9.5 nm. There the ground rises sharply due to the Campsie Fells, an east-west line of hills with a peak height in the vicinity of the final approach track of 1,840 ft. Glasgow's ATC procedures are designed to allow for this ridge feature. The relevant part of the Manual of Air Traffic Services (MATS) describes a line 105°/285°, the 'Campsie Line' (Figure 1), at 9.5 nm on the approach for Runway 23.

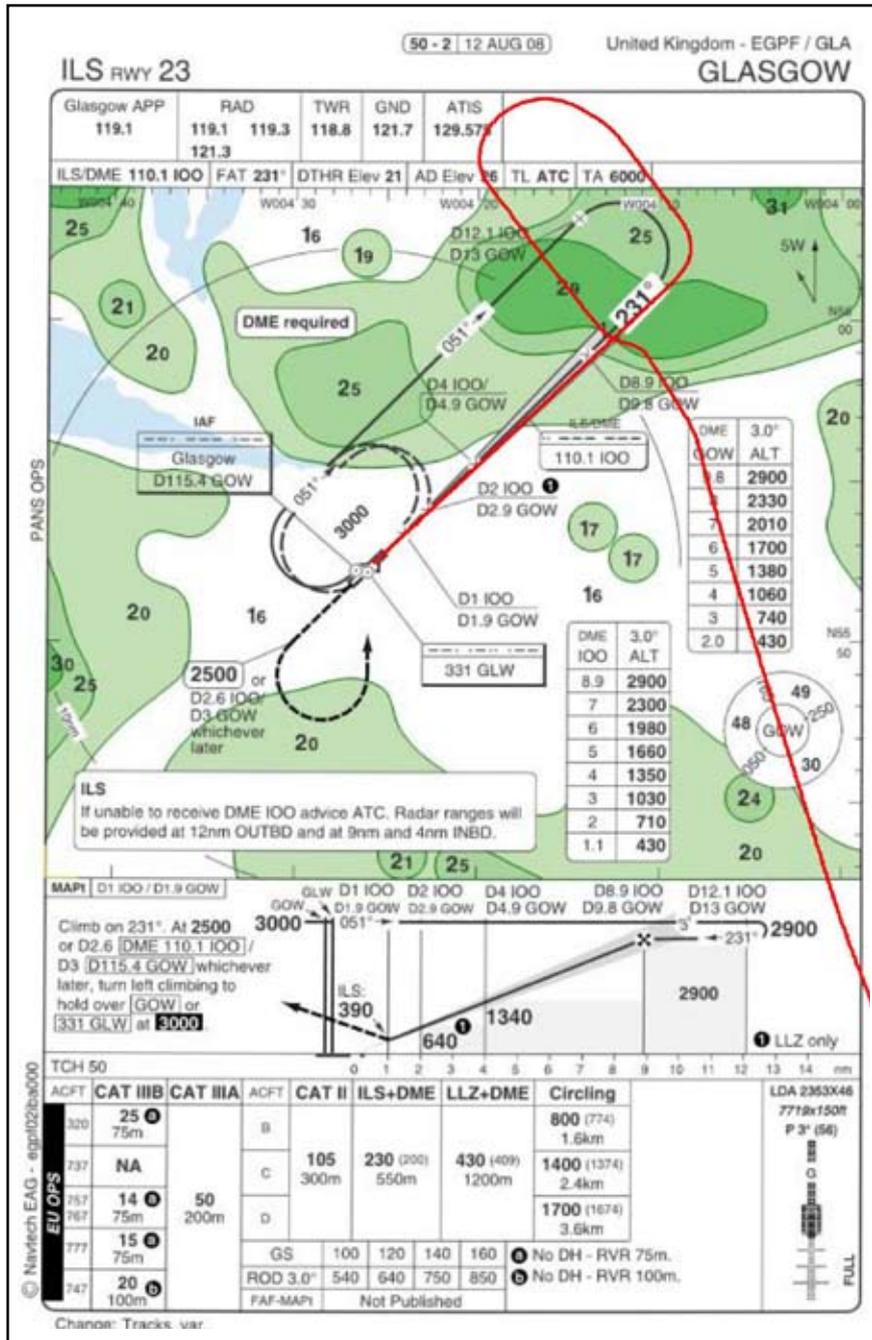
Figure 2

On receiving the GPWS warning the PF had climbed the aircraft to 5,000 ft, which was above the Minimum Safe Altitude (MSA) on the approach chart (Figure 2) of 4,900 ft. The crew levelled at 5,000 ft before being vectored for a second approach.

Approach chart - ILS RWY 23

The ILS RWY 23 chart shows the approach in detail and includes diagrammatic representations of the higher terrain in progressively darkening green. The side profile box provides greyed-out minimum altitudes for the approach. Both these charts also include a 25 nm MSA, based on the GOW VOR, for emergency use. For the sector used this shows an MSA of 4,900 ft within 25 nm.

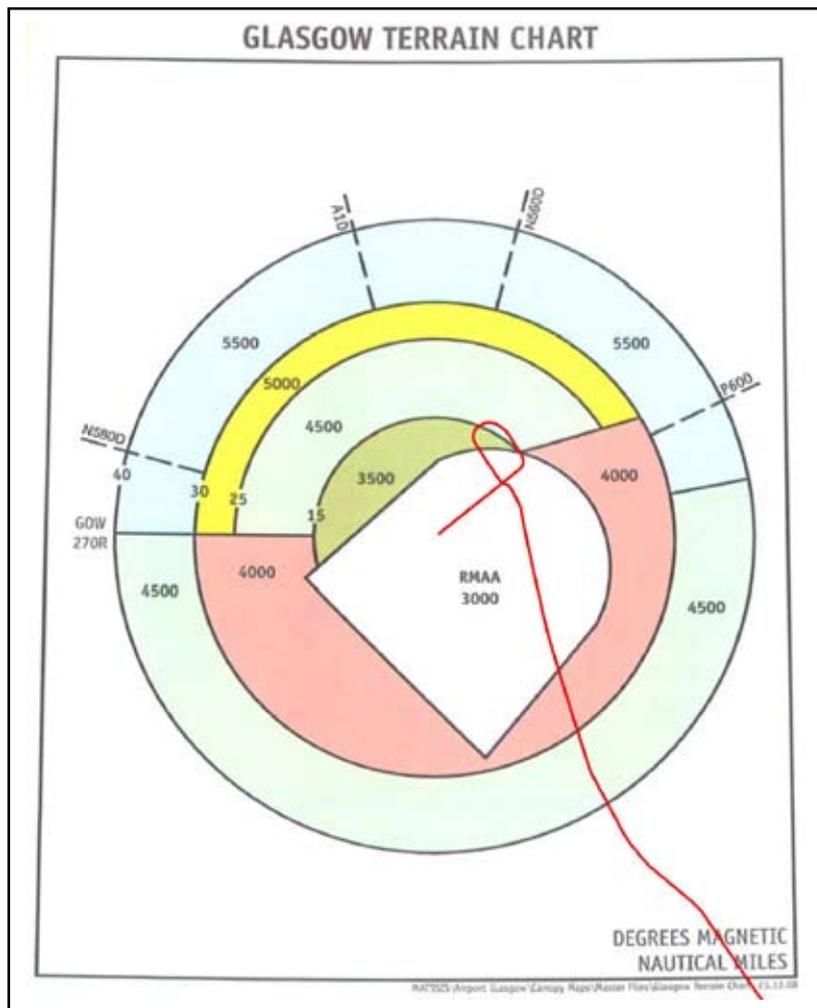
**Figure 3**

The controller then instructed a descent from 5,000 ft to 4,000 ft. At the point the clearance was issued this altitude was permitted on the controller's terrain chart (Figure 3). However as the aircraft turned to the north north-east the track was influenced by the 40 kt south-westerly wind. The resulting ground track took the aircraft into an area where the ATC terrain chart had an MSA of 4,500 ft. The controller did not recognise this second breach of ATC MSA. The flight crew were unaware that this descent had taken them

Glasgow Terrain chart

During the investigation an attempt was made, by a CAA Air Traffic Services Investigator (ATSI), the AAIB Inspector and a NATS ATC Manager, to locate accurately the incident aircraft on the ATC Glasgow terrain chart, using an ‘as live’ radar replay. The team found this chart difficult to use and were unable to perform the task satisfactorily.

With the initial situation resolved and the aircraft above the MSA, tracking north-west, the controller then instructed a descent from 5,000 ft to 4,000 ft. At the point the clearance was issued this altitude was permitted on the controller's terrain chart. However as the aircraft turned to the north north-east its track was influenced by the 40 kt south-westerly wind. The resulting ground track took the aircraft into an area where the ATC terrain chart had an MSA of 4,500 ft and the controller did not recognise this second breach of ATC MSA.

The ATSP is planning to conduct further work, including trials, to overcome the issues with MSAW at Glasgow. The ATSP has also initiated changes to the presentation of the Glasgow terrain chart to improve readability and accuracy.

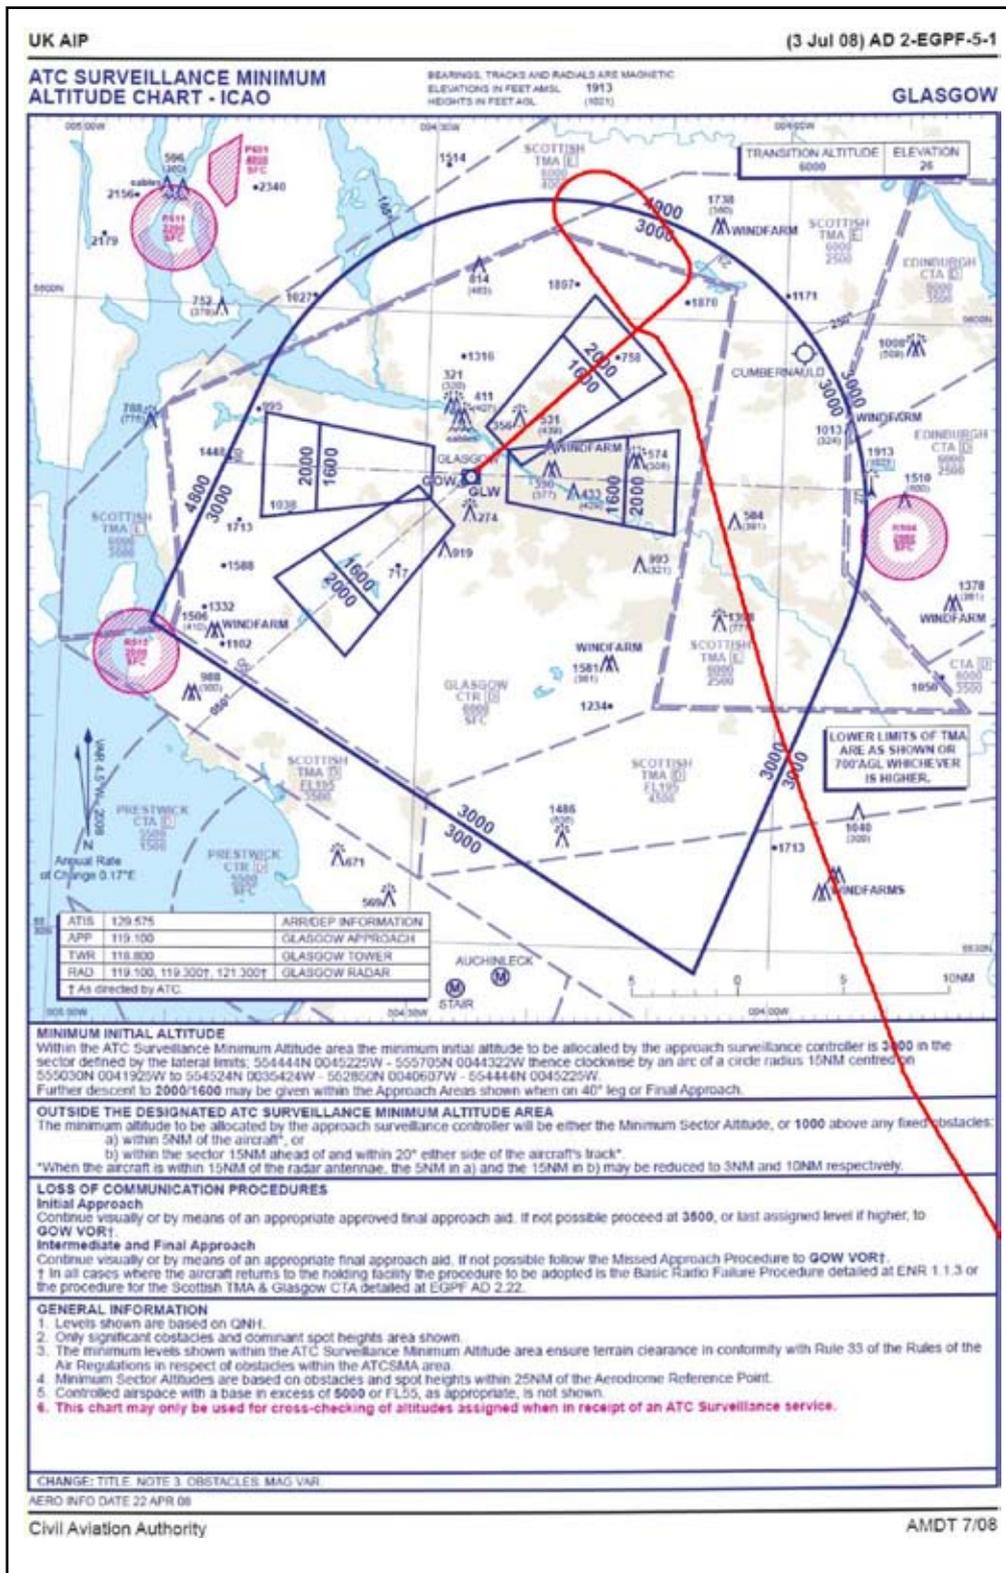
Figure 4  
Minimum Altitude chart

the company approach plate booklets, The aircraft's ground track has been overlaid on these figures. The radar minimum altitude chart provides an area overview and minimum vectoring heights for flight crew to use.

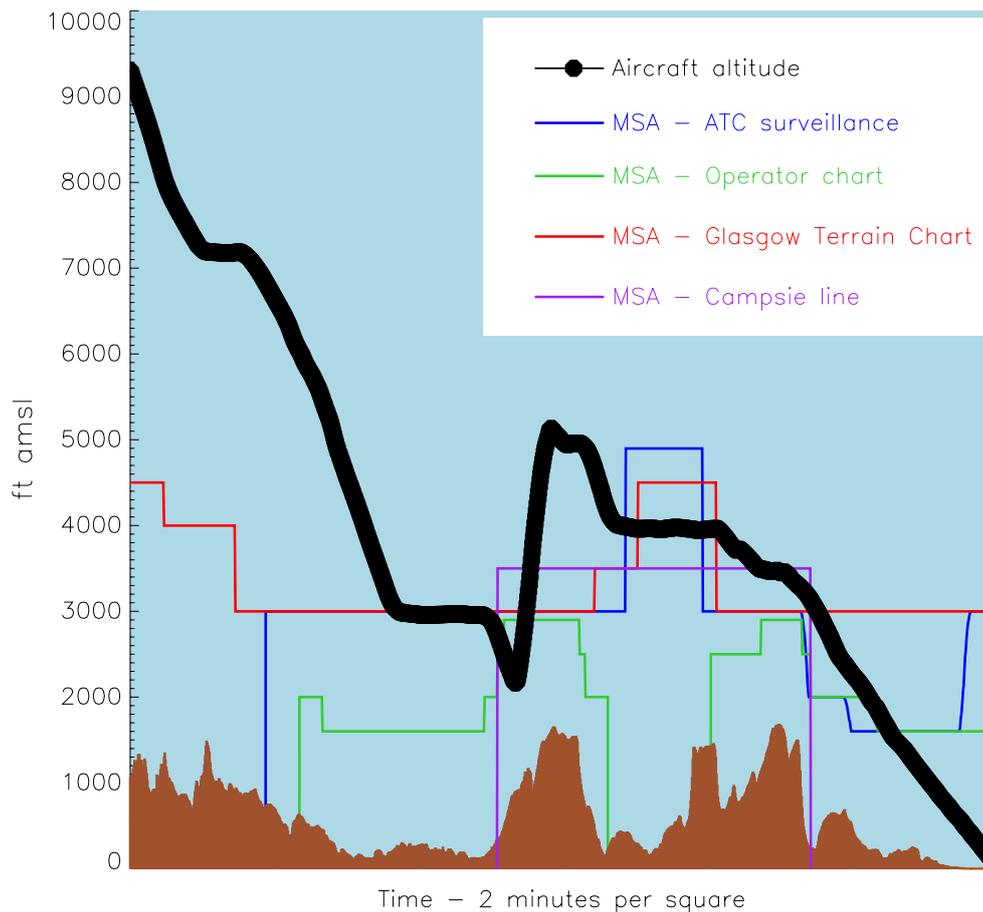
**Fig 5**

The ATCO had available two sources of terrain information however the radar overlays of certain features, including the Campsie Line (Figure 1), were his primary source of information. A laminated colour copy of the Glasgow Terrain Chart (Figure 3) was also available at his station. This chart is also contained in Glasgow's MATS Part 2 document. The track overlay in Figures 2 to 5 was generated using data overlays not available to the controller. Figure 5 is a summary, in side view, of data in Figures 2 to 4 (all in plan view).

Summary of altitude data - G-EUUR
