## AVIATION INVESTIGATION REPORT

A08W0007

### ENCOUNTER WITH WAKE TURBULENCE

AIRBUS A319-114 C-GBHZ

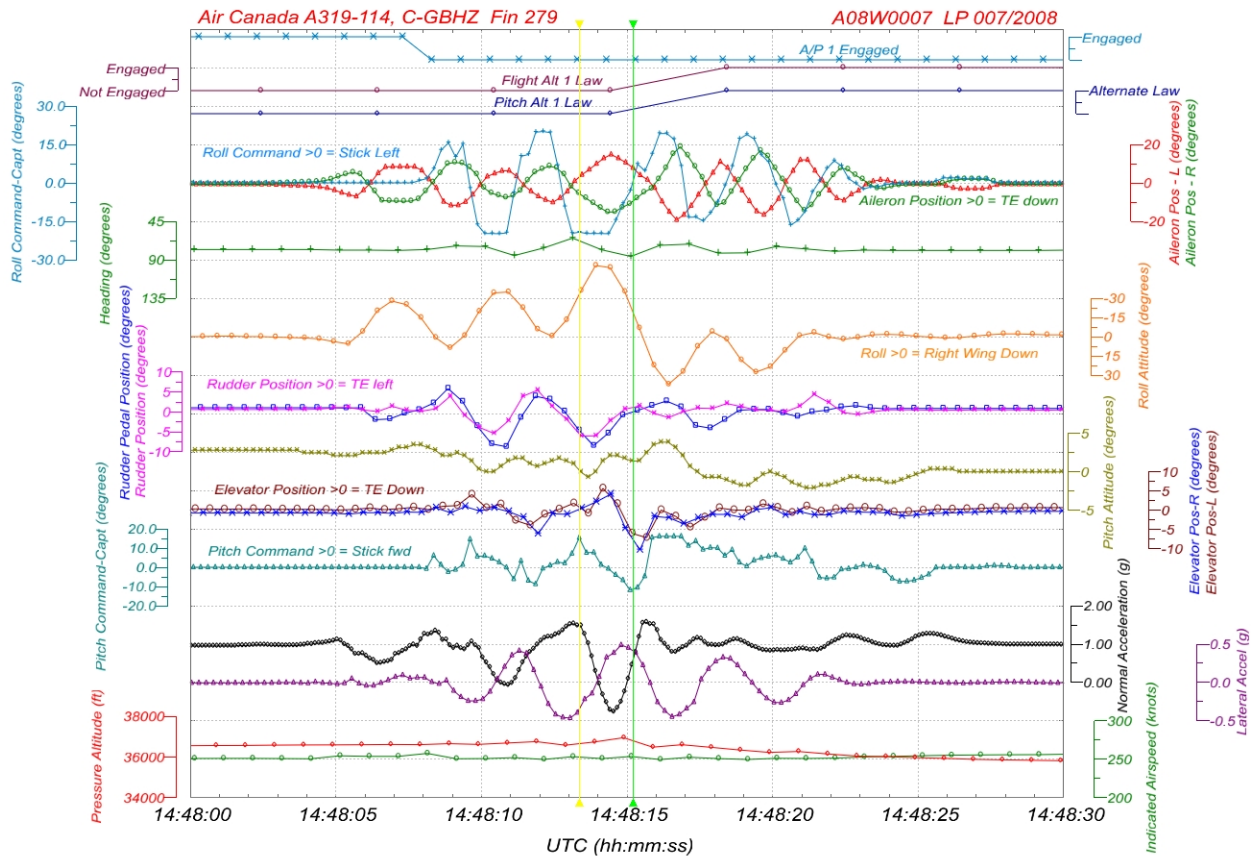
# Appendix B – DFDR Summary of the Event

Analysis of DFDR data indicated that, during the event, vertical accelerations reached peak values of +1.57g and -0.77g.<sup>3</sup> Lateral accelerations reached peak values of +0.49g (right) and 0.46g (left) during four oscillations.

From 06:48:07 to 06:48:25, pilot sidestick roll inputs were 90° out of phase with aircraft motion. From 06:48:07 to 06:48:15, lateral accelerations and heading deviations were approximately 90° out of phase with the rudder pedals. This indicated that after the autopilot was disconnected, most of the aircraft motion in the roll axis resulted from pilot inputs and that lateral accelerations were due mostly to pilot rudder control inputs. Rudder control inputs, which were coordinated with the out of phase roll inputs, had a direct relationship with vertical stabilizer loads. Abnormal accelerations in the normal or vertical axis were correlated with changes in angle of attack, and sidestick pitch control inputs opposed these aircraft angle of attack excursions.
