AIRCRAFT INCIDENT REPORT AND EXECUTIVE SUMMARY

Reference	CA18/3/2/0707	
Aircraft Registration	ZS-PYM	Date of Incident	19 March 2009		Time of Incident	1210Z
Type of Aircraft	BAe 146-200		Type of Operation		Commercial	
Pilot-in-command Licence Type		Airline Transport	Age	37	Licence Valid	Yes
Pilot-in-command Flying Experience		Total Flying Hours	9 850,0		Hours on Type	633,0
Last point of departure		George Aerodrome (FAGG)				
Next point of intended landing		Cape Town International Aerodrome (FACT)				
Location of the incident site with reference to easily defined geographical points (GPS readings if possible)						
On runway 19 at Cape Town International Aerodrome (FACT)						
Meteorological Information		Wind direction 350°, wind speed 6 kts, temperature 14°C, cloud base 3 500 ft, cloud cover SCT, dew point 13°C, visibility good				
Number of people on board		2 + 2 + 19	No. of people injured	0	No. of people killed	0
Synopsis						
<p>The aircraft was flown on a scheduled flight from Cape Town International Aerodrome (FACT) to George Aerodrome (FAGG). After landing on runway 29, the flight crew experienced a no. 1 engine flame out and the no. 3 engine spooled down into a hung state.

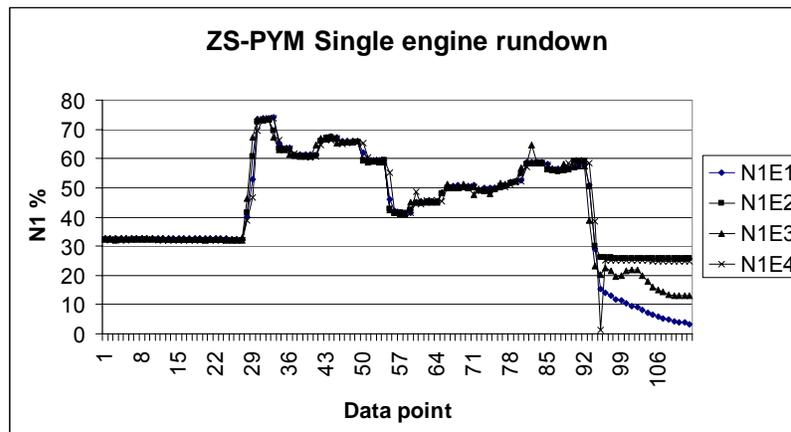
Figure 2: Graph of single-engine rundown

1.11.4 The summary of the FDR read-out information on the graph below was for the initial engine incident at FAGG (no. 1 engine flame-out and no. 3 engine spooled down into hung state).

1.11.4.1 The FDR data on the graph can be summarized as follows: During the approach for landing to FAGG, the aircraft engines (N1E1, N1E2, N1E3 and N1E4) were all operating at approx. 33% as indicated on the graph, data points 1 to 27. The engine throttles were advanced to increase the power to approx. 75%. The engines' power was gradually reduced to approx. 60% and then 40%. There was an increase again of engine speed to 60% when on touchdown engine N1E1 flamed out and N1E3 spooled down into a hung state. The other two engines N1E2 and N1E4 was

operating and producing power below 30%, at an estimated level of approx. 25%.

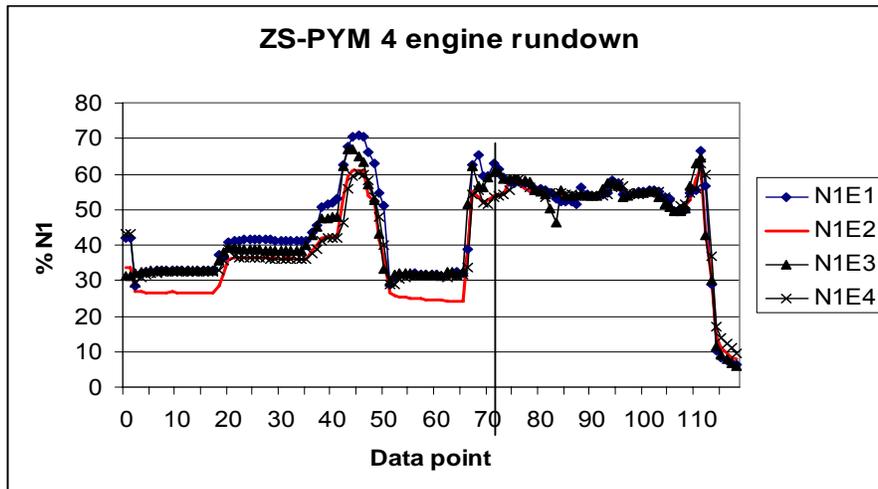
Figure 3: Graph of all-four-engine rundown

1.11.5 The summary of the FDR read-out at FACT for the four engines flaming out was plotted on a graph. According to the FDR read-out information, the recording of the incident was from 00:07:47 to 00:19:39, which is approx. 12 minutes into flight until the aircraft touched down at FACT.

1.11.5.1.11.11.5.1 The FDR data on the graph can be summarized as follows: During the approach for landing at FACT, the engines' performance was measured at approximately (N1E1 = 42.1%, N1E2 = 33.8%, N1E3 = 31.1% and N1E4 = 43.3%). Four seconds into flight, three of the engines (N1E1, N1E3 and N1E4) ran down to approx. 30% and N1E2 to 26.5%. The graph further shows that from data points 15 to 35, 60 seconds later the throttles were advanced to performance levels (N1E1 = 37.3%, N1E2 = 28.4, N1E3 = 35.8% and N1E4 = 35.5%). The engines operated at these performance levels for 64 seconds. The throttles were then advanced to performance levels (N1E1 = 70.5%, N1E2 = 60.8%, N1E3 = 63.4% and N1E4 = 58.4%).
