Statens haverikommission
Swedish Accident Investigation Board

Report RL 2003:19e

Incident involving aircraft OH-SAT and a passenger car at Stockholm/Arlanda airport, AB County, Sweden on the 18th of December 2001

Case L-002/02

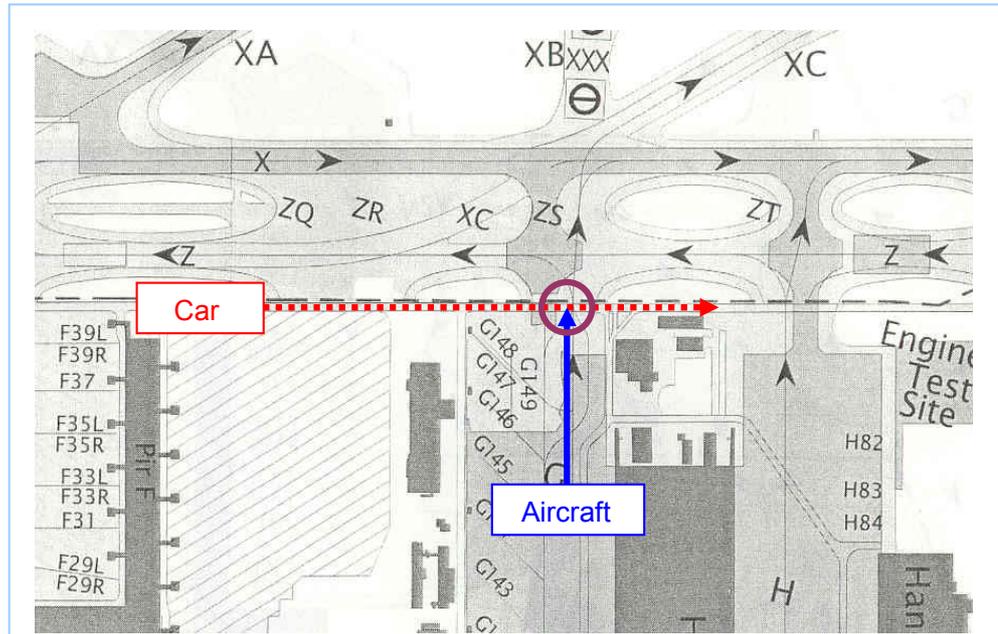
The incident occurred at an intersection between an exit from Ramp G to taxiway Z and the ground transport road, which runs parallel to the taxiway and lies between the ramp and the taxiway. The ground transport road along this stretch is governed by LVP as elucidated in 1.16.4.

Paths of the passenger car and the aircraft

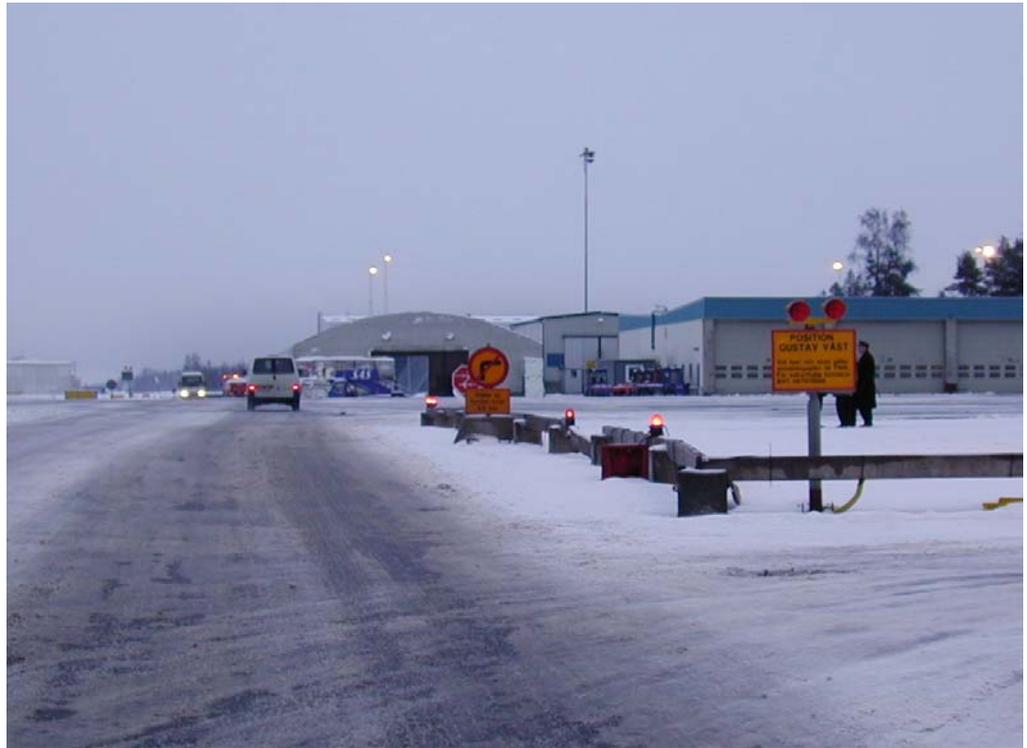
At the intersection in question, the sign with red signal lamps that indicate when LVP is in effect was placed approximately 20 meters before the stop sign.

All of the road signs on the airport are retro reflective (normal level). No sign is internally or externally illuminated.

The incident intersection at Ramp G from the car driver's perspective

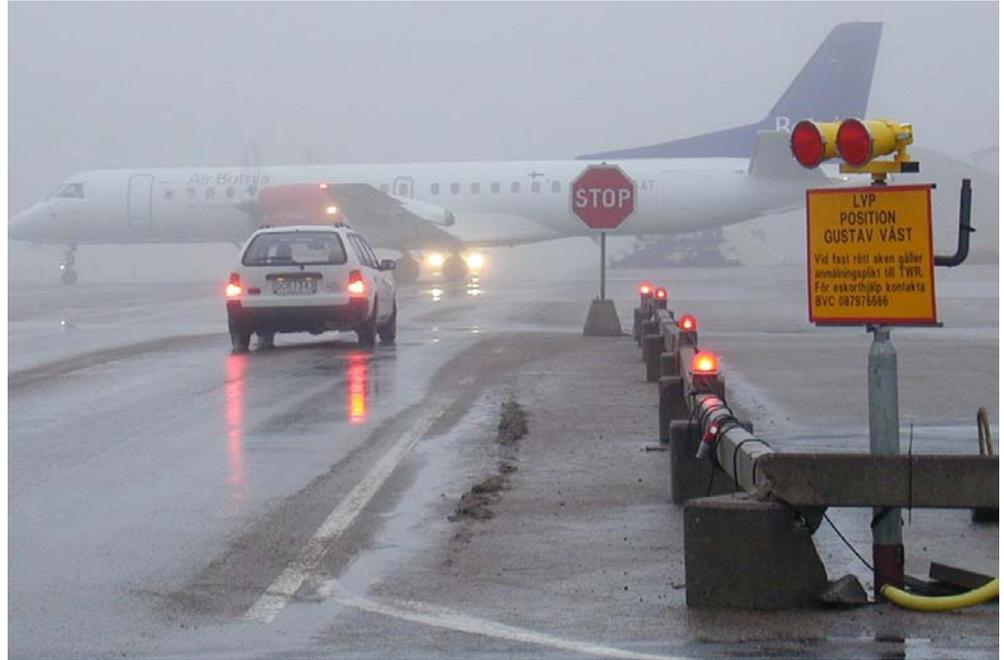
New type of stop sign at Ramp G

- The stop signs have been replaced with a type of sign that is used in the public road network.
- The sign prohibiting right hand turns has been removed.
- LVP-signs/lamps have been complimented with booms that lower manually with LVP conditions.
- During LVP, all vehicle traffic is prohibited on sections of the Inner Transport Route that is regulated by LVP.
- During LVP conditions, contingency for driving around the whole of Ramp G has been created.

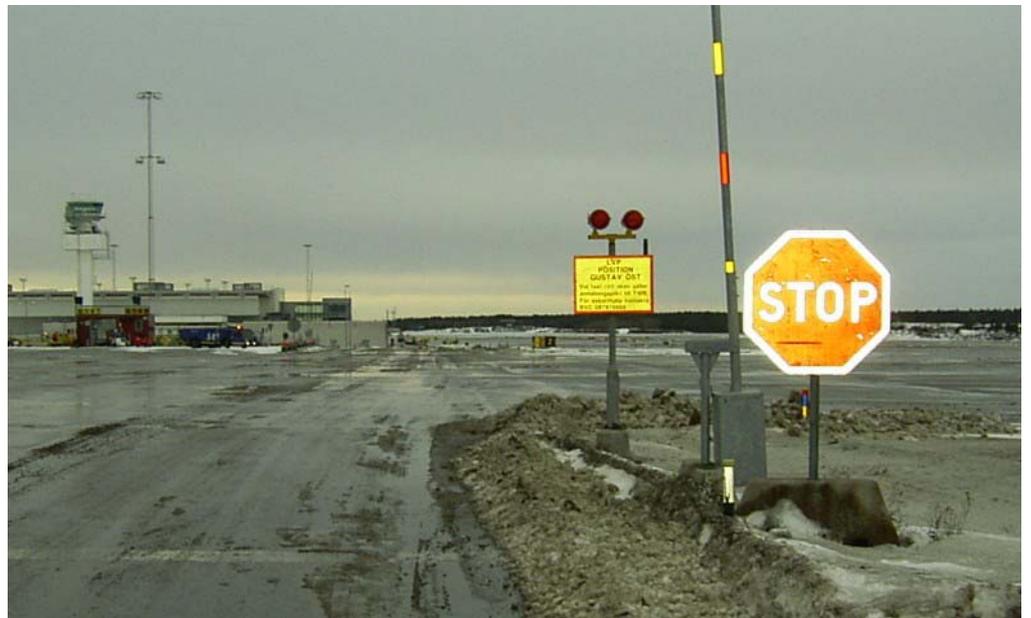
LVP-booms at Ramp G
