Report

Accident on **21 March 2008**
at **Limoges-Bellegarde aerodrome (87)**
to the **Boeing 737-800**
registered **EI-DAF**
operated by **Ryanair**

BEA

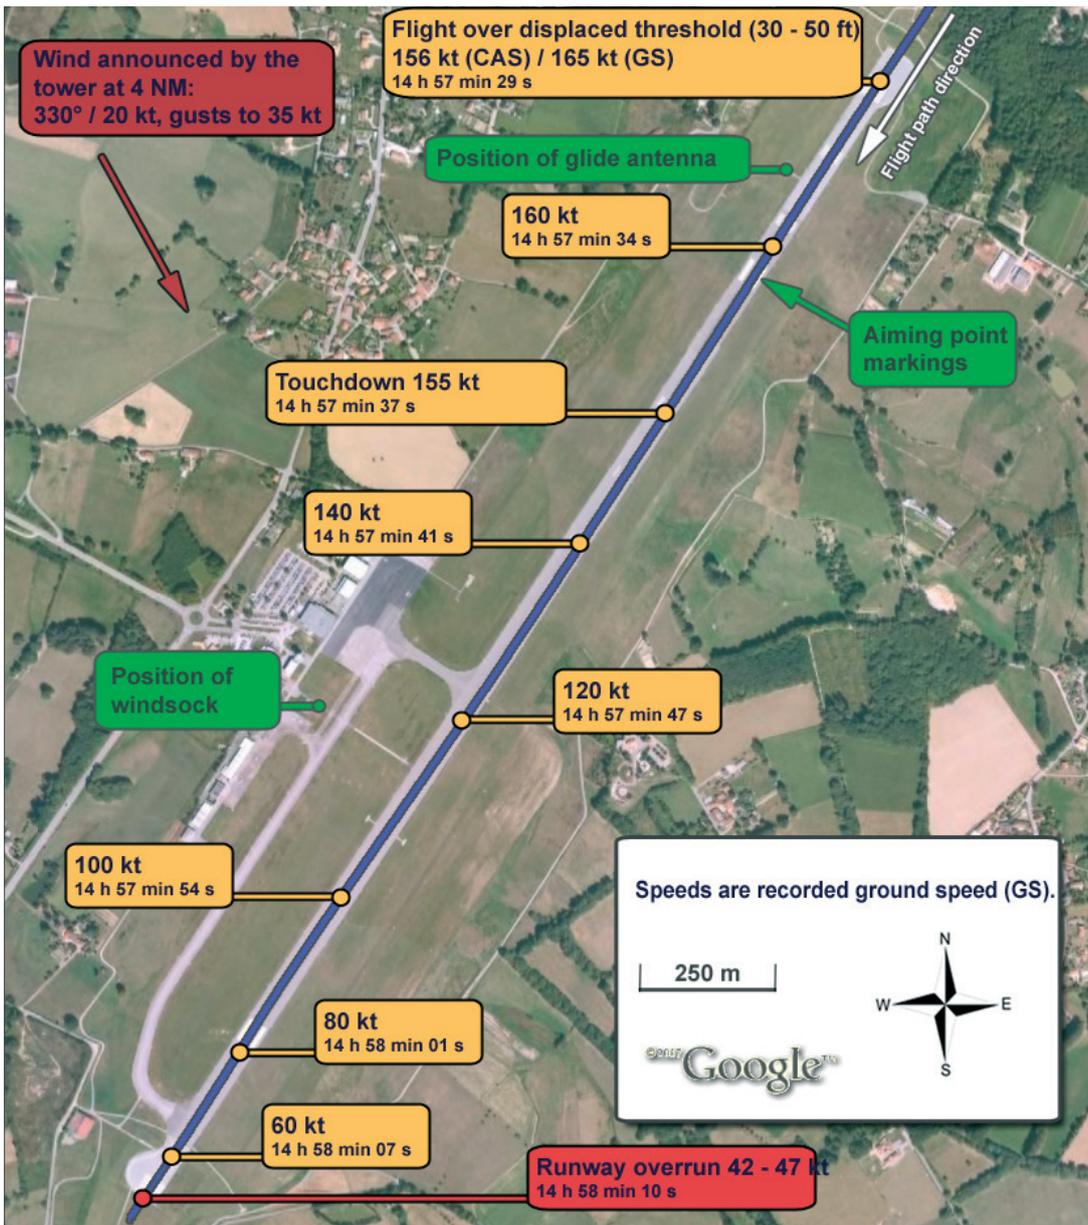
The airplane overran the runway at a speed of about 45 kt, then came to a stop around fifty metres past the runway end. The Captain called for an emergency evacuation.

The engines were damaged by the ingestion of earth and stones and the airplane was bogged down. Extensive excavation work was required in order to be able to tow the airplane back to the runway.
