# **Final Report No. 2088**

## **by the Aircraft Accident Investigation Bureau**

concerning the serious incident - Airprox  
involving the Airbus A318-111 aircraft, registration F-GUGK  
operated by Air France under callsign AFR 989Z  
and the Boeing B737-8AS aircraft, registration EI-DHK  
operated by Ryanair under callsign RYR 1702  
on 8 June 2009  
over Trasadingen beacon, 15 NM north of Zurich airport

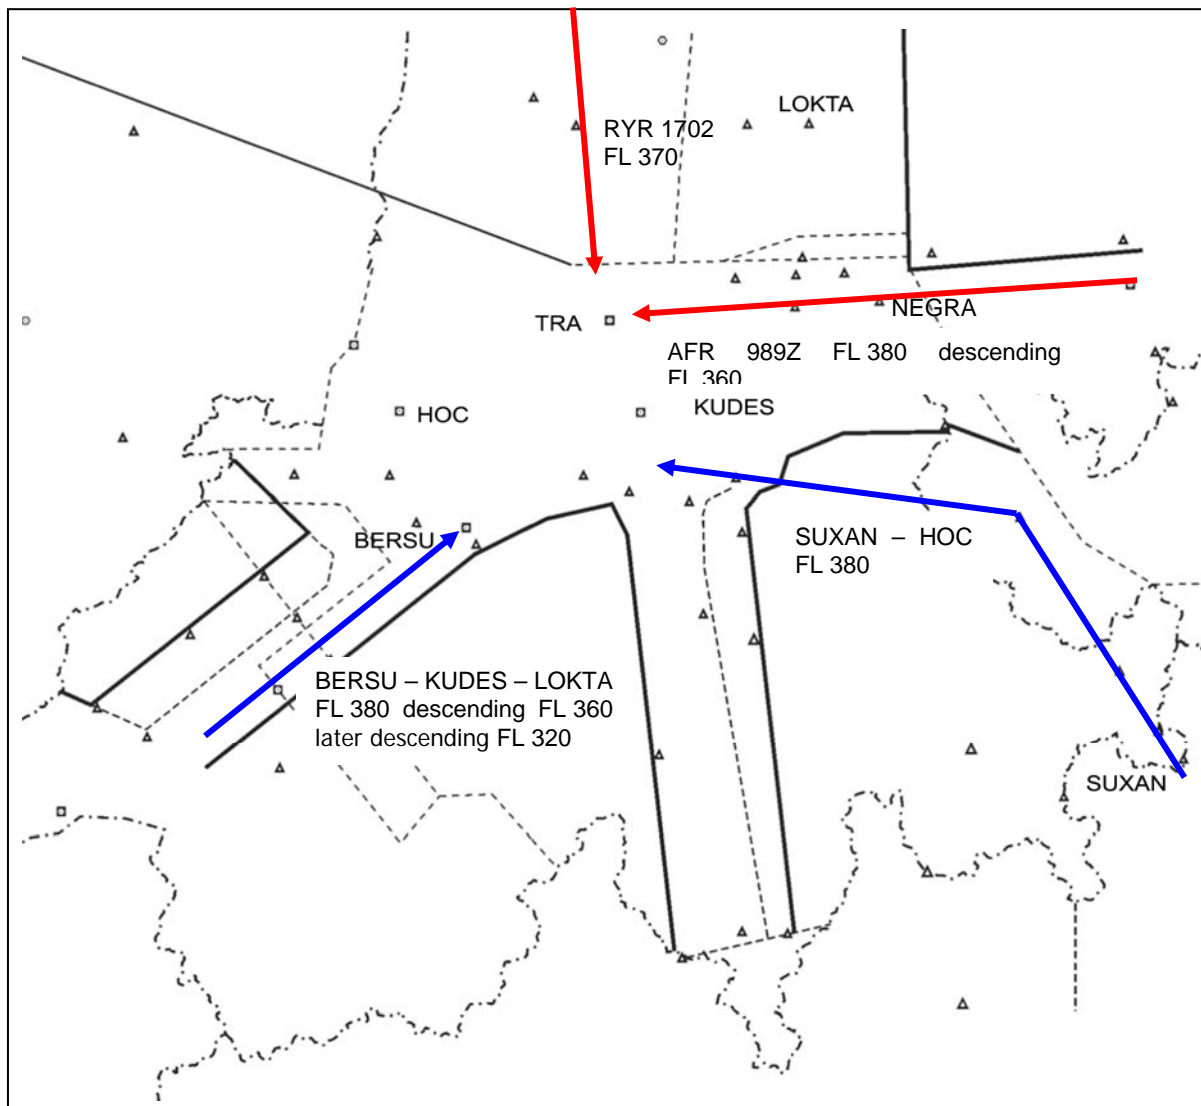
When the RP-M4 turned back to the radar display after two coordination conversations, he noticed AFR 989Z descending, shortly before the Trasadingen VOR. After repeating his question in this regard he received the RE-M4 trainee's answer, to the effect that this aircraft was descending.

**Figure 2:** Schematic representation of the flight paths of the aircraft from the south-west, direction waypoint BERSU and the aircraft from the south-east over waypoint SUXAN, direction NEGRA, with a shortcut through the airspace in military use (both shown in blue, both at FL 380). Flight AFR 989Z is approaching the TRA VHF omnidirectional radio beacon from the east at FL 380 and flight RYR 1702 from the north (both shown in red).

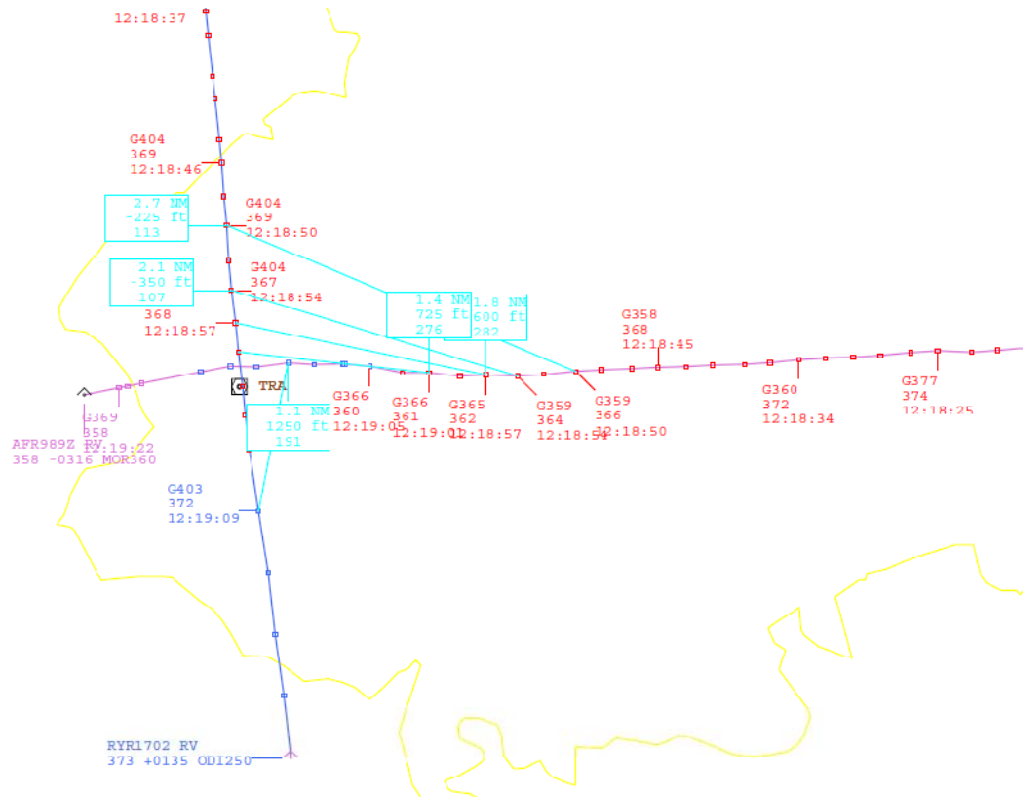
**Figure 3:** Radar recording of the crossing of AFR 989Z (red) and RYR 1702 (blue). The Trasadingen beacon (TRA) is shown in brown and the national frontiers are shown in yellow.

The radar recording shows that RYR 1702 first descended to FL 367 and then climbed back to FL 369. The two aircraft crossed above Trasadingen with a lateral distance of 1.4 NM and an altitude difference of 725 ft. Both crews continued their flights to their destinations.
