Vibrations, failure of the right main landing gear torsion link during landing roll

Aircraft	Boeing B737-300 registered G-CELD
Date and time	23 July 2011 at 8 h10 UTC ⁽¹⁾
Operator	Jet2.com
Place	Paris Charles de Gaulle Airport
Type of flight	Scheduled international transport of passengers
Persons on board	Captain; Co-pilot; 3 cabin crew; 128 passengers
Consequences	Right main landing gear damaged

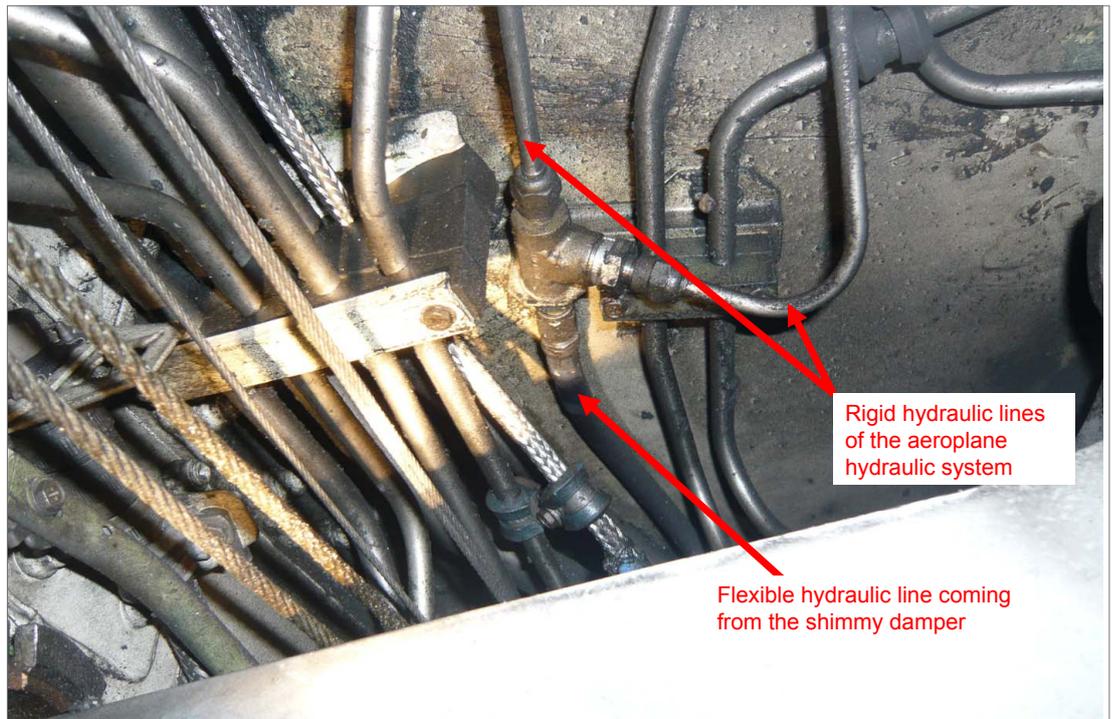
Figure 3 - Installation of lines in normal position

A flexible hydraulic line links the shimmy damper to the aeroplane hydraulic system, located in the upper part of the landing gear (see below).

On Friday 22 July 2011, the aeroplane underwent maintenance operations that included the complete replacement of the landing gear. These operations took place at the Jet2.com maintenance centre at Leeds/Bradford Airport. During installation of the new right main landing gear, the shimmy damper hydraulic line was not reconnected to the aeroplane's hydraulic system. The following day, the aeroplane took off bound for Paris Charles de Gaulle. This was the first flight after changing the landing gear.

- Jet2.com added some items on the landing gear change work card that specifically require checking the hydraulic connection on the shimmy damper and an independent check being made by a 2nd supervisor.

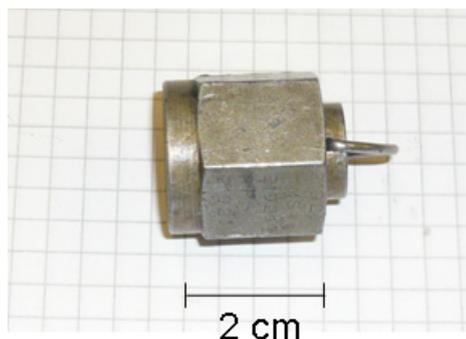
Figure 4 – Metal plug

The examinations undertaken after the accident showed that the threaded end that enabled connection of the flexible line to the hydraulic system at the level of the T-junction was blocked by a metal plug similar to that shown in figure 4 below.

This plug allows hydraulic pressure to be maintained in the aeroplane's hydraulic system even if the shimmy damper is not connected. The check tests that are performed at the end of the maintenance operation involve extending and retracting the landing gear ten times, with the aeroplane still jacked up. These tests do not engage the shimmy damper and did not make it possible to detect the anomaly.

The shimmy damper was thus not supplied by the aeroplane's hydraulic system. It could not then function normally. During the landing, the vibrations caused by the high speed of the wheels and the heavy braking could not be damped down. The strong vibrations quickly weakened the lower torsion link until it failed suddenly.

- A new technical procedure was published relating to managing and checking plugs to blank off hydraulic systems, as well as pneumatic and gas systems. This specified the attachment of identification tags visibly on the plugs used and making an entry in a log every time a plug is placed on a pipe or line. As soon as a plug is removed, a new entry in the log is to be made. At the end of the operation, the procedure requires a check that the number of plugs placed should be the same as the number of plugs removed.
