ENGLISH TRANSLATION OF MAIN TEXT OF VENEZUELAN ACCIDENT REPORT

JIAAC-9-058-2005

SYNOPSIS

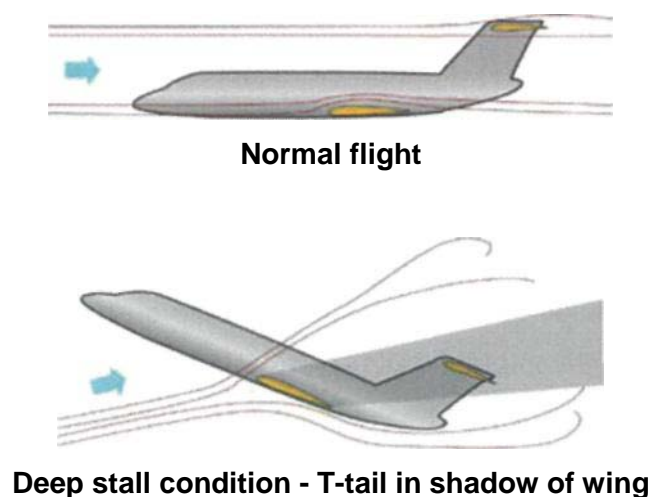
Fig. 53: Illustration of a deep stall

The tape stopped at 07:00:31 UTC. The site of the accident confirmed that the aircraft crashed in a nose-up attitude. This coincides with the data extracted from the FDR, and with the evidence obtained from the analysis carried out on the bulbs in the central warning panel, which indicates that the aircraft's anti-ice system was being used.

A deep stall is a very dangerous type of stall which affects certain aircraft designs, notably those with a T-tail configuration, like the MD-82. In these designs, the turbulent wake of the wing, which has stalled owing to the angle of attack, "blankets" the horizontal stabilizer, rendering it completely ineffective, with the result that the aerodynamic effects which allow control of and changes in pitch attitude (nose up and nose down) are lost, making it impossible for the aircraft to recover from the stall.
