Final report RL 2012:16

Serious incident between an aircraft with registration OO-DJX and a service vehicle at Landvetter Airport, Västra Götaland county, on 8 September 2011

Ref no: L-96/11

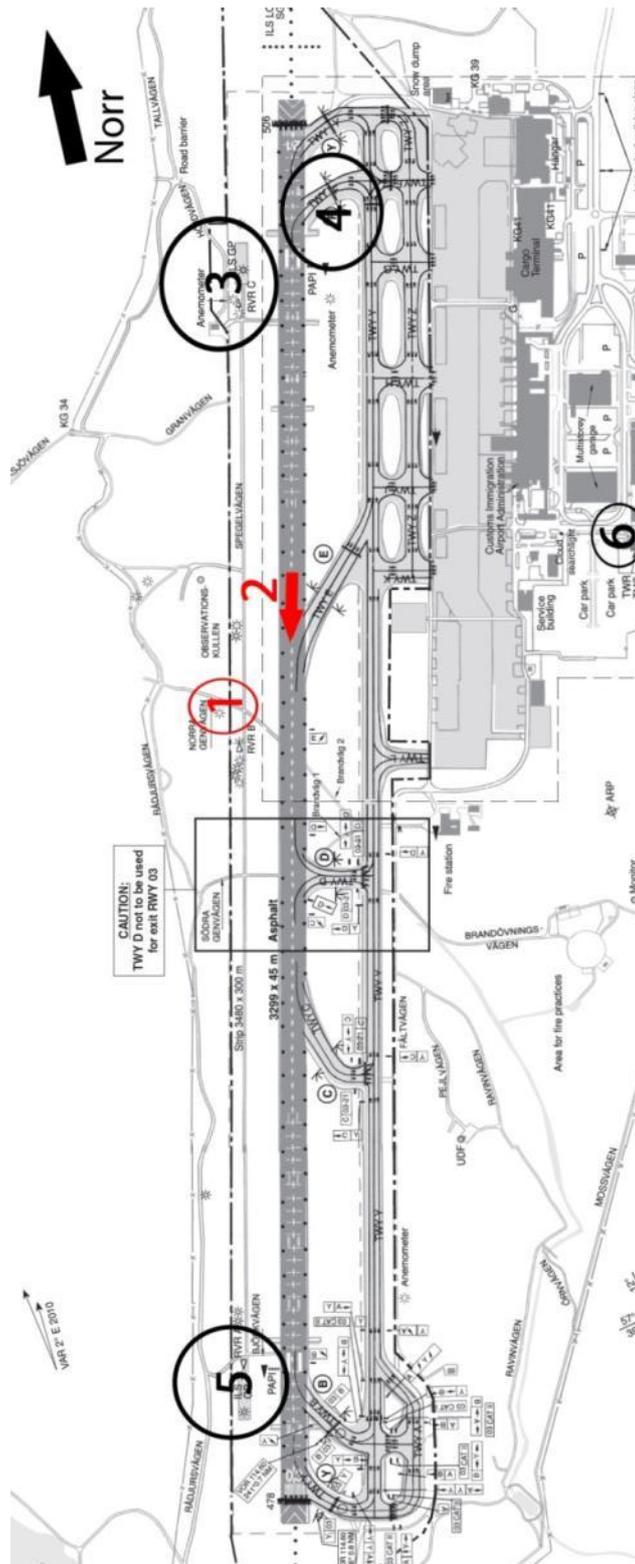
The vehicle RMS726 was on NORRA GENVÄGEN (see Fig. 1), which is situated west of the runway at Landvetter Airport, in order to drive out onto the runway. As the air traffic controller (AD2 – trainee with instructor) had in-

RMS726, which at this point was on NORRA GENVÄGEN, started to drive towards the runway, whereupon the driver perceived a light from the left at the same time as he heard a rumbling noise. He spotted the aircraft which was taking off and stopped immediately.

Fig. 1. Ground map of Landvetter Airport. The markings indicate the approximate positions and directions of the ground vehicles and the aircraft at the time of the incident. 1. RMS726, 2. Aircraft performing take-off, 3. KIOSK211, 4. Service vehicles 238+235, 5. GPO3, 6. Air control tower.

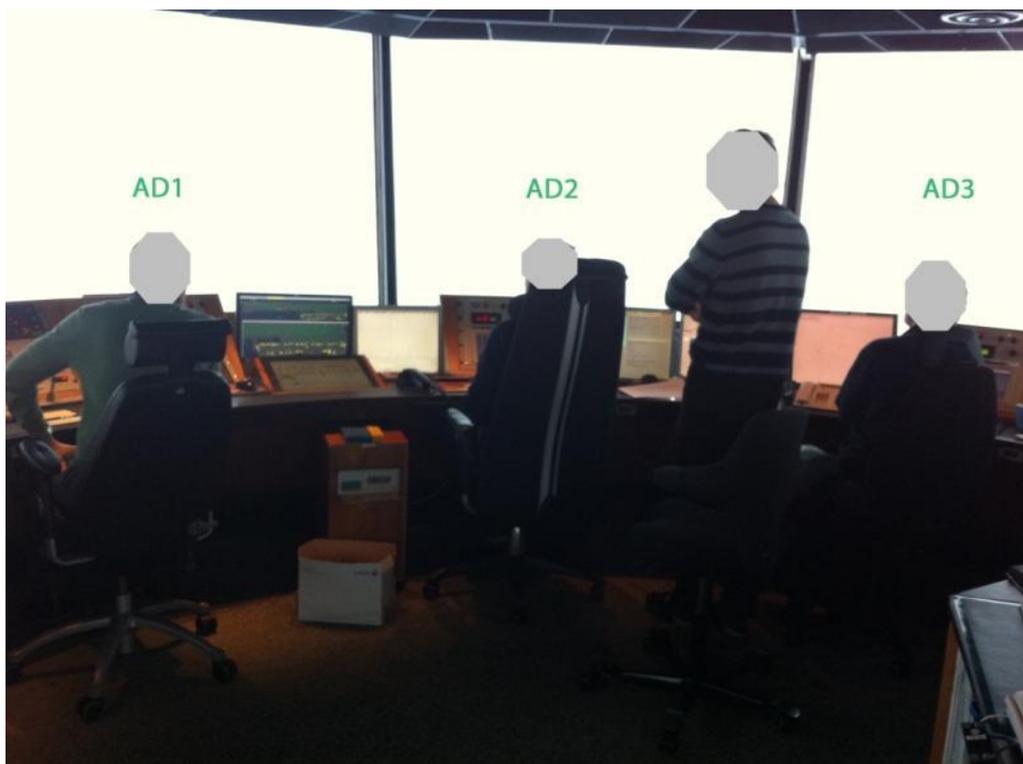
In the tower at Landvetter Airport, there were three air traffic controller positions, AD1, AD2 and AD3 (see Fig. 2). At the time of the incident, two positions were open according to the configuration for basic staffing, i.e., AD2 put together with AD3 and AD1 as a separate position. AD1 was manned by an individual air traffic controller who was responsible for the runway as well as incoming and outgoing traffic. AD2 was manned by a trainee and instructor, who were responsible for taxiing, clearance and vehicle traffic. The instructor was positioned just behind the trainee in AD2. Minutes before the present incident, the instructor and trainee were relieved by an individual air traffic controller so that they could go to lunch.

Fig. 2. The Landvetter tower - placing of the air traffic controller positions AD1, AD2 and AD3 (Photo: SHK. The picture was taken on a different occasion).

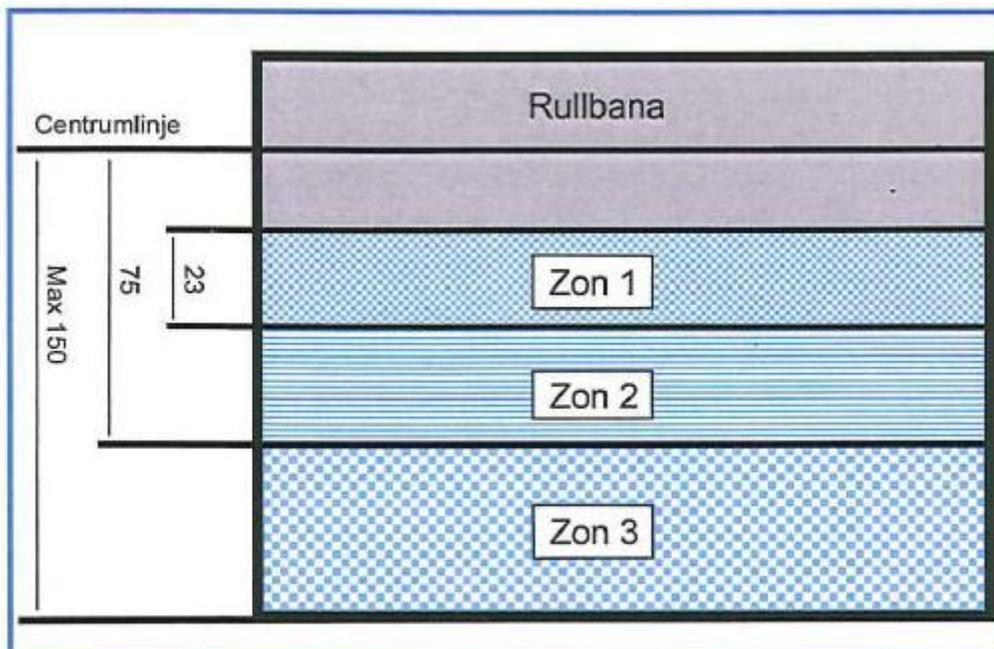
Fig. 4. Zone division.

At this point, RMS726 was 27 metres from the white stripes at the side of the runway and 50 metres from the runway centre line, and was therefore in zone 2 (see Figure 4), all according to information from the aviation safety coordinator at Landvetter Airport.

- *Zone 1 runs from the edge of the runway to 23 m from the same.*
- *Equipment/vehicles are not permitted when the runway is open for traffic.*
- *Zone 2 runs from the outer edge of zone 1 to 75 m from the runway centre line.*

According to Landvetter Airport's aviation safety coordinator, there were 27 metres between RMS726 and the edge line of the runway when the vehicle stopped. At the time of the incident, there were signs marking where it was permitted for vehicles to move without permission from air traffic control.

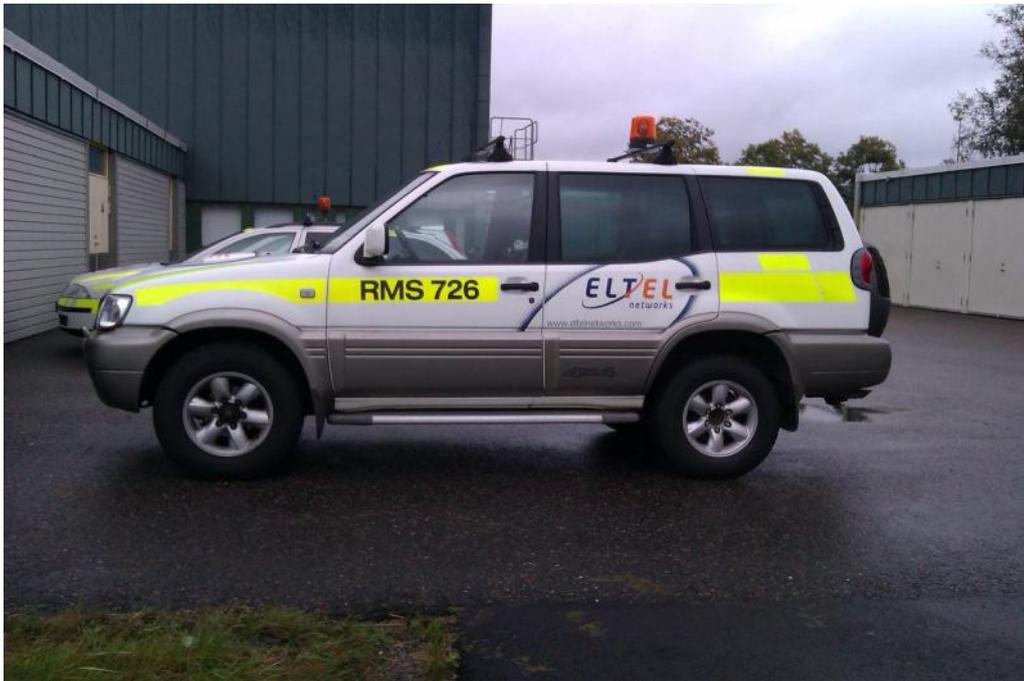
Fig. 6. The vehicle RMS726 (Photo: Swedavia).

The driver of RMS726 spoke Swedish with an English accent. The air traffic controllers at Landvetter explained that RMS726 tended to stay by KIOSK211. According to interviews with the driver of RMS726, the rotating warning lamp on the roof of the vehicle was activated when the incident occurred.
