LOSS OF SEPARATION

The incident which is described below took place in the middle of the day in the terminal area near a major European airport. The three aircraft involved were operated by major European airlines. The details of the incident have been changed to protect confidentiality but the facts are very much as they happened.

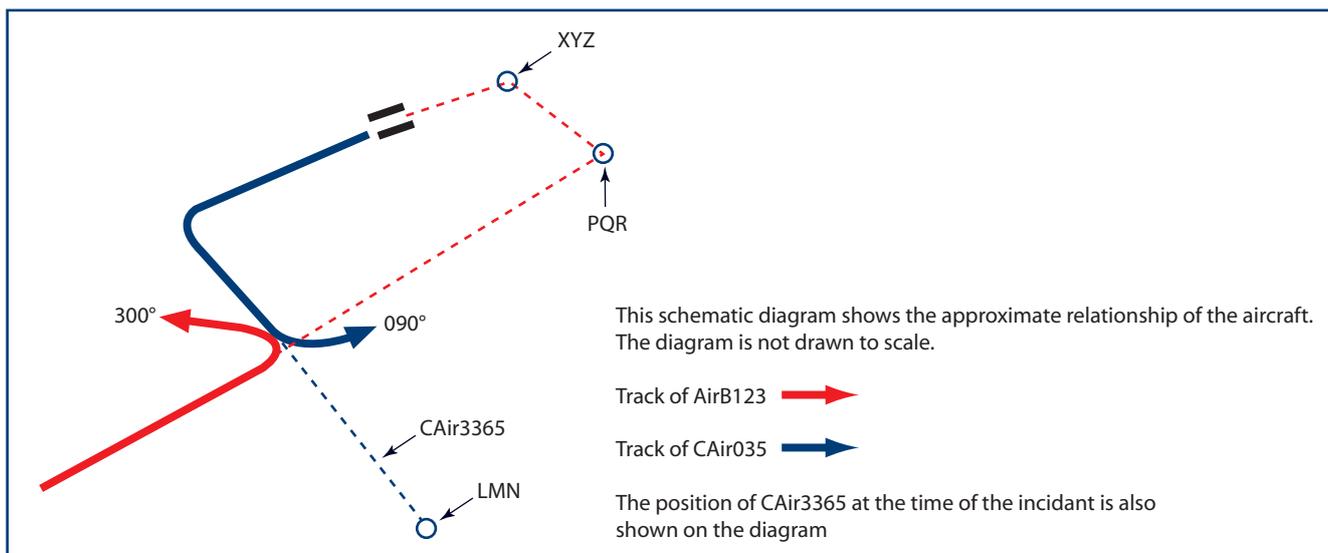
At 1206.30, AirB123 informs INI that he has the traffic in sight on his right hand side. The aircraft pass 1.5nm apart, both at FL096, descending.

The pilot of CAir035 received a TCAS "climb" RA and reported to ATC that he was following it however he apparently continued to descend in accordance with ATC avoiding instructions.
