**CZ-10-229**

# **FINAL REPORT**

**Air accident involving  
Airbus A321-131, registration mark D-AIRT  
And  
Boeing B737-8BK, registration mark TC-SNM,  
On 18<sup>th</sup> June 2010 at LKPR.**

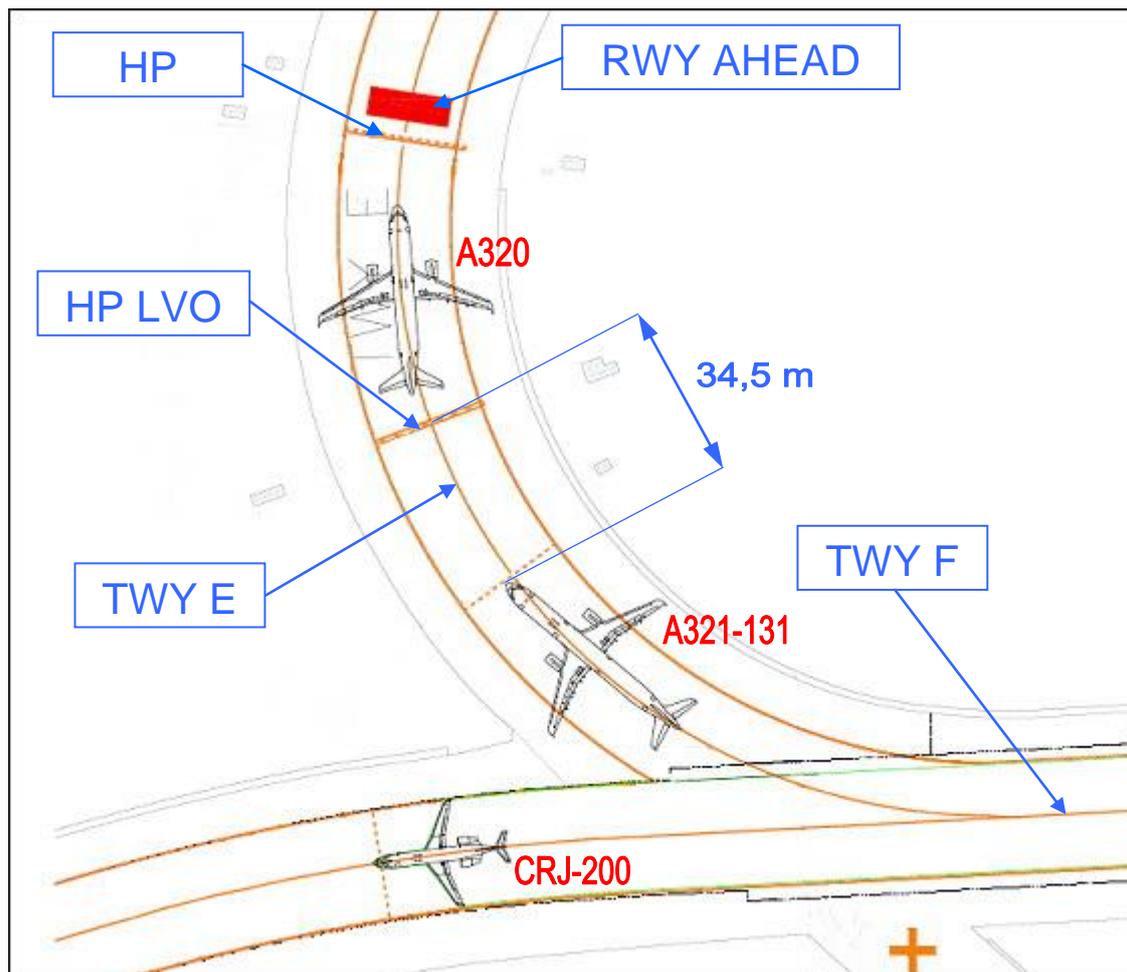
Scheme 1

RWY 06 was the runway in use at LKPR. Operation took place in the morning rush hours. The A321-131 crew began taxiing at 08:26:21 from the stand 17 on TWYs H, F, E following ATS instructions. The A321-131 crew stopped at the crossing TWY F and TWY E and after a short hold (ca 5 seconds) went a little bit farther on TWY E. The A321-131 nose was more than 34.5 m behind the A320 that was standing in front of it at the RWY 06 holding point. On TWY E the A321-131 crew reported “ready at sequence” at 08:31:40. At 08:34:45 an airplane CRJ-200 taxiing on TWY F to RWY 06 holding point passed behind the A321-131 (see Scheme 1). The distance between the CRJ-200 wing tip and the A321-131 tail was ca 6 m.

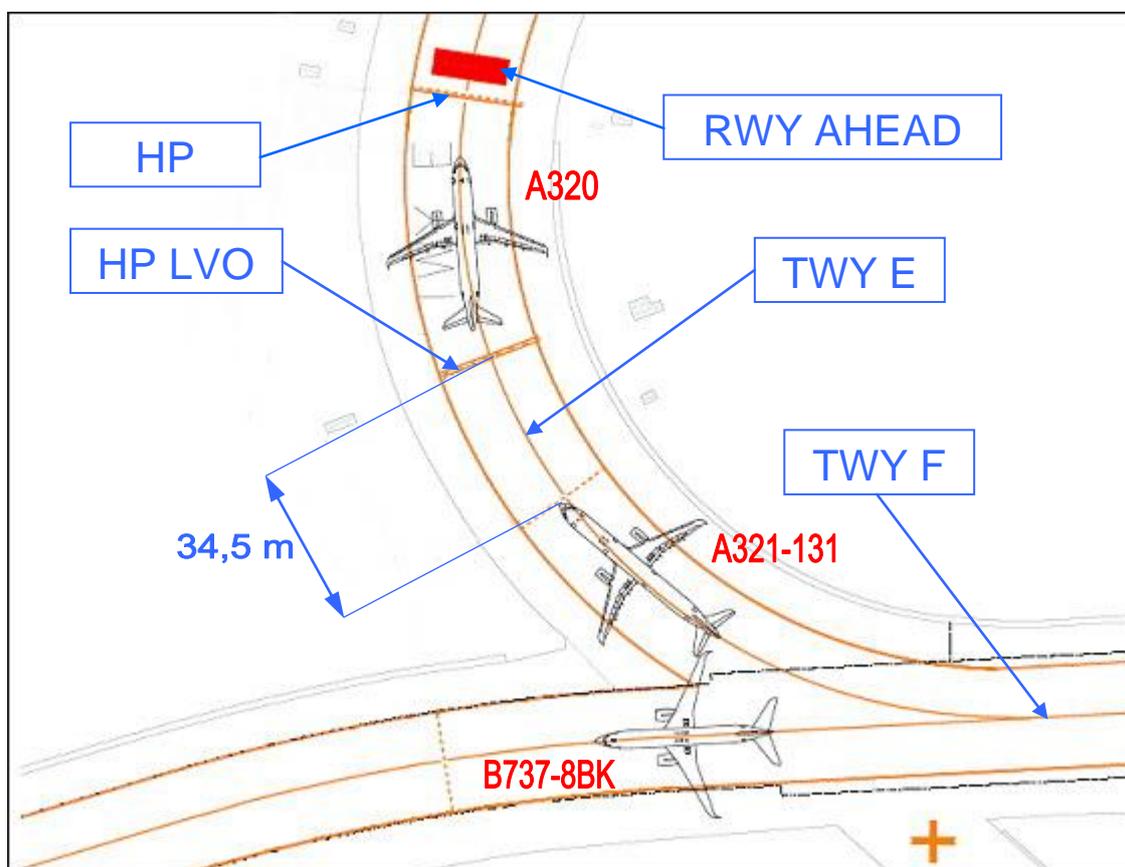
Scheme 2

At 08:37:04 the B737-8BK crew reported it could start from RWY 06 / TWY E intersection and stopped at TWY F on TWY FF level. TWR-GEC issued an instruction, for operational reasons, "continue to the end please". At 08:37:40 the B737-8BK crew continued its further taxiing on TWY F toward THR RWY 06. During this taxiing the B737-8BK right winglet struck the stabiliser of the A321-131 standing on TWY E (see Scheme 2). After the collision the B737-8BK crew stopped. At 08:38:23 the B737-8BK crew reported the event over the TWR-GEC frequency.

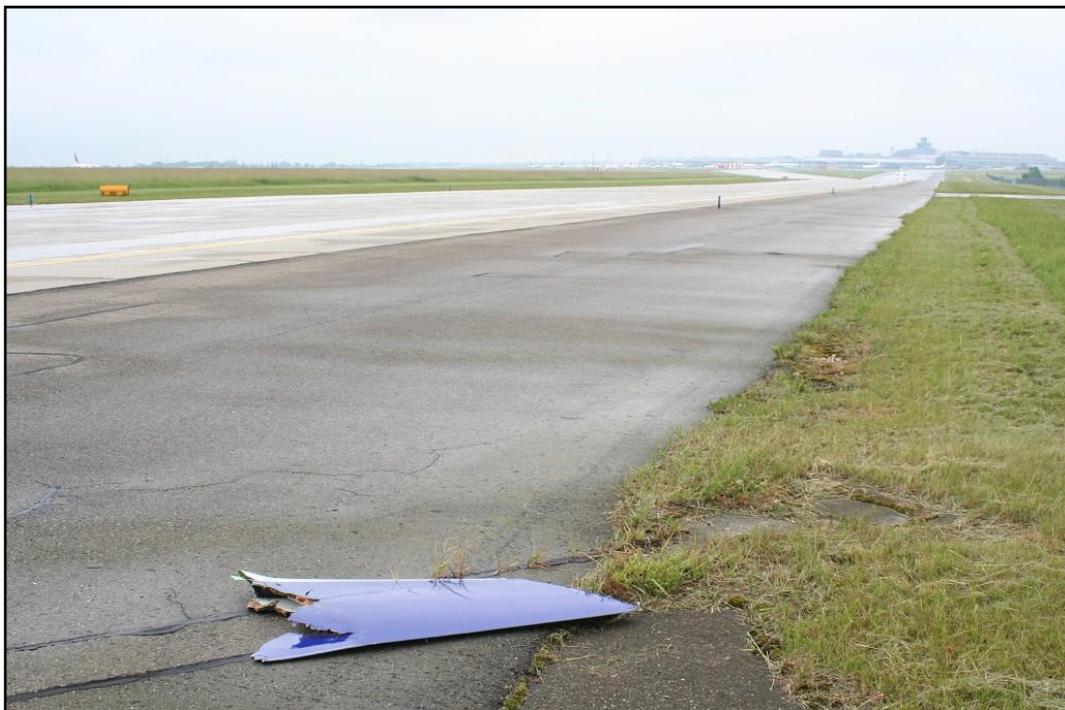
Fig. 2 Scene of the collision and a B737-8BK right wing winglet piece long approx. 1.2 m.

- At 08:47:40, an RPL dispatcher came to the TWY F / TWY E intersection and removed a piece of the B737-8BK winglet about 1.2 m long.
- At 08:58:22, RPL checked RWY 06/24 for clearance after the damaged B737-8BK had passed, and reported RWY 06/24 serviceability to TWR.

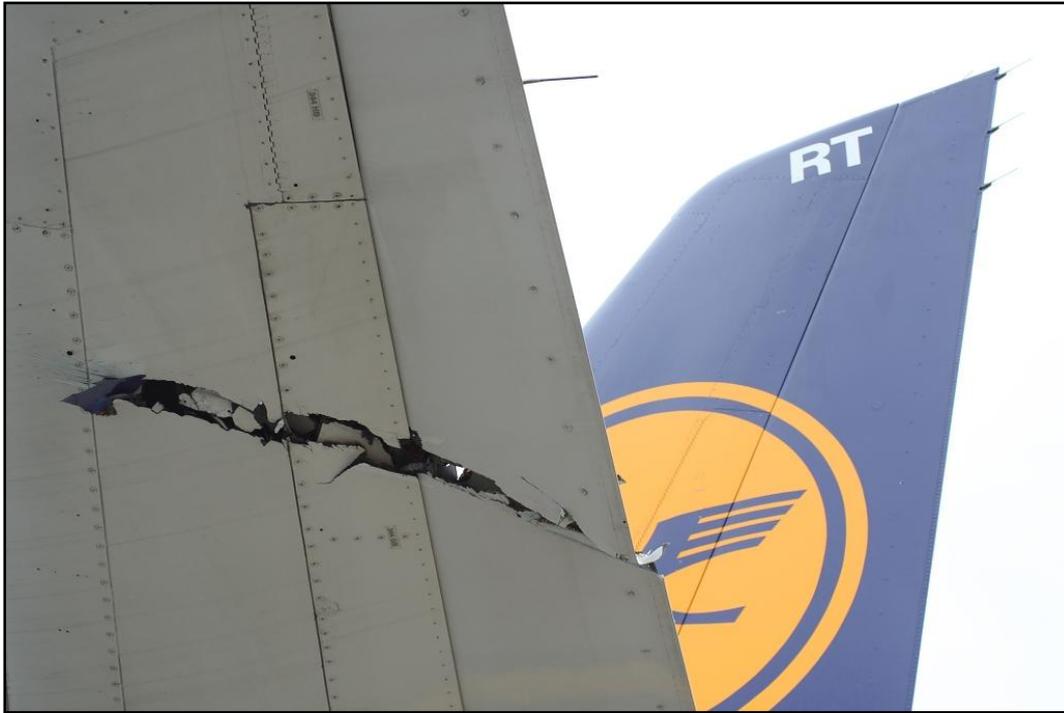
The A321-131 - Left stabiliser and left elevator damaged.  
The B737-8BK - Right winglet damaged.

Fig. 3 Damage to A321-131 left rudder and stabiliser.

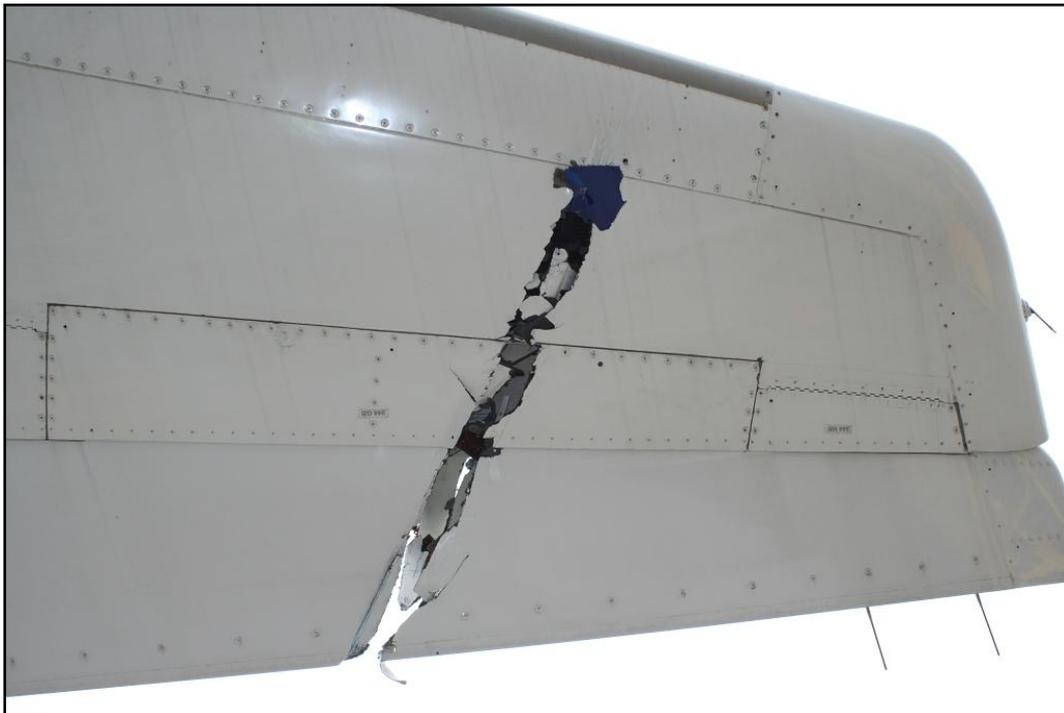
Fig. 4 Damage detail of A321-131 left rudder and stabiliser.

- At 08:38:07 there was a collision as the B737-8BK right winglet hit the A321-131 left elevator and left stabiliser.
- At 08:38:18 the B737-8BK stopped on TWY F behind the intersection with TWY E.

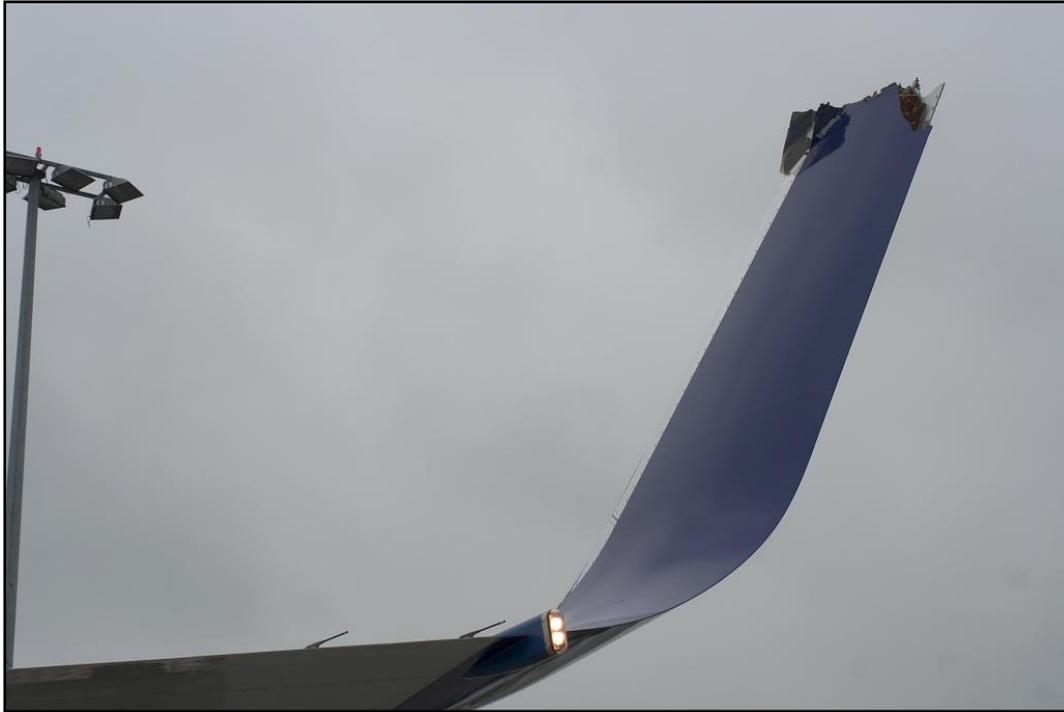
Fig. 5 Damage to B737-8BK right wing winglet.

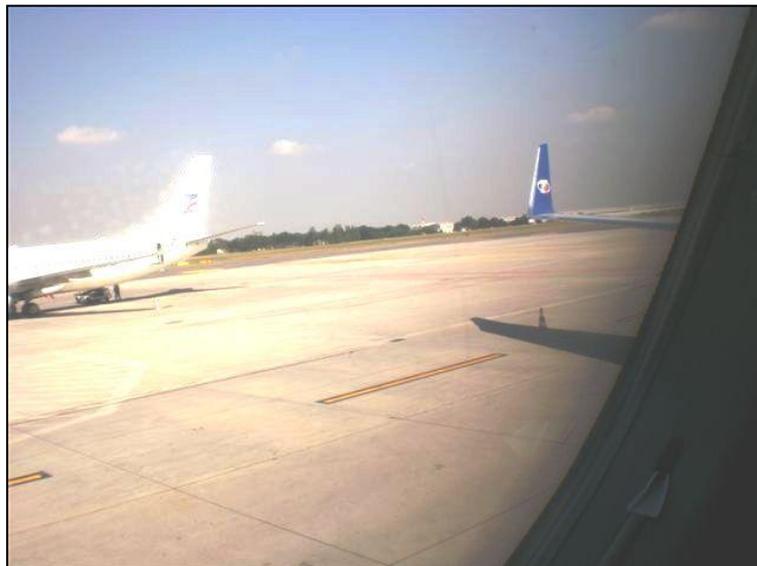
FO confirmed this information. The reality whether FO could have seen end of wing from his seat was check experimentally.

Fig. 6. View from the right seat of cockpit to end of right halves of wing B737-800

- The PIC relied on FO's information on the clearance between the wing and the second airplane, the piece of information FO was not able to determine uniquely from his position.

- The B737-8BK crew did not make good assessment of the distance between their right wing tip and the A321-131. FO was not able to tell the distance uniquely.
- Both of the crews did not make good judgement of the gravity of the situation, did not ask for the damage scope assessment on the scene, and taxied with their damaged aircraft back to the apron.
- The TWR shift leader decided not to put HZS on the alert Air Accident since he had not enough information available at that time.
