DATA SUMMARY

Date and time	Thursday, 20 April 2010; 03:59 local time¹
Site	Zaragoza airport (Spain)

Registration	UR-82029
Type and model	ANTONOV 124-100
Operator	Antonov Design Bureau

REPORT

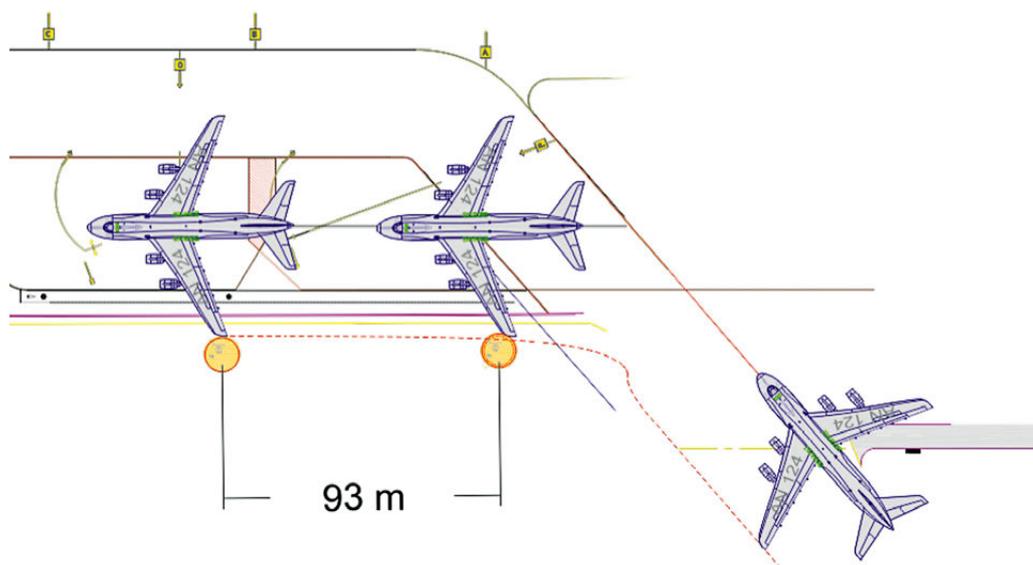
Figure 1. Path taken by the aircraft to the parking stand

The aircraft followed the car via taxiway TA and C2-2 to the parking apron. The aircraft exceeded the dimensions of the available parking stands at the airport, so it was assigned to parking stands O and N. On previous occasions, before parking stands were made available for B747 aircraft, these stands had been used for B747-type aircraft.

Once the aircraft reached the apron, the marshaller exited the car to provide parking instructions to the aircraft. The crew followed the indications given by the marshaller but during the maneuver, the left wingtip struck the number 6 light tower on the apron. The aircraft continued forward and struck the number 7 light tower, damaging the navigation light at the end of the wing, at which point the aircraft was stopped.

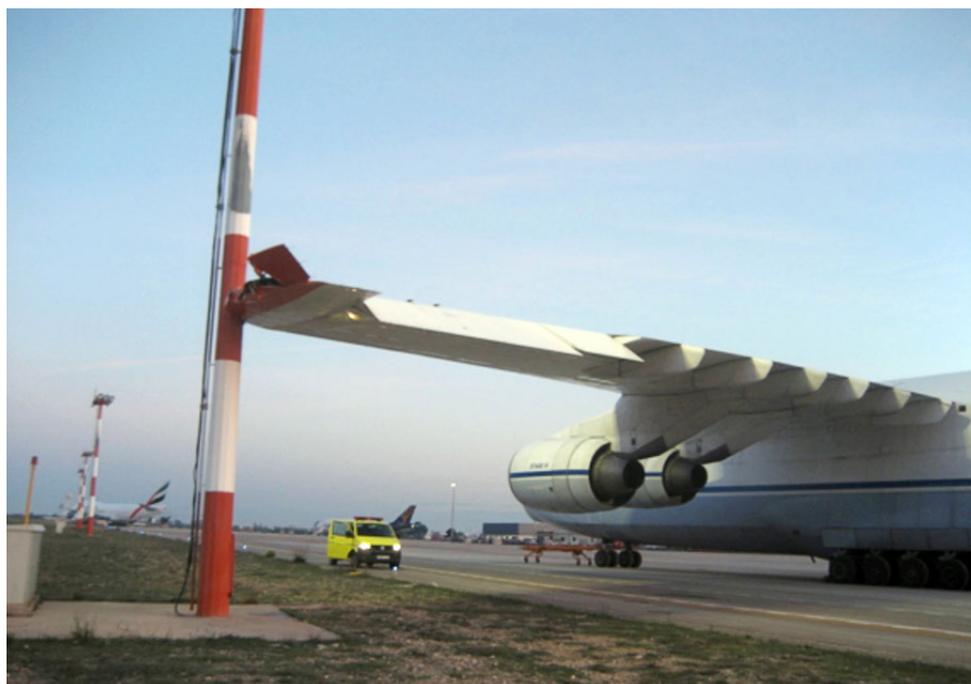
Figure 2. Damage suffered by the aircraft

Part of the aircraft's left wingtip was broken off as a result of the impact with the light tower on the apron, which itself had been scratched by the impact.

Signs of a second impact were also evident on the navigation light on the same wing. This impact took place when the aircraft struck the second light tower.

REC 14/12. It is recommended that Aena restrict as much as possible the practice of parking an aircraft in a stand that is not properly marked and sized for the aircraft's dimensions. In those cases in which this practice is employed, a specific procedure should be developed that defines the risks present and the criteria to be used by personnel and means to mitigate said risks.
