**ACCIDENT**

<b>Aircraft Type and Registration:</b>	Airbus A319-111, G-EZJV
<b>No &amp; Type of Engines:</b>	2 CFM56-5B5/3 turbofan engines
<b>Year of Manufacture:</b>	2010 (Serial no: 4327)
<b>Date &amp; Time (UTC):</b>	14 February 2012 at 1359 hrs
<b>Location:</b>	London Luton Airport
<b>Type of Flight:</b>	Commercial Air Transport (Passenger)
<b>Persons on Board:</b>	Crew - 6                      Passengers - 142
<b>Injuries:</b>	Crew - None                      Passengers - None
<b>Nature of Damage:</b>	All landing gear legs exceeded their maximum certified load
<b>Commander's Licence:</b>	Airline Transport Pilot's Licence
<b>Commander's Age:</b>	45 years
<b>Commander's Flying Experience:</b>	10,700 hours (of which 500 were on type) Last 90 days - 128 hours Last 28 days - 61 hours
<b>Captain U/T's Licence:</b>	Airline Transport Pilot's Licence
<b>Captain U/T's Age:</b>	37 years
<b>Captain U/T's Flying Experience:</b>	3,998 hours (of which 672 were on type) Last 90 days - 170 hours Last 28 days - 19 hours

<b>Information Source:</b>	AAIB Field Investigation

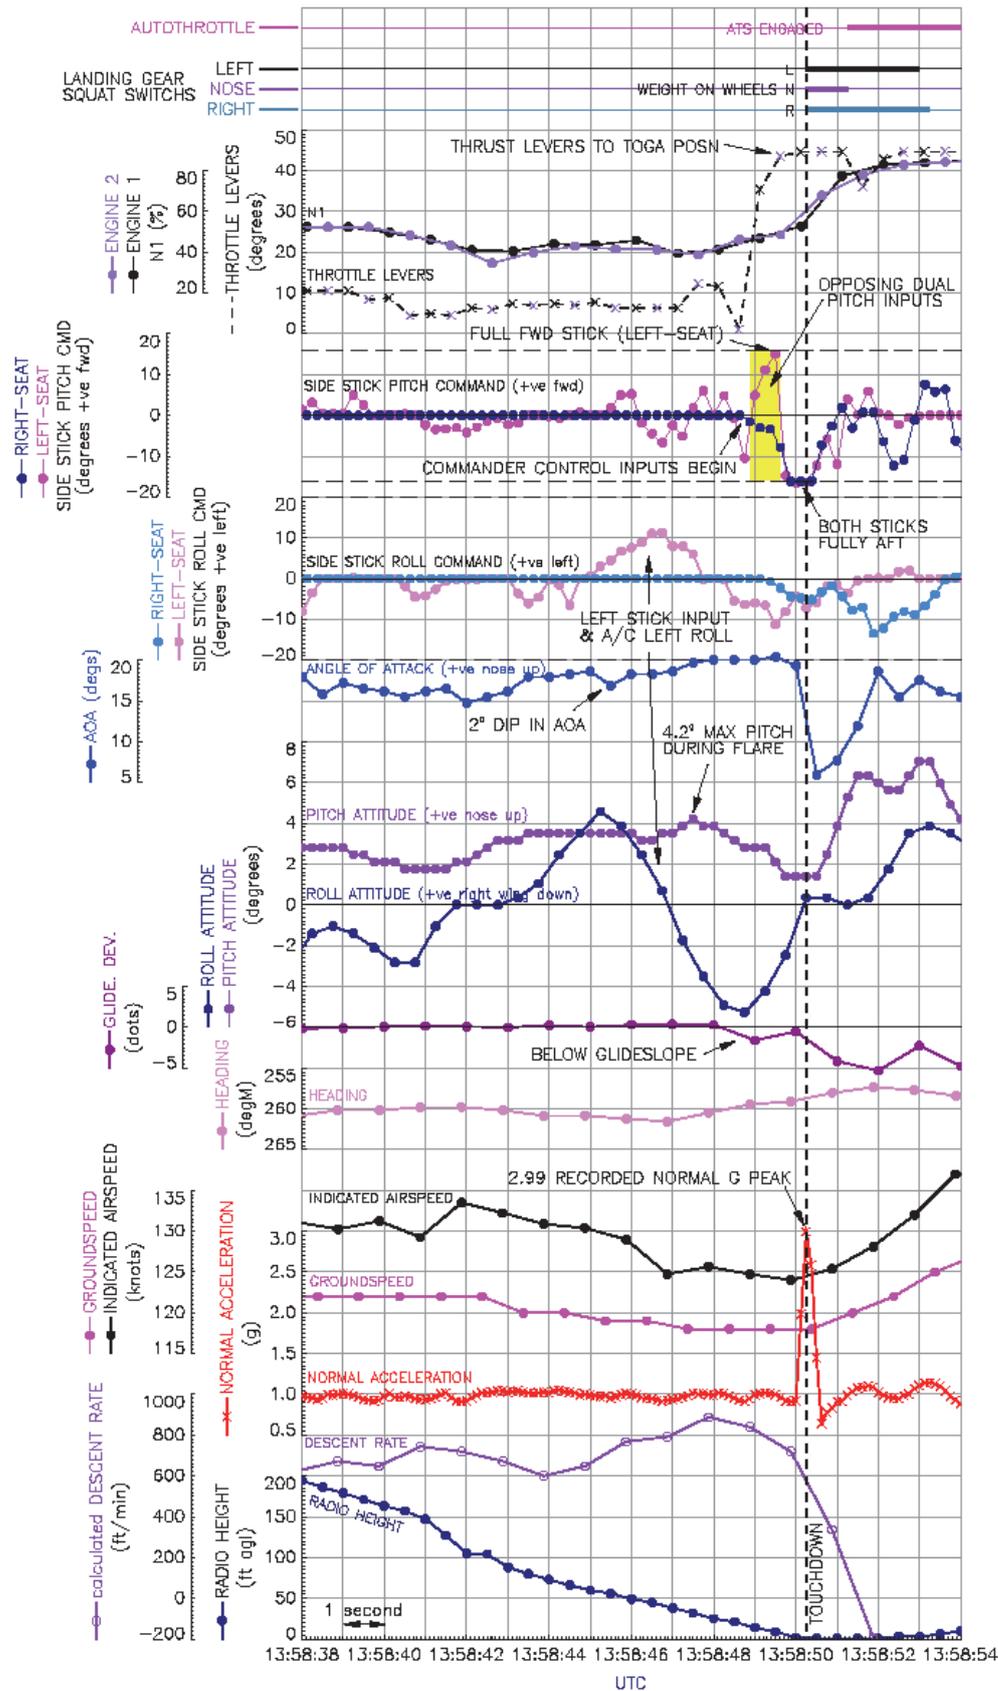
Figure 1 shows the salient recorded parameters approaching the touchdown. The data illustrated starts at 1358:38 hrs, with the aircraft at 200 ft agl, 130 kt indicated airspeed and descending at 625 ft/min. At this point the aircraft's attitude was 3° nose-up and 2° left wing low. Left-seat sidestick control inputs were made which resulted in the aircraft rolling wings level as it descended through 100 ft agl. The wings remained level for just over one second before further inputs rolled the aircraft right (to 4.5° at 60 ft agl), then left (to 5.5° at 21 ft agl), then back to wings level at touchdown.

As the aircraft descended through 60 ft agl, at 1358:46 hrs, a momentary 2° reduction in angle of attack was recorded while the pitch attitude remained steady at 3.5° nose-up. A maximum pitch attitude of 4.2° occurred at 32 ft agl, 2.5 seconds before touchdown. This was followed by some pitch-down control inputs (from the left seat) which resulted in a decreasing pitch attitude, the descent rate peaking at just under 900 ft/min, and the aircraft descended below the nominal glideslope. The left-seat pilot then applied an aft sidestick control input of 10° (out of a maximum of 16°) which was coincident with a small aft-stick input by the commander. Both thrust levers were then advanced to the TOGA position. However, there was also a simultaneous forward sidestick input of 15° from the left seat pilot, which was countered by an aft input of 8° by the commander (ie a net input of 7° forward). Both sidesticks were then moved to the fully aft position. Half a second later the aircraft touched

down on all three landing gear simultaneously, during which a normal acceleration of 2.99 g was recorded. The aircraft then lifted off, completed a go-around and returned for an uneventful landing.

Salient FDR parameters for incident touchdown at Luton
