Investigation report

C1/2010L

AVRO RJ85 Jetliner Fuel Feed Low Level Failure During the Cruise Phase on 17 December 2009

OH-SAK

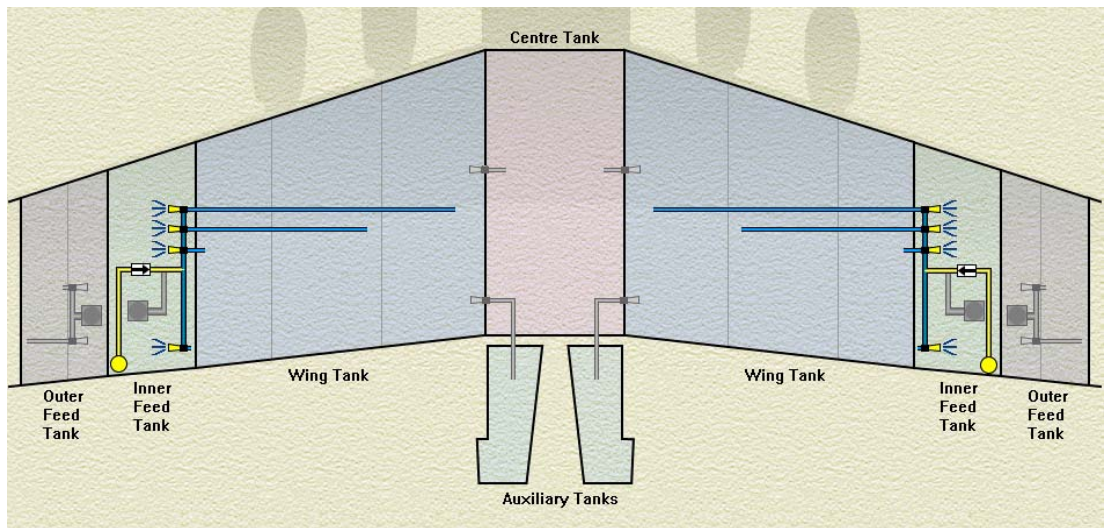
Figure 1. Fuel tank and boost pump arrangement. Source: BAE Systems.

Whereas fuel feed is normally engine-specific, common feed and cross feed arrangements make it possible to supply fuel to any engine with any boost pump. Should the electric boost pumps fail, the jet-pumps are driven by hydraulic standby pumps and the engines draw the fuel from the feed tanks. The fuel pump arrangement is presented in figure 1 of appendix 2.

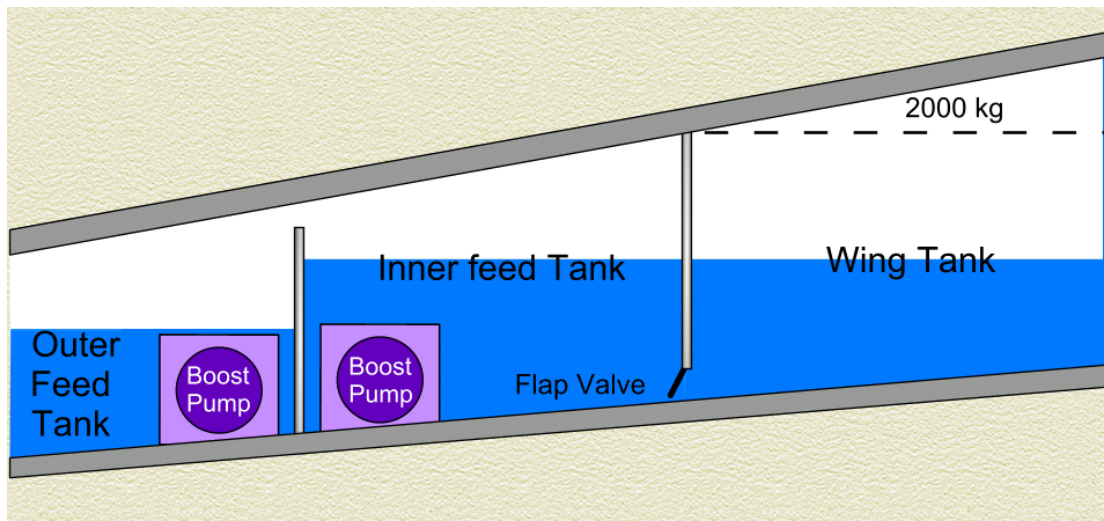
Figure 2. Wing cross-section. Source: BAE Systems.

Should the hydraulic standby pumps fail as well, most of the fuel can be supplied to the engines by means of gravity feed and engine-generated suction. A mechanical flap valve will permit the fuel to flow from the wing tank compartment to the inner feed tank. In addition, fuel will flow from the inner feed tank to the outer feed tank over the high level weir which is open at the top. The wing's cross-section is presented in figure 2 of appendix 2.
