RUNWAY EXCURSION SOUTHWEST AIRLINES - BOEING 737 OVERRUN

This article contains a brief summary of the full accident report, which may be viewed on the US National Transportation Safety Board (NTSB) web-site: <http://www.ntsb.gov/publictn/publictn.htm>

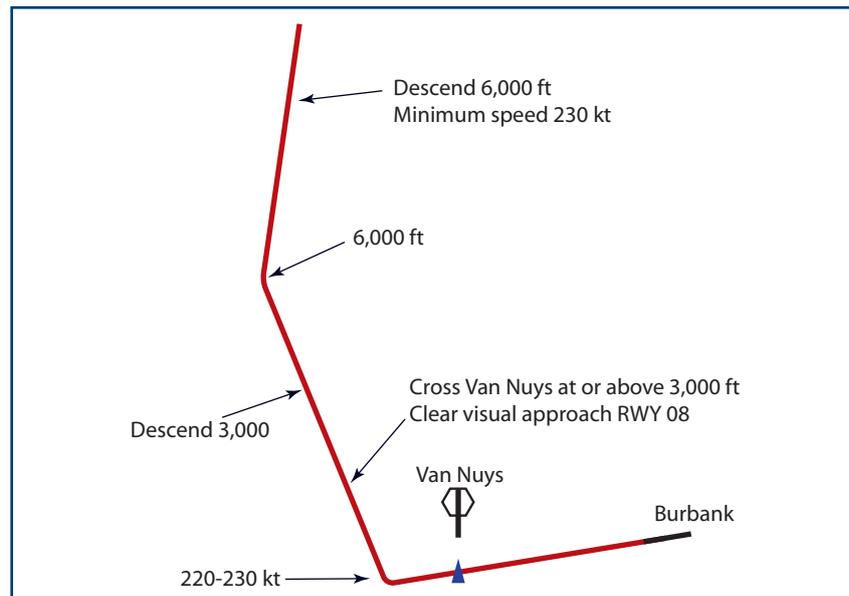
The aircraft departed the right side of the runway, penetrated a metal blast fence and an airport perimeter wall, and came to a stop on a city street off the airport property. An emergency evacuation ensued, and all crewmembers and passengers successfully exited the aircraft.
