National Transportation Safety Board

Accident Number: DCA11MA039
Operator/Flight Number: Southwest Airlines, Flight 812
Aircraft and Registration: Boeing 737-3H4, N632SW
Location: Yuma, Arizona
Date: April 1, 2011
Adopted: September 24, 2013

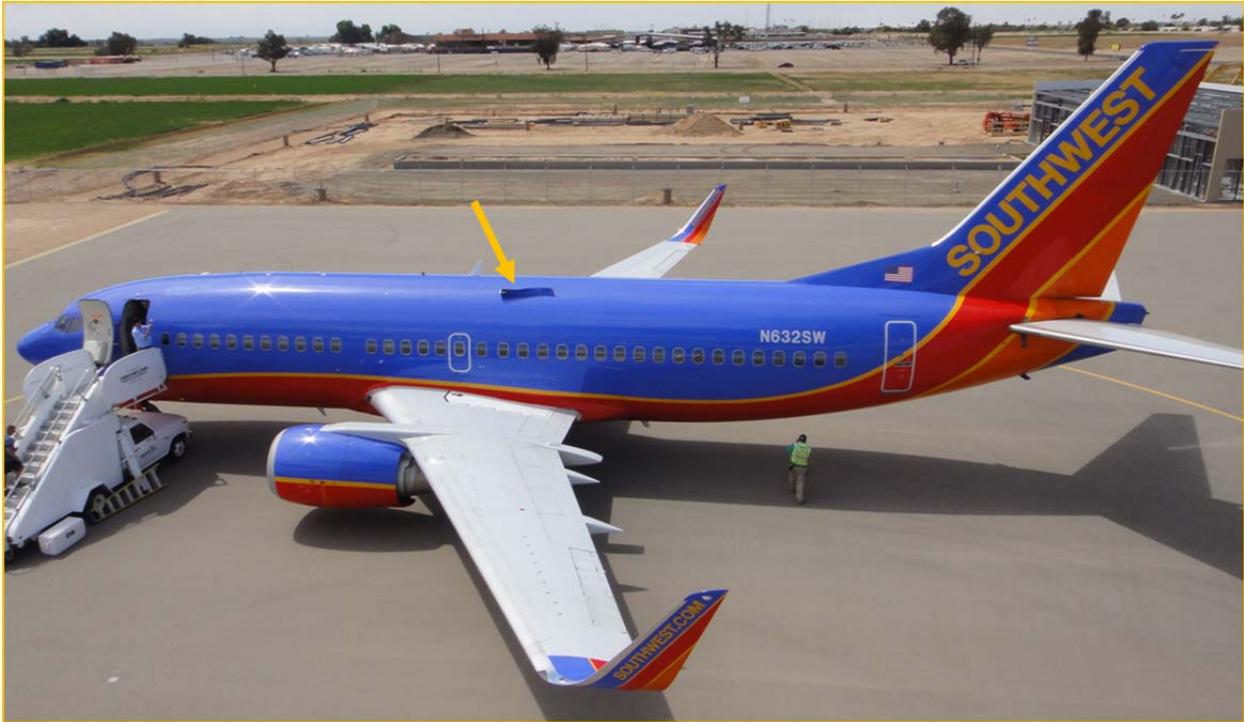
Postaccident inspection of the airplane revealed that a section of fuselage skin about 60 inches long by 8 inches wide had fractured and flapped open on the upper left side above the wing (see figure 1). The damaged section of fuselage side skin was bounded by body station² (BS) 663 and BS 727 in the fore-aft direction and stringer³ (S)-4L and S-5L in the circumferential direction (see figure 2). S-4L is the location of a lap joint with three rivet rows. The entire section of skin remained attached along the lower edge and was deformed outward. There were some abrasion marks on the fuselage skin below the forward edge of the hole that matched the shape of the forward edge of the attached section. The fracture along the upper edge was through the lower rivet row of the lap joint. The forward edge was fractured about 1/2 inch aft of the edge of the bonded doubler at BS 663. The aft edge was fractured along the forward rivet row of the BS 727 butt joint. There was some deformation to the intercostal installed between the BS 663 and BS 685 frames. There was no visible damage to the surrounding frames, stringers, and stringer clips. Some insulation was missing from the location around the hole. During the postaccident skin repair, two cracked stringer clips were found along S-4L (at BS 685 and at BS 706).

Figure 1. Photograph of N632SW with the hole in upper left fuselage.

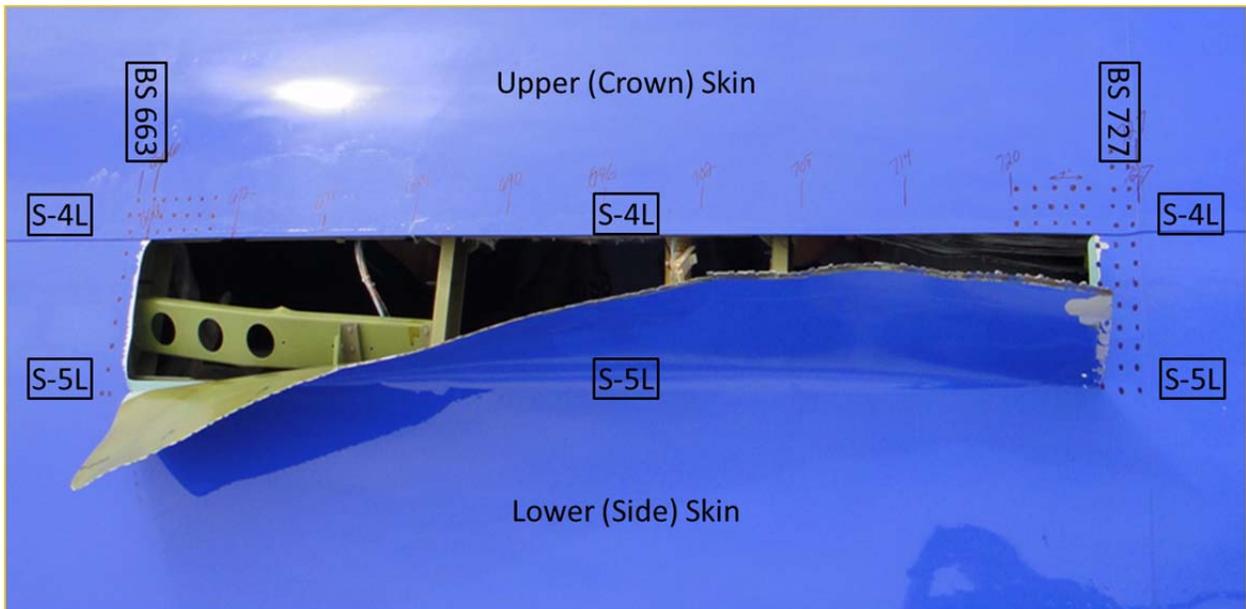
Figure 2. Close-up photograph of hole in fuselage side skin on N632SW.

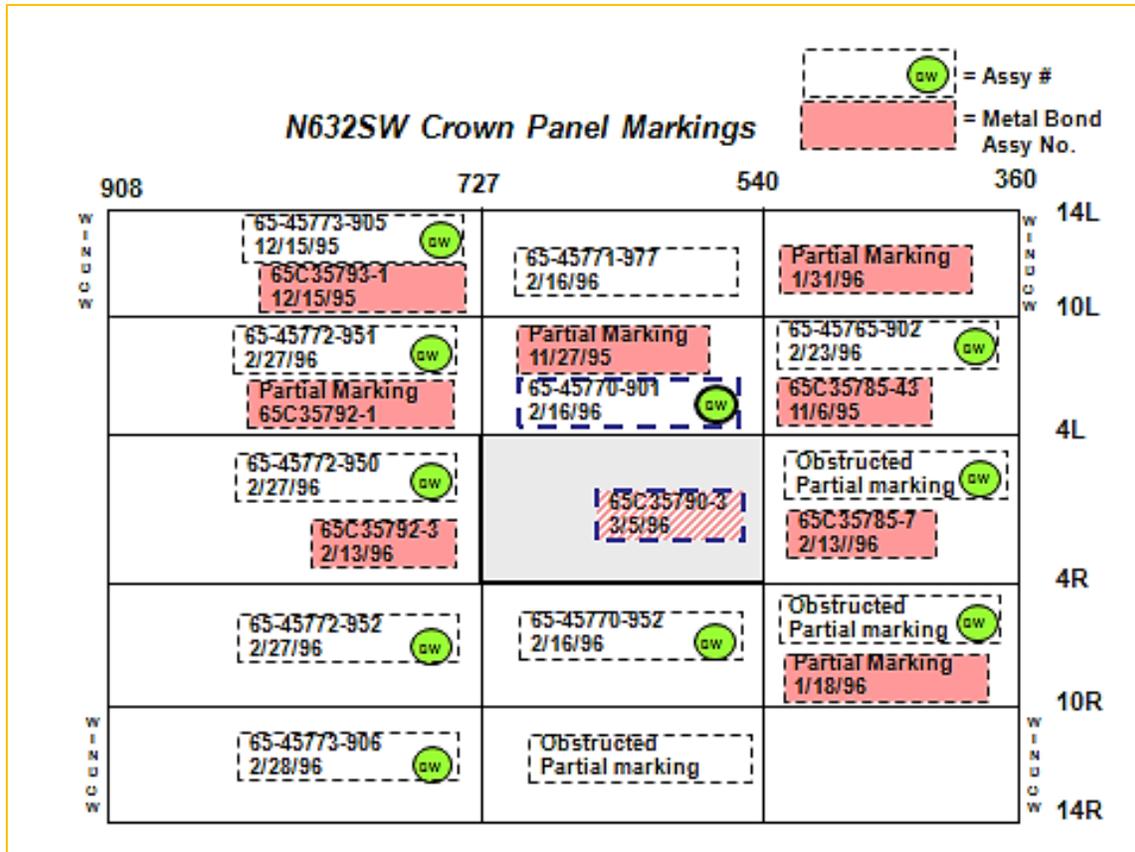
After the accident, all of the airplane’s interior components and insulation were removed, allowing examination of the interior surface of the fuselage skins. The visible markings on the skin panels⁵ surrounding the crown skin panel (BS 540 to BS 727, S-4L to S-4R) immediately above the fractured skin panel were documented. Typically, a skin panel should have two markings: one for the manufacture of the skin panel itself and one for the manufacture of the built-up panel assembly. Additionally, the built-up panel assembly should have a marking to indicate that the assembly had been approved by the QA process. Figure 3 shows the markings on the accident airplane. The three-panel crown assembly from S-10L and S-10R that included the fracture had QA stamps dated February 16, 1996, with the exception of the grey panel in figure 2. The panel assemblies aft of the accident crown panel had QA stamps dated February 27, 1996. One of the three panel assemblies forward of the accident crown panel had a QA stamp dated February 23, 1996, while the other two markings were obstructed. The accident crown skin panel above the fracture and coincident with the lap joint where the fracture occurred only had a stamp for the skin panel manufacture and was dated March 5, 1996.

Figure 3. Documented markings on the accident airplane skin panels.

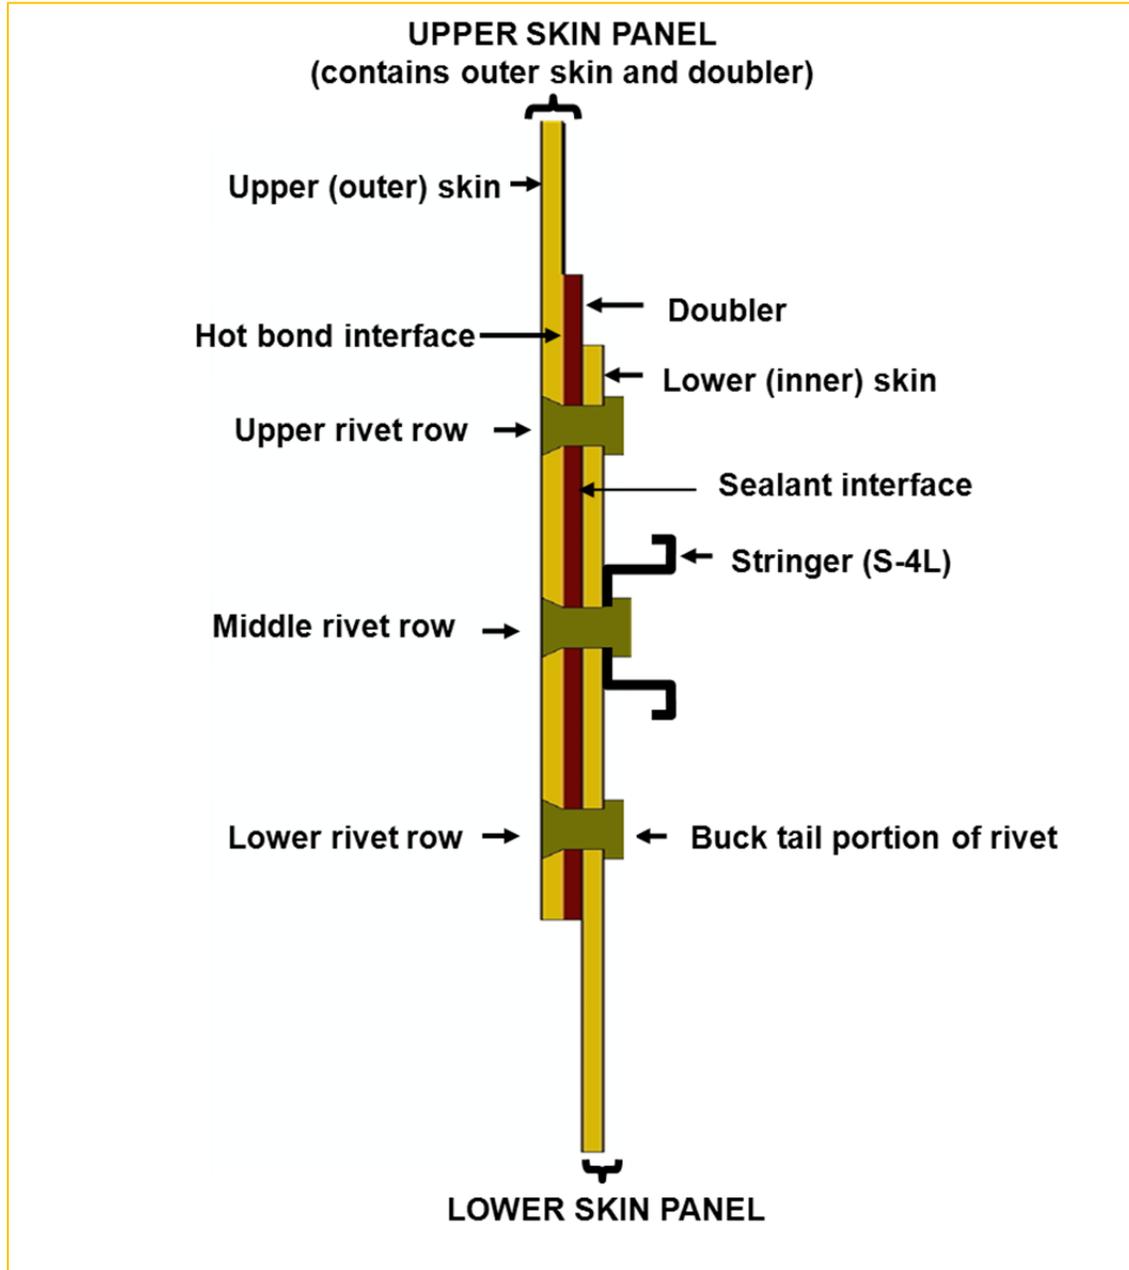
The area of the accident airplane skin panels containing the hole was excised from the airplane and sent to the NTSB materials laboratory for detailed examination, which revealed that the longitudinal fracture extended through the lower skin portion of the lap joint at S-4L. The fracture extended between BS 666 and BS 725 and through the lower row of rivets of the lap joint, intersecting 58 consecutive rivet holes at approximately 1-inch intervals. (A cross section of the lap joint on the accident airplane is shown in figure 4.)

Figure 4. Diagram of a Boeing 737 lap joint in the fracture area (not to scale).

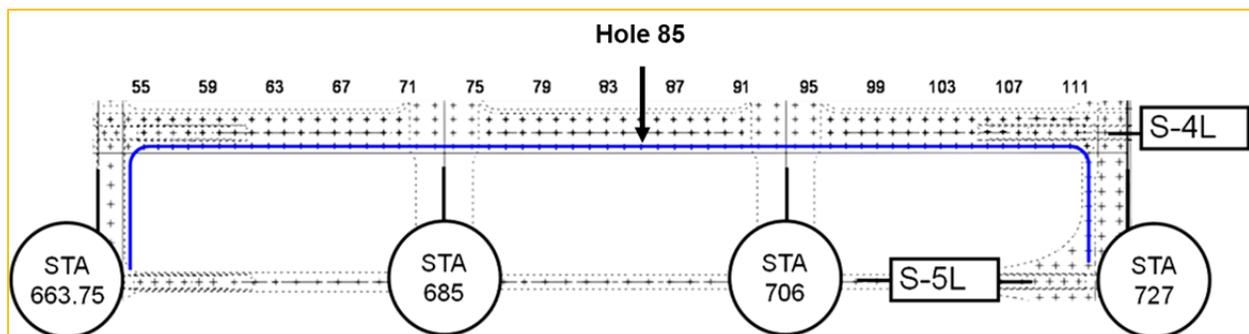
Microscopic examination of the longitudinal portion of the fracture surfaces revealed thumbnail fracture features consistent with fatigue cracking that originated from 54 out of 58 rivet holes. The fatigue cracks emanated from the outer surface of the lower skin. This surface is not visible from the interior or exterior of the airplane. In nine adjoining rivet holes (81 through 89), fatigue cracking occurred through 100% of the skin thickness. The depth of each fatigue crack varied along its length. The two longest fatigue cracks were found on the forward and aft side of rivet hole 85. The crack on the forward side of the rivet hole measured 0.55 inch, and the crack on the aft side measured 0.60 inch. The fatigue cracks propagated forward and aft with respect to each rivet hole. Figure 5 shows a drawing of the fuselage skin in the area of the fracture. As the distance from rivet hole 85 was increased, the length of a fatigue crack on each side of a rivet hole for each successive rivet hole decreased. The fracture face in the areas located outside of the fatigue crack regions showed rough texture features consistent with overstress separation. The remaining 4 of the 58 rivet holes (69, 71, 97, and 98) contained no evidence of fatigue cracking. The fracture intersected two tear straps⁶ at BS 685 and BS 706. The face of the fracture for the tear straps contained no evidence of fatigue cracking.

Figure 5. Drawing of the lap joint in the area of fracture (blue line represents the fracture).

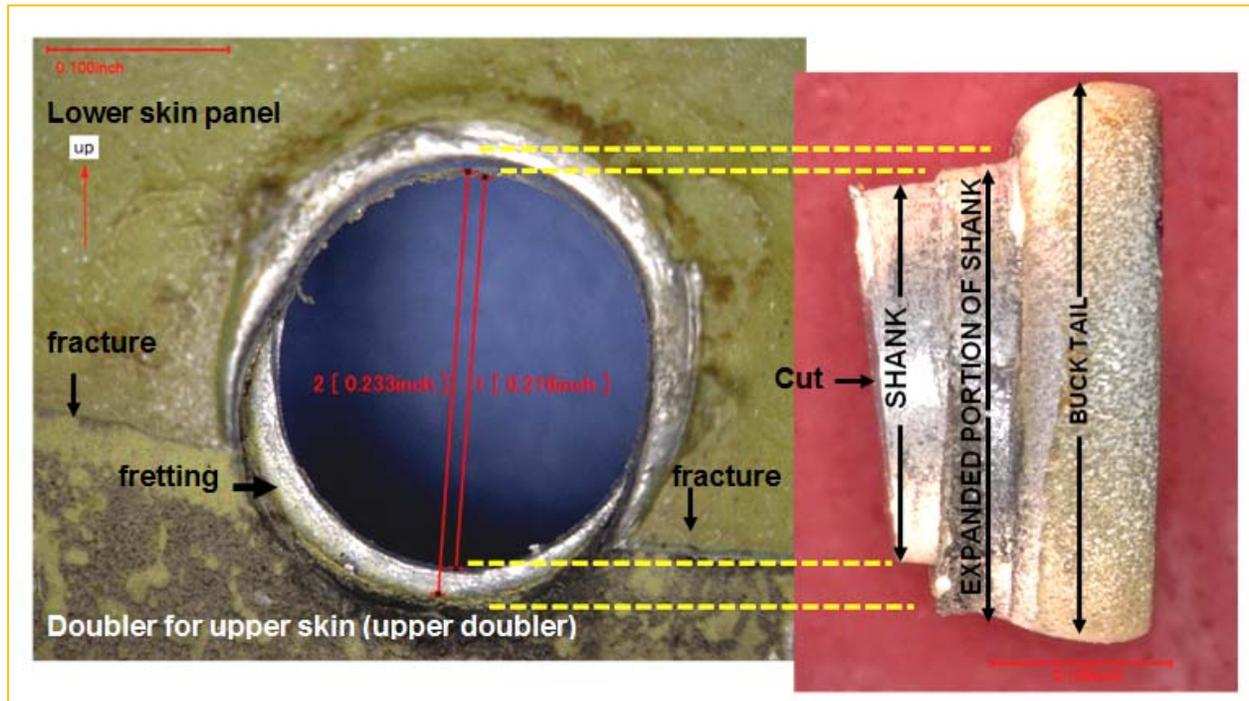
Examination of the rivets in the fracture area revealed that 10 of the 58 lower-row rivets were oversized, while the upper-row rivets were standard sized. Numerous bucked tails on the lower-row rivets exhibited a finish that was different than rivets elsewhere on the panel, ranging anywhere from exposed bare aluminum to partially covered with primer to fully covered with primer coating. Additionally, many rivets in the lap joint were under driven, and areas around the driven heads exhibited curled metal consistent with metal burrs. Microscopic examination of the disassembled rivets revealed the diameter of the shank portion in the area adjacent to the bucked tail portion for a majority of the rivets was larger (expanded) compared to the diameter of the shank. The expanded diameter portion in the shank coincided with the thickness and larger hole in the lower skin. Figure 6 shows the side profile view of rivet 85 with its corresponding rivet hole. At the inner surface of the lap joint, the rivet holes in the upper and lower skins were found to be slightly offset relative to each other, and many of the rivet holes on the lower skin were not

circular but slightly oval. Many of the rivet holes appeared similar to a figure 8 or a double-drilled hole. The fracture (fatigue cracks) intersected the lower portion of a majority of the lower-row rivet holes. The corresponding area located at the underside of the expanded portion of the rivets also showed fretting damage consistent with the underside of the expanded portion of the shank rubbing against the doubler. The bore of many rivet holes contained deposits of dark gray material consistent with BMS5-95 sealant.

Figure 6. Rivet hole 85L when viewed from inner face of the skin panel (left side) and side view of corresponding rivet that was removed from the rivet hole (right side).
