<b>Aircraft Type and Registration:</b>	Reims Cessna FRA150M, G-BFGX	
<b>No &amp; Type of Engines:</b>	1 Continental Motors O-240-E piston engine	
<b>Year of Manufacture:</b>	1977	
<b>Date &amp; Time (UTC):</b>	27 January 2005 at 1202 hrs	
<b>Location:</b>	Prestwick International Airport, Glasgow, Scotland	
<b>Type of Flight:</b>	Training	
<b>Persons on Board:</b>	Crew - 1	Passengers - None
<b>Injuries:</b>	Crew - None	Passengers - N/A
<b>Nature of Damage:</b>	Damage to both wingtips and propeller	
<b>Commander's Licence:</b>	Student pilot	
<b>Commander's Age:</b>	19 years	
<b>Commander's Flying Experience:</b>	25 hours (all on type) Last 90 days - 10 hours Last 28 days - 2 hours	
<b>Information Source:</b>	Aircraft Accident Report Form submitted by the pilot and subsequent enquiries by the AAIB

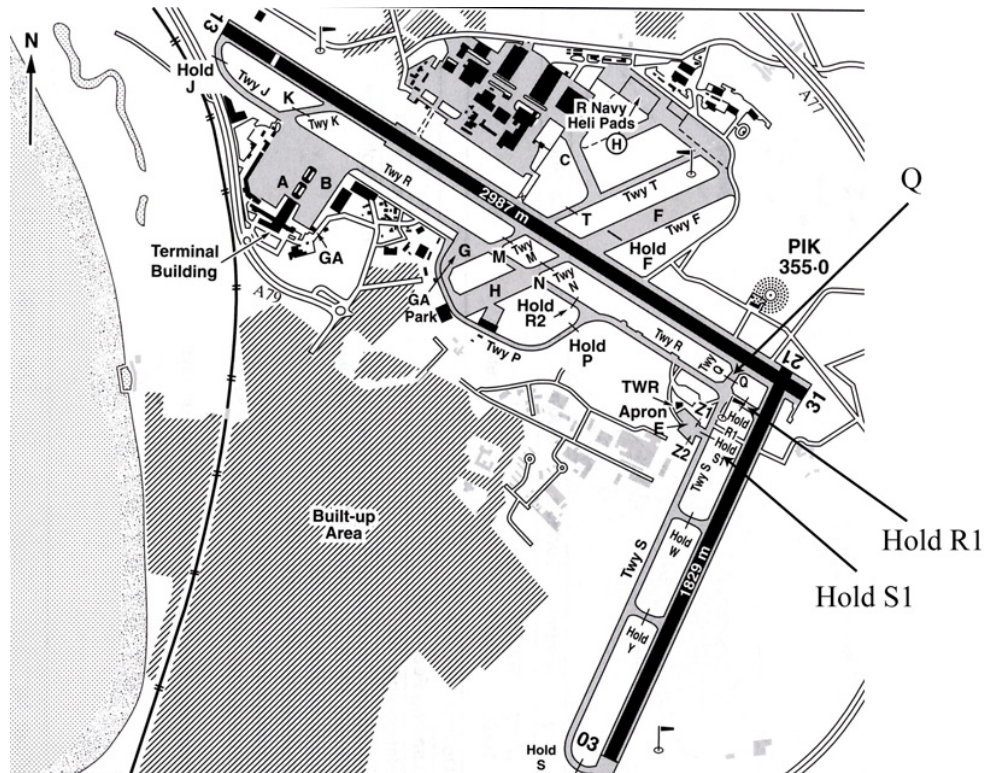
Figure 1: Airfield Map

The student pilot had initially been cleared by ATC to taxi to holding point 'S1' from Apron 'E'; Figure 1 shows the runways and holding positions. The student was also advised that a B747 was taxiing to 'R1'. After about 10 minutes at the holding point, the student watched as the B747 approached and then stopped at 'R1'. After a further five minutes, ATC cleared G-BFGX to taxi to holding point 'Q'. The student's impression was that the B747 was sitting with engines at idle as G-BFGX passed directly behind. He then felt his aircraft start to shake violently. Almost immediately, it was blown up onto its left wing and then clockwise through about 180° before the right wing and propeller struck the ground. The aircraft was then blown onto the grass where the student shut down the engine. The surface wind was light and variable.
