AIRCRAFT ACCIDENT REPORT 2/2016

**Report on the serious incident to
Saab 2000, G-LGNO
Approximately 7 nm east of Sumburgh Airport, Shetland
15 December 2014**

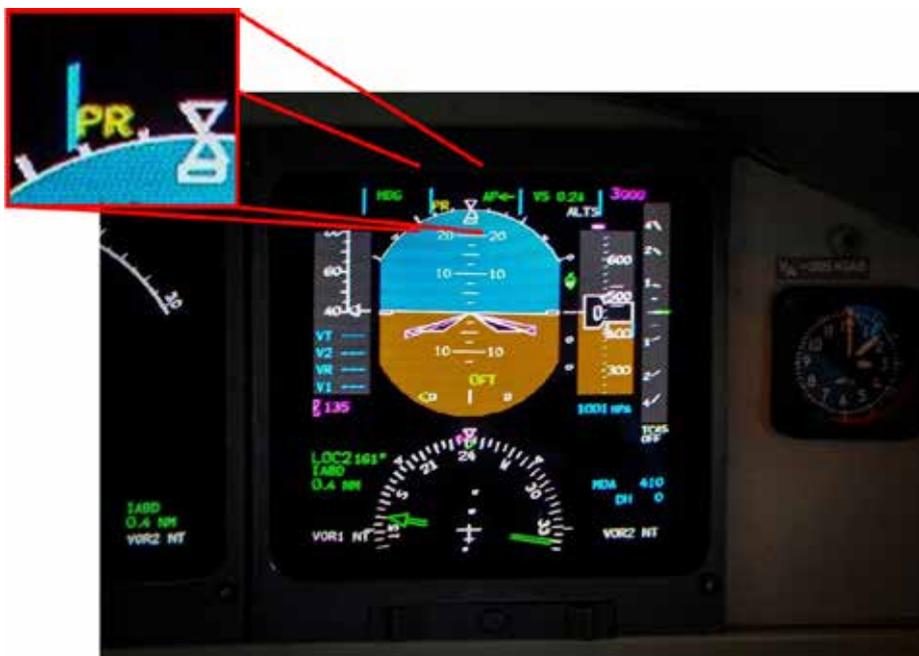
Figure 1

The aircraft climbed, but the commander perceived that his increasingly purposeful pitch control inputs did not appear to be having the expected effect. The co-pilot also applied nose-up pitch inputs and pitch trim inputs, but similarly perceived that the aircraft was not responding as expected. Pitch and roll mistrim indications were presented on the primary flight displays (PFDs) in the form of a flashing 'P' and an 'R' for the respective condition (Figure 1) and autopilot pitch and roll mistrim cautions were presented.

PFD showing 'P' and 'R' captions at the top of the PFD

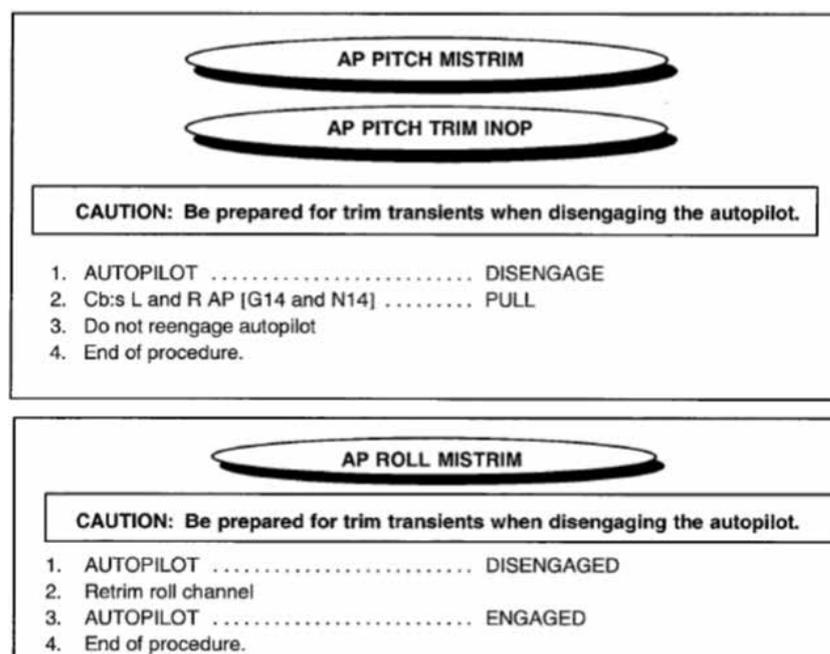
Figure 6

The AOM did not state that a 'P' or 'R' on the PFD could be an indication that the pilot was overriding the autopilot. There was no checklist in the AOM for the flight crew to follow for a flashing 'P' or 'R' on the PFD; however, there was a checklist to follow for the AP PITCH MISTRIM and AP ROLL MISTRIM cautions as shown in Figure 6.

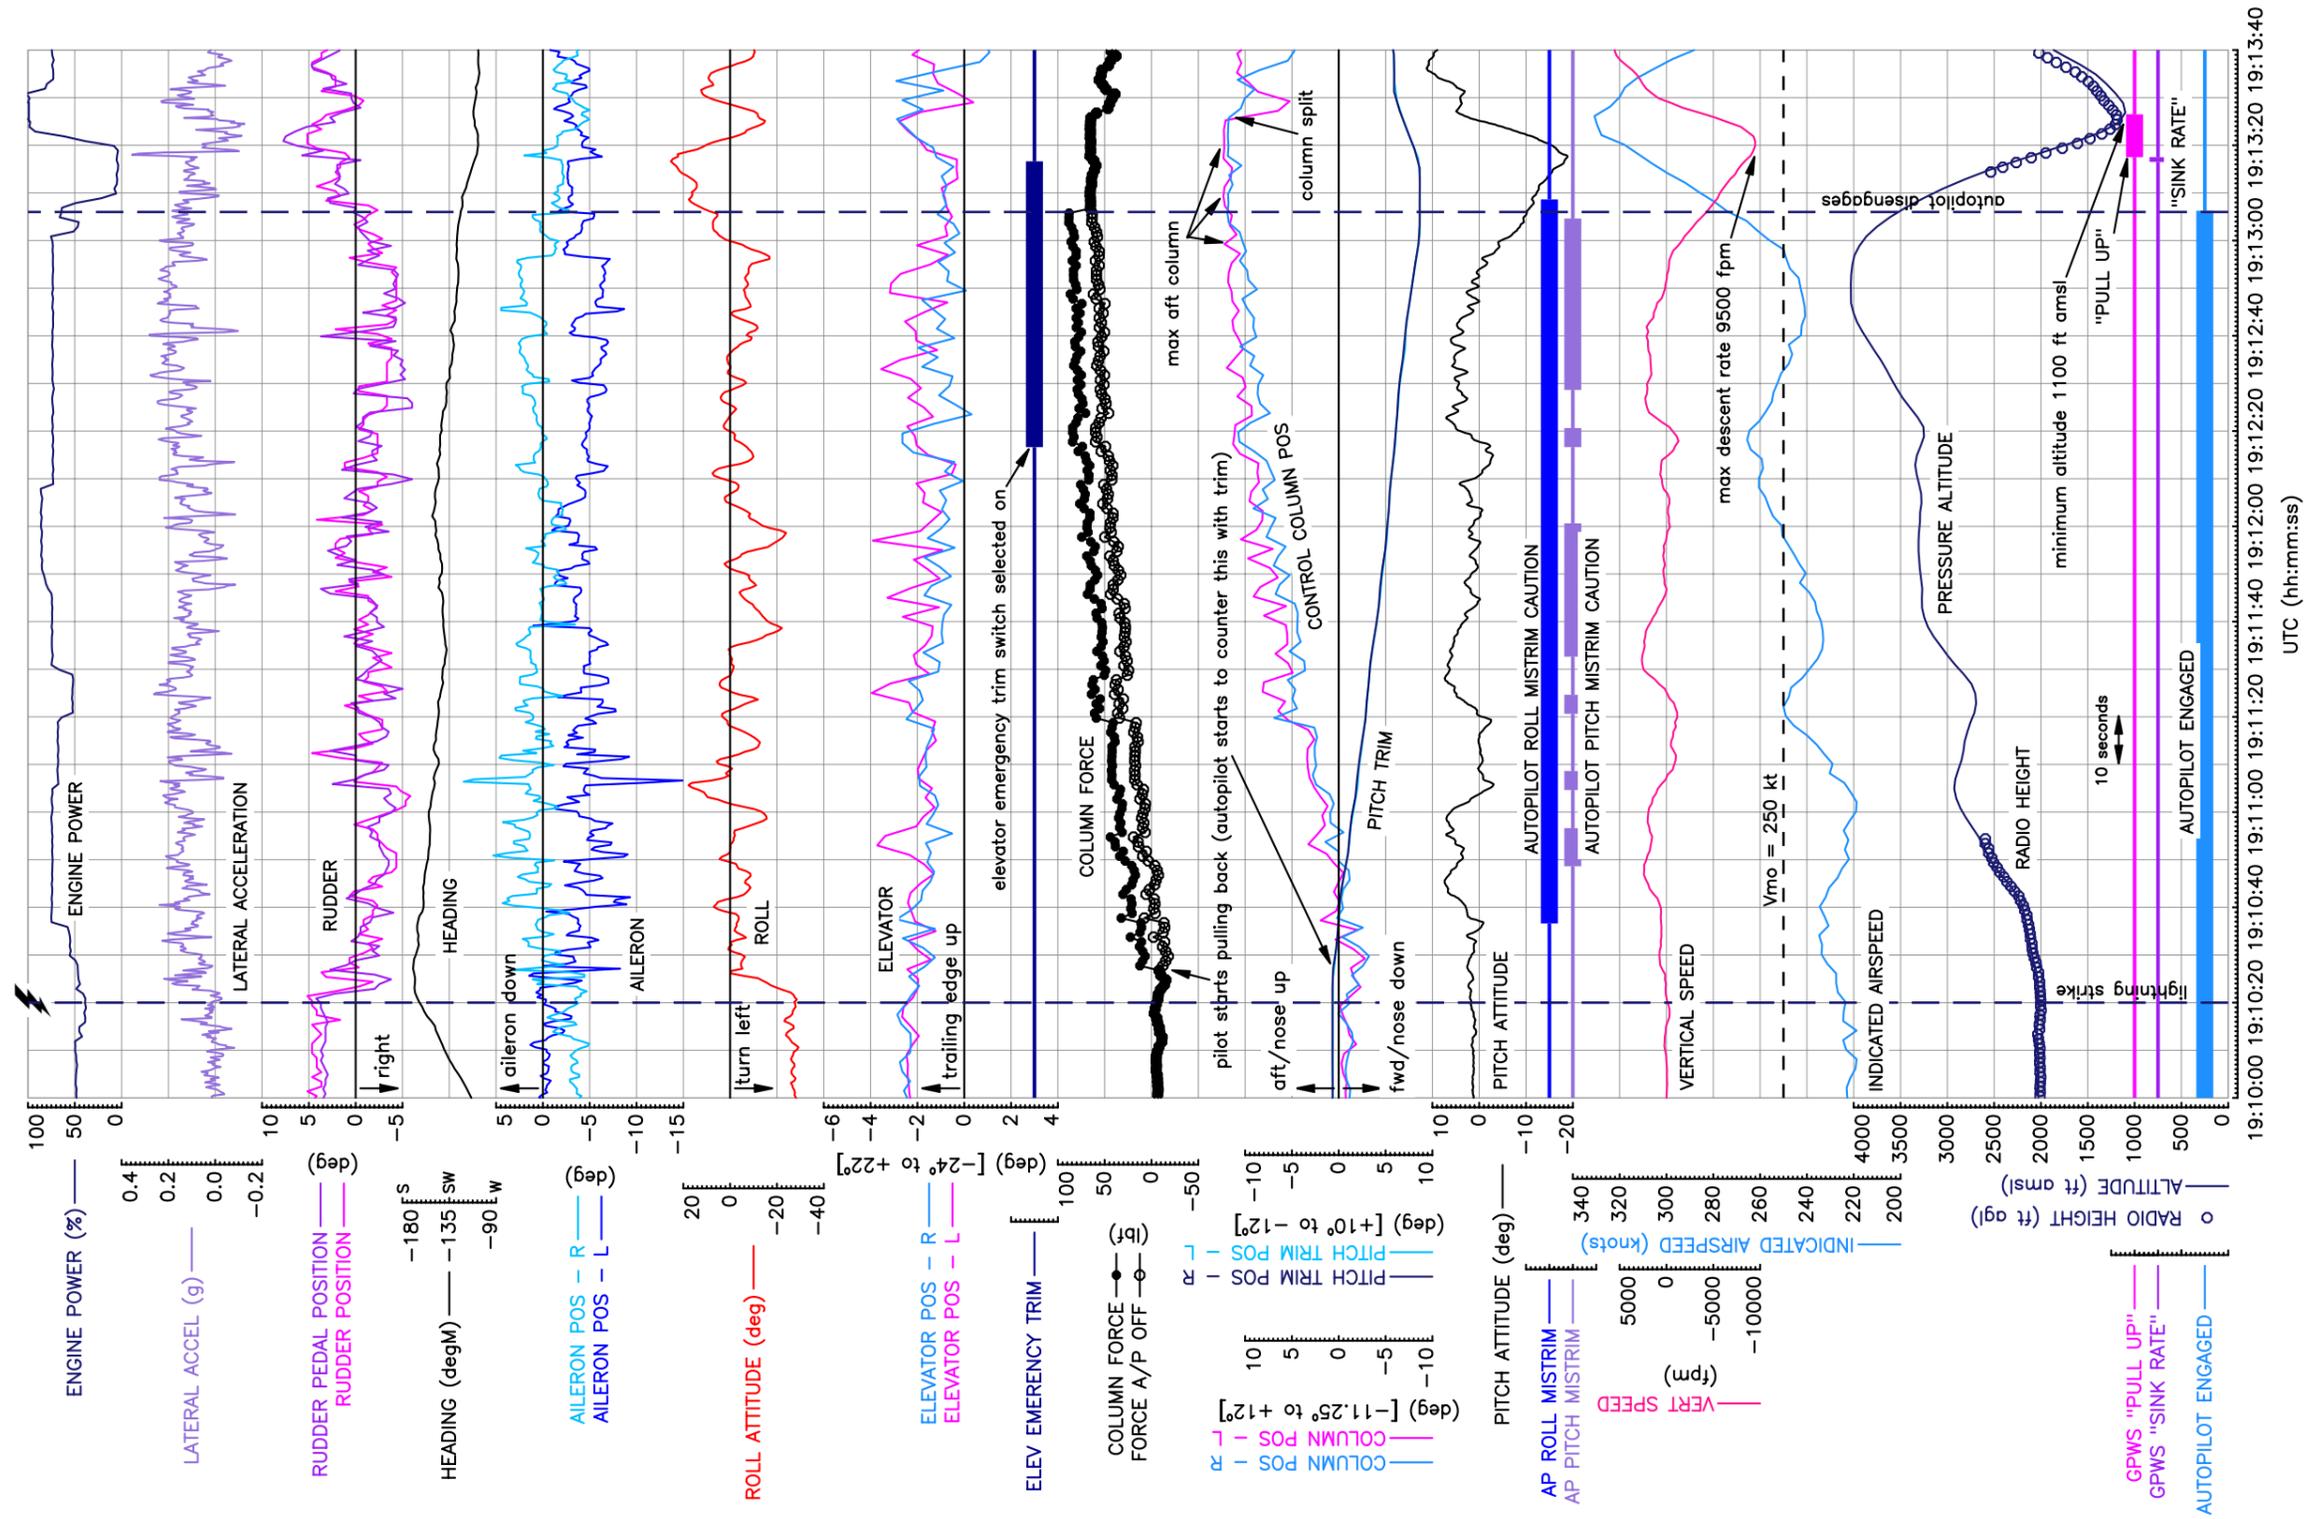
Figure 7

Immediately after the lightning strike, the aircraft rolled wings level. Aft control column pilot inputs were then made together with small increases in engine power which caused the aircraft to climb²⁰. The pitch trim (commanded by the autopilot) then began to move in the opposite direction trying to regain the selected altitude of 2,000 ft. With the autopilot engaged, the pilots needed to apply an additional 24 lbf on top of the forces generated by the break-out and stick force unit, in order to move the elevator.

Salient flight data from FDR

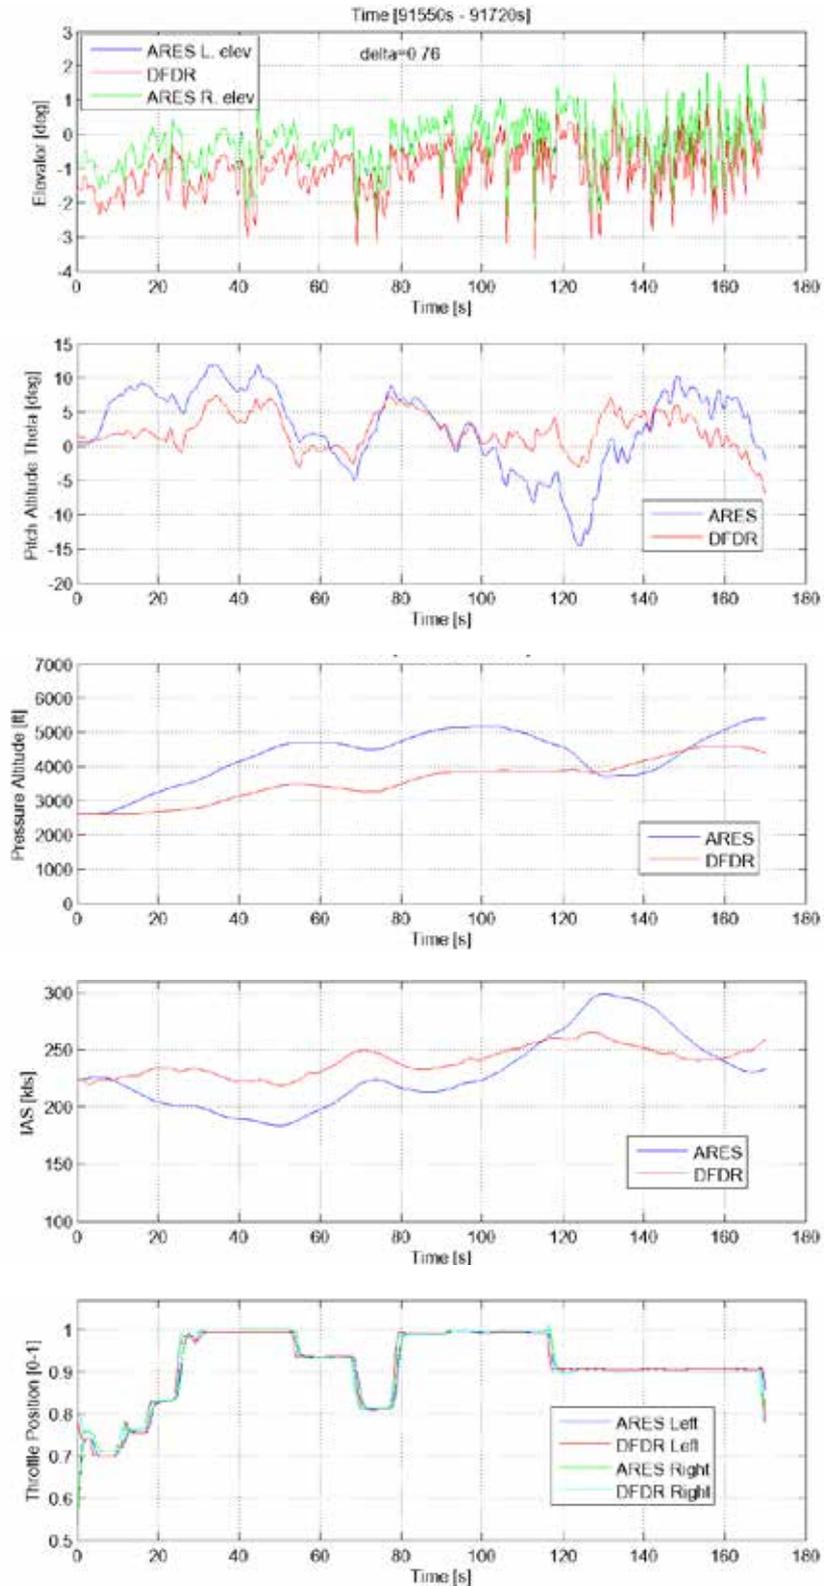
The resulting comparisons are presented in Figure 8 and Figure 9 for the climb and descent respectively. They show a good correlation between the simulation (labelled ARES) and the recorded data (labelled DFDR). In particular, there was close matching in frequency of the small variations in pitch attitude in direct response to the elevator inputs. However, the inaccuracies in the aerodynamic model, errors in the re-sampling of input data (which itself could have been aliased), and external factors not modelled, meant the magnitude of the responses was not always accurate, with errors accumulating over time. For the slower trends in the recorded data, the simulation followed these reasonably well and did so for several minutes at a time, such as during the climb portion of

Saab ARES Saab 2000 modelling for climb post lightning strike compared to FDR data (note that the pressure altitude plotted is not corrected to amsl)

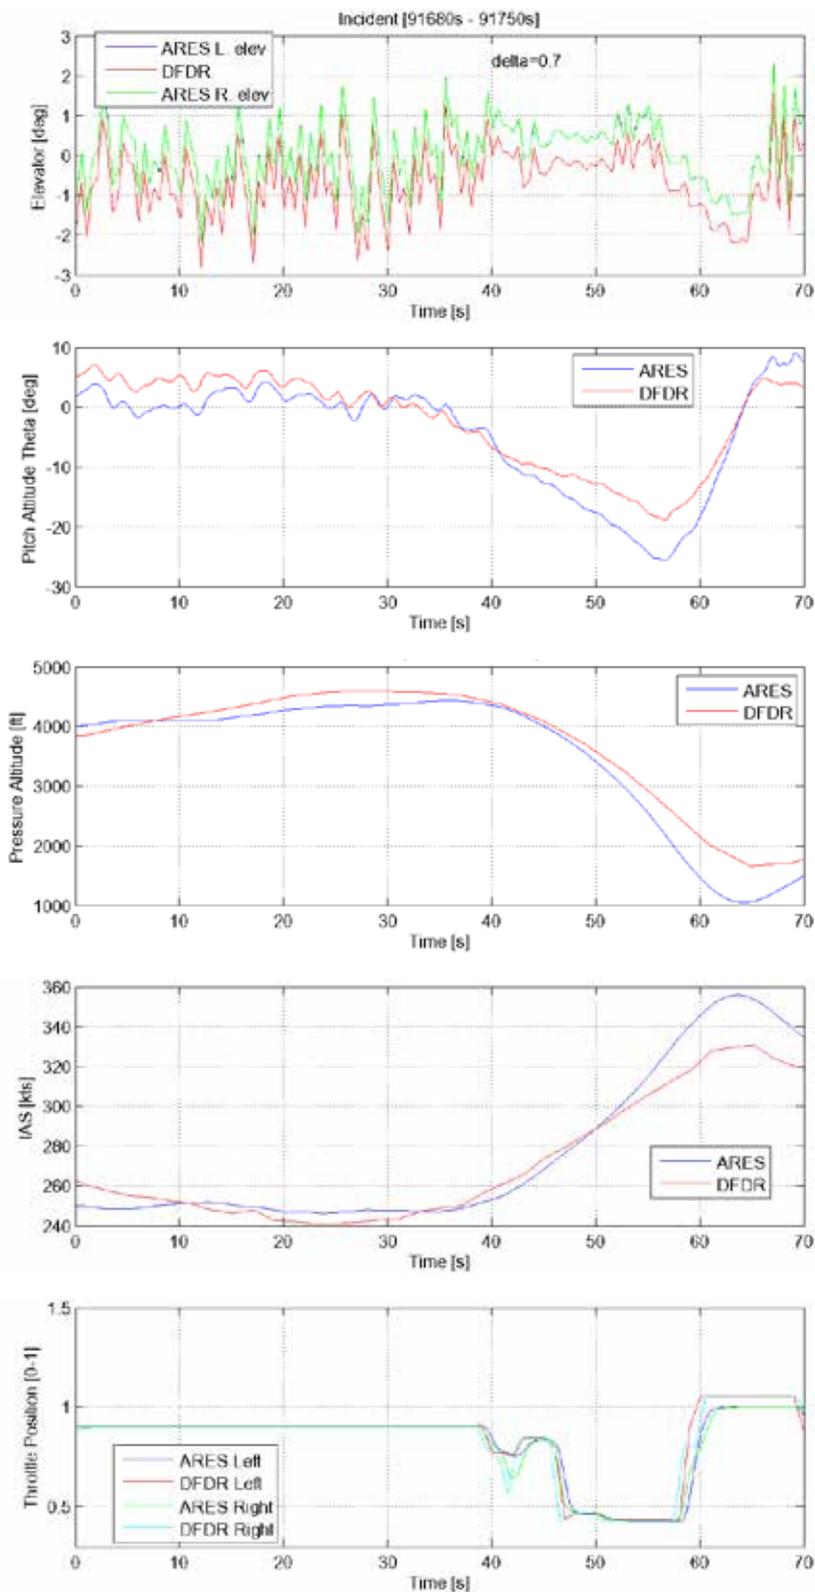
Figure 9

Saab ARES Saab 2000 modelling for post-lightning strike descent from 4,000 ft compared to FDR data (note that pressure altitude plotted is not corrected to amsl)
