# **Final Report No. 2221 by the Swiss Accident Investigation Board SAIB**

concerning the serious incident (Airprox)

involving the Airbus A320 aircraft, registration G-EUUD

and the Agusta Westland AW139 helicopter,  
registration HB-ZUV

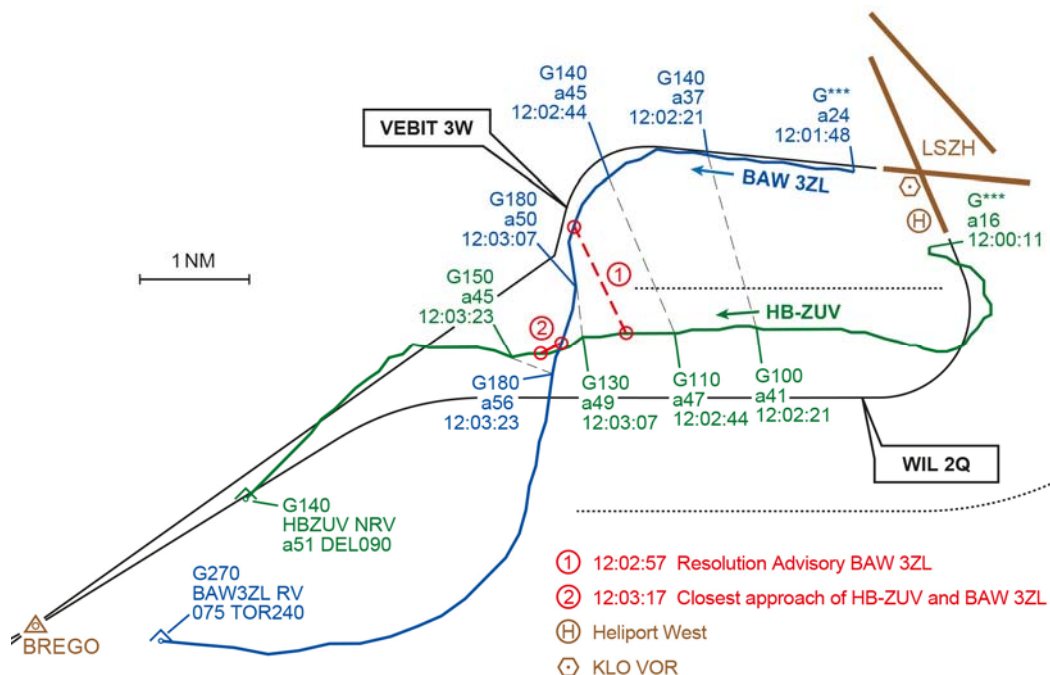
At 12:03:17 UTC the two aircraft crossed at a lateral distance of 0.24 NM and an altitude difference of 750 ft (cf. Figure 2). After the crossing, the crew of BAW 3ZL continued to fly for approximately 2 NM on a southerly heading, before they initiated a right turn towards waypoint BREGO and returned to the SID VEBIT 3W. Helicopter HB-ZUV continued to follow SID Willisau 2Q. Both aircraft continued their flights to their destination points.

**Figure 2:** The two nominal flight paths SID VEBIT 3W und WIL 2Q from Zurich airport are shown in black lines. The black dotted lines show the corridor borderlines as part of the SID WIL 2Q, based on the SID specification. The flightpath of HB-ZUV is shown as green line and the flightpath of BAW 3ZL as blue line. The radar labels consist of three lines that include the following information: first line: ground speed in knots; second line: altitude in hundreds of feet; third line: time in UTC. The red dotted lines show the point of time of the TCAS resolution advisory (RA) triggering in aircraft BAW 3ZL ①, respectively the point of time of the minimal distance between the two aircraft ②.

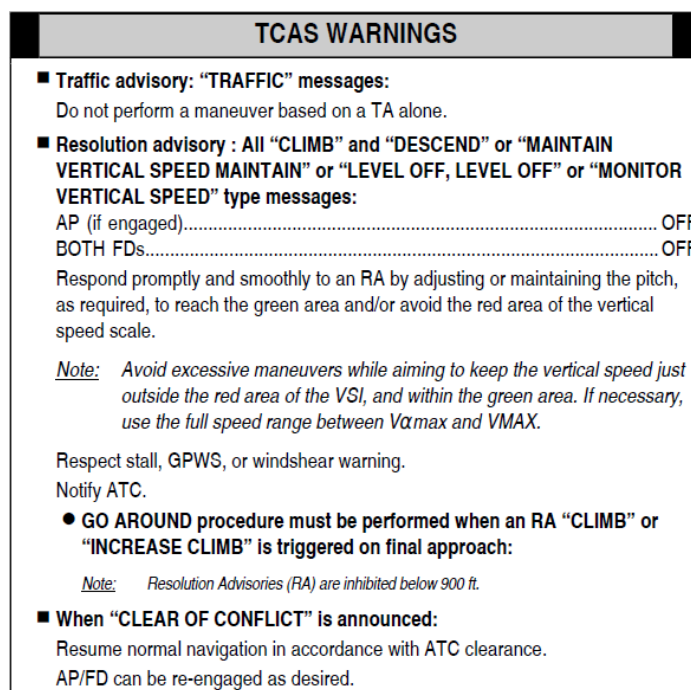
**Figure 3:** Excerpt from the quick reference handbook of the Airbus A320 commercial aircraft type involved in the serious incident, in relation to dealing with TCAS alerts. This procedure published by the aircraft manufacturer is identically published in the operator's documents.

This procedure does not provide information about the case in which a TCAS resolution advisory occurs in a turn.

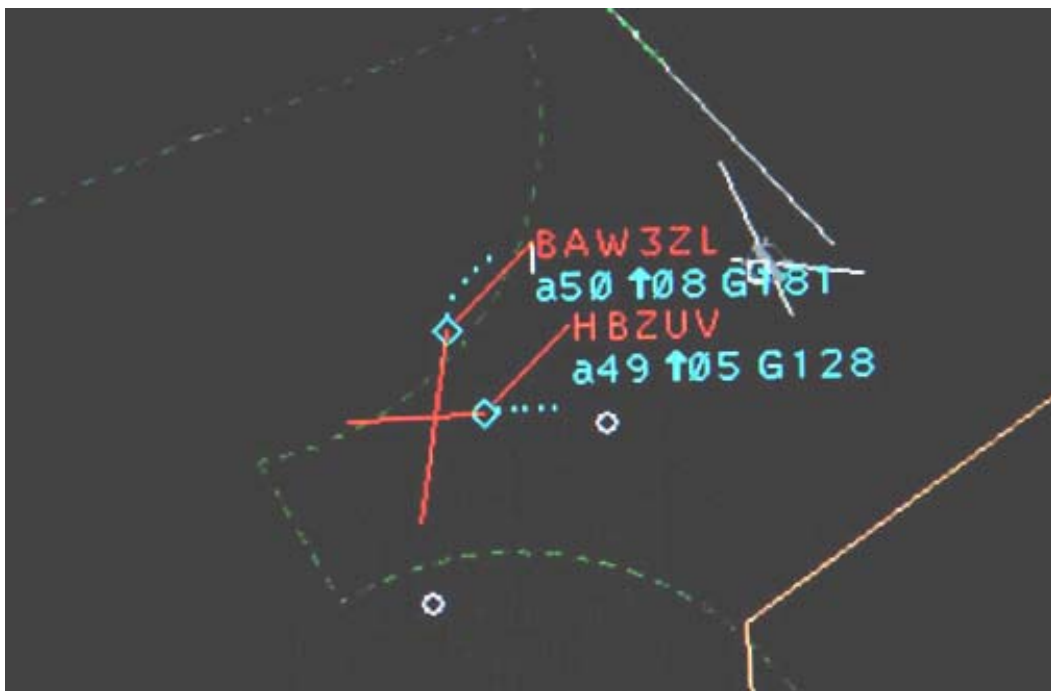
Although the STCA, because of its parameterisation, is not primarily designed for defusing conflicts which occur on arrival at and departure from airports, in this case the system did issue an alert 25 seconds before the dangerous convergence (cf. Figure 4). The STCA alert occurs only visually in the aerodrome control centre but visually and acoustically in the departure control centre.

**Figure 4:** Representation of the situation just before the point of closest approach of the two aircraft according to the legal recording. The above picture serves as illustration of the STCA alert who also was displayed in aerodrome control. The red flight plan call signs and the red directions of movement show the STCA warnings and indicate an impending conflict.
