AIR ACCIDENTS INVESTIGATION
INSTITUTE OF CZECH REPUBLIC
Beranových 130
199 01 PRAHA 99

FINAL REPORT

**Serious incident involving
A319 AFR1482 and B735 CSA77E
on 7th September 2012 at LKPR**

September 2013

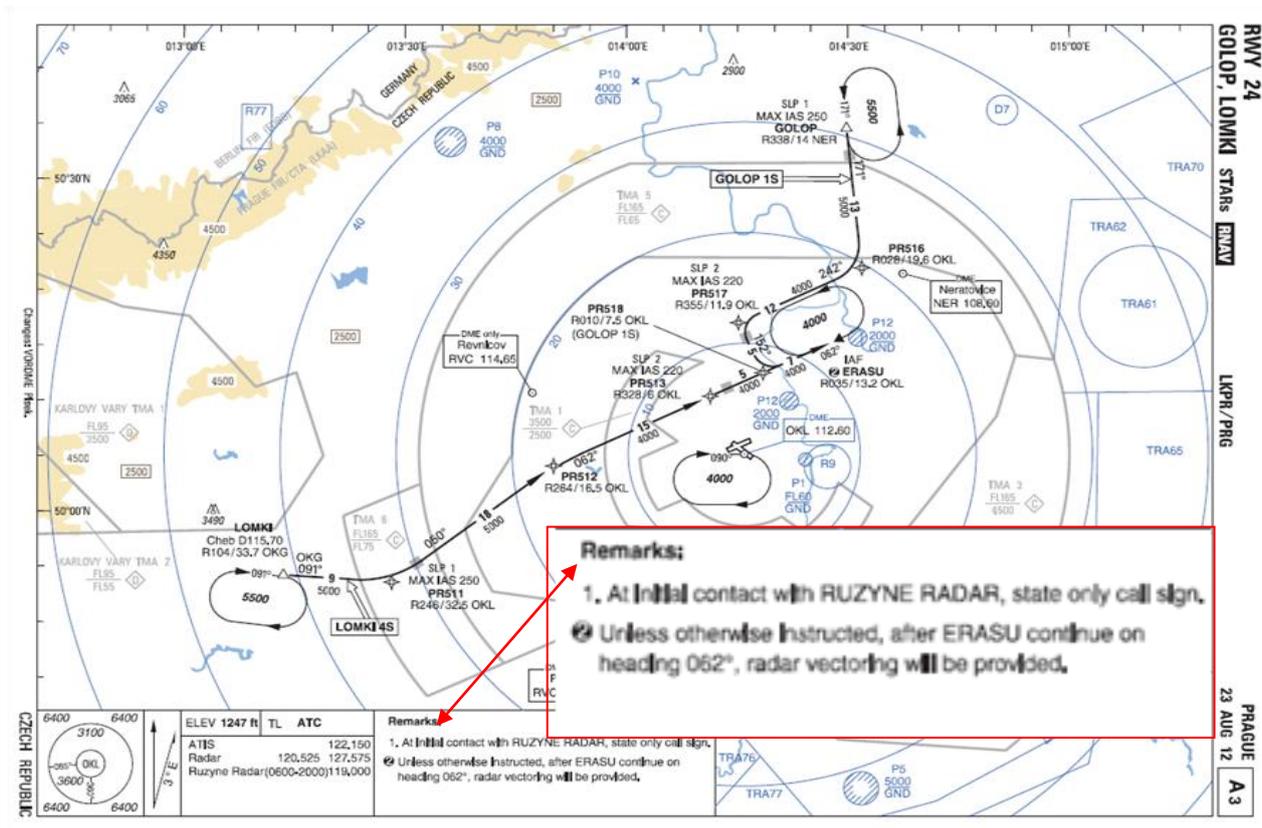
For navigation preparation, the crew had a map for approaching the LKPR on RWY 24 GOLOP, LOMKI STARs RNAV, publisher not stated, which was in accordance with the AIP of the Czech Republic. A note on the map states the procedure for approach along STAR LOMKI 4S after passing IAF ERASU.
