Air Accident Investigation Unit Ireland

SYNOPTIC REPORT

**Avions de Transport Régional
ATR 72-202, EI-FXG
Shannon Airport
26 February 2014**

AAIU Report No: 2015-009

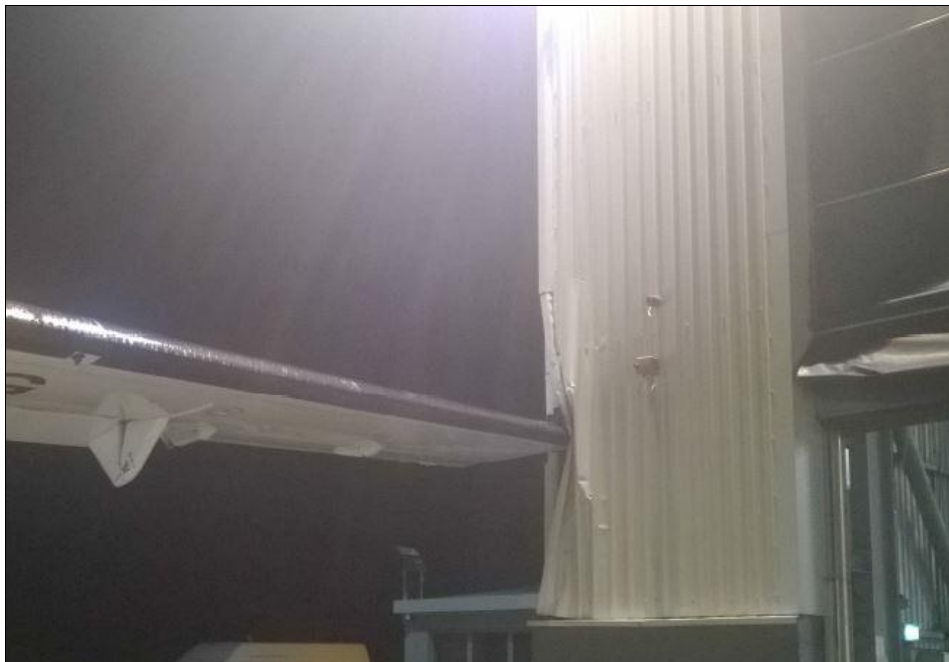
On opening the front cargo door, it became apparent to the Commander that the left wing-tip had struck the corner of the hangar (**Photo No. 1**). The Co-pilot was instructed to complete the normal shutdown checklist. The Flight Crew pulled the CVR⁷ circuit breaker and completed the Technical Log.

Photo No. 1: Left wing-tip impact with hangar cladding

The outboard leading edge of the left wing and the navigation light lens cover were the only parts of the aircraft to make contact with the hangar. The leading edge of wing rib No. 31 (the outermost rib) was slightly distorted at three locations. A section of the upper flange was distorted less than 2 mm and two sections of the lower flange were distorted by less than 3 mm. HFEC NDT⁹ was carried out on this component and no cracks were detected.

No sealant was disturbed on the leading edge prior to removal and there was no damage to the leading edge boot apart from a small cut. There were no marks or scratches on the aileron to suggest that contact had been made. The aileron inspection panels were removed and the aileron inspected for damage; none was found. Aileron travel checks were carried out and no faults were found. The navigation light lens and wing de-icing boot were replaced. The Aircraft Manufacturer allowed the replacement of the wing-rib to be deferred until the next C-check.

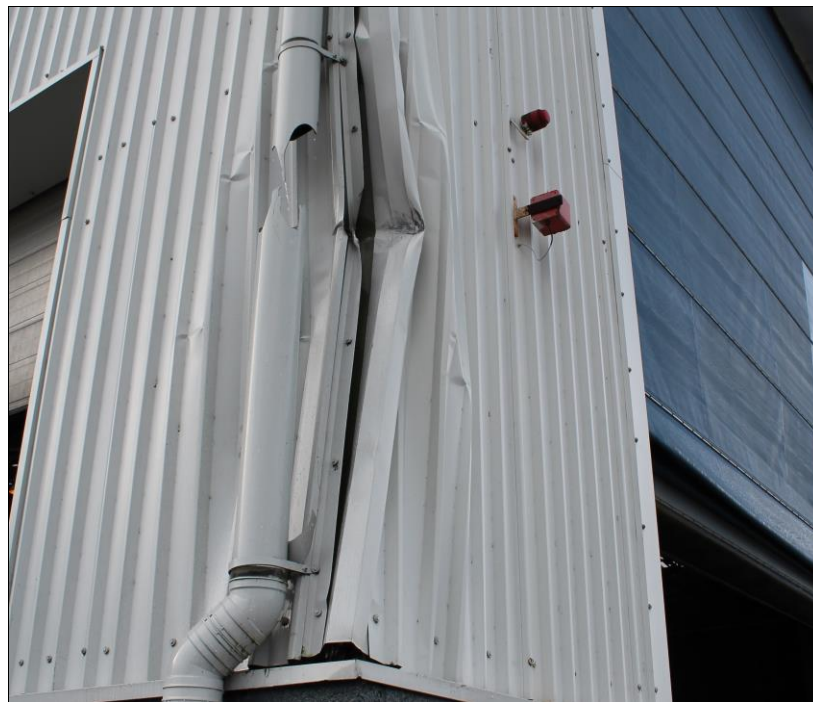
Two metal cladding panels covering the hangar structure and a section of corner angle cladding were damaged by contact with the wing-tip, a section of plastic drainpipe was also damaged (**Photo No. 2**). The internal steel structure of the hangar was undamaged.

Photo No. 2: Damage to hangar

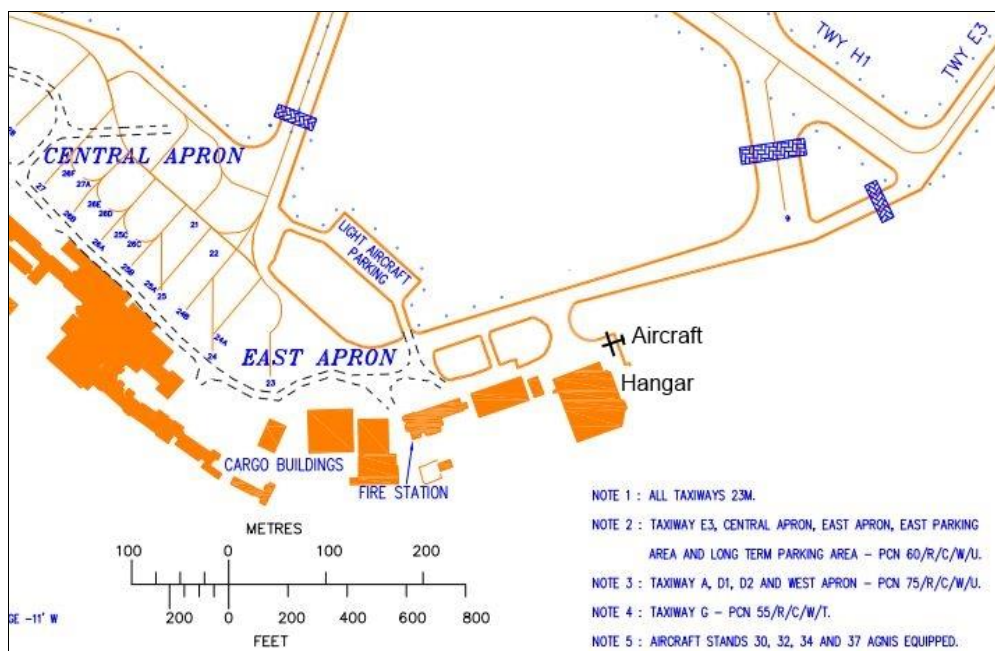
The hangar in question is situated adjacent to a de-designated taxiway (formerly Taxiway E1) between the East Apron and Taxiway E3 (**Figure No. 1**). Responsibility for aircraft towing in these areas rests with the handling company involved. The paved area in front of the hangar (termed a support stand) was designed as temporary parking for aircraft using the hangar. It was not intended for use as a permanent parking area for loading and unloading aircraft.

Figure No. 1: Position of aircraft and the East Apron hangar
(based on IAIP Chart AD 2.24-2)

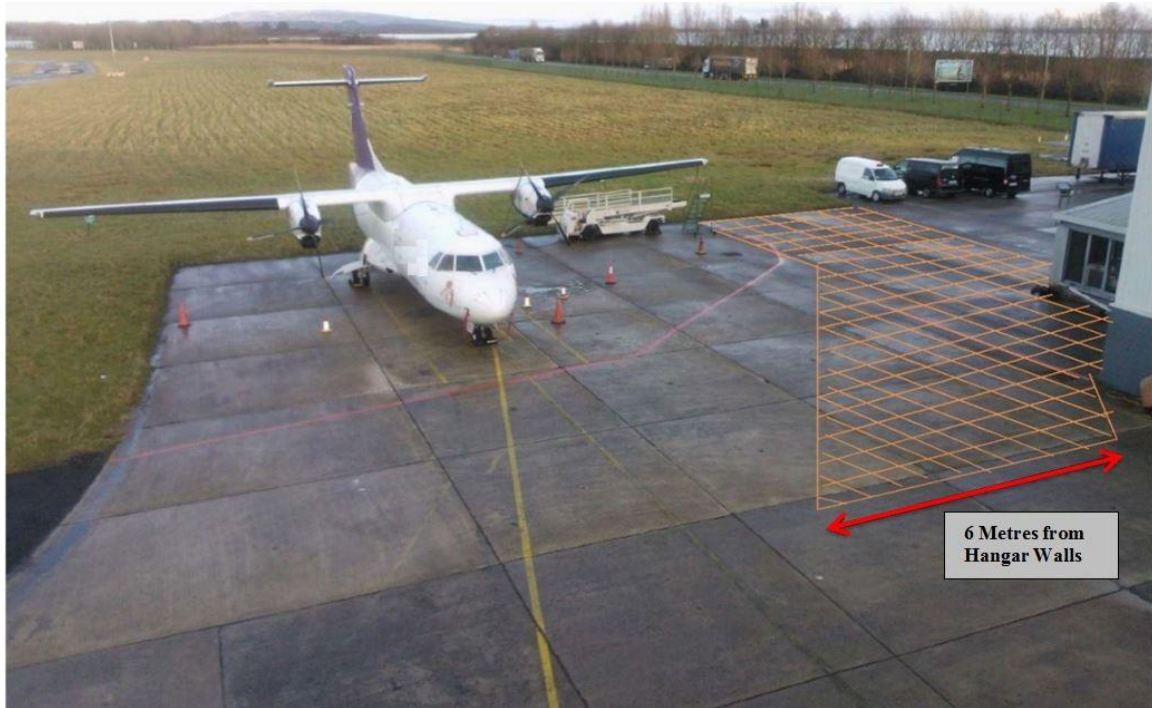
A yellow lead-out line was marked from the position of the nose wheel such that it provided a clearance of approximately 6 metres between the left wing-tip of the aircraft and the hangar. The lead-out line was set at an angle from the parked aircraft position thus requiring an immediate right turn to be carried out upon taxi in order to follow the line and be assured of the wing-tip clearance (**Photo No. 3**).

Photo No. 3: Example of an ATR 42 parked on the East Apron support stand (*File Photo*)

As the wingspan of the ATR 72 is 2.48 metres greater than that of an ATR 42 (**Photo No. 3**), the left wingtip of EI-FXG extended into the hatched area. A photograph taken by the Handling Company prior to the departure of EI-FXG showed the left main landing gear well forward and left of the ramp markings applicable to the ATR 42, as a result, the nose of the aircraft extended well beyond the red line (protected area).
