A U S T R A L I A N T R A N S P O R T S A F E T Y B U R E A U

AIR SAFETY INVESTIGATION

200100213

Boeing 737-400, VH-TJX
Brisbane, Qld

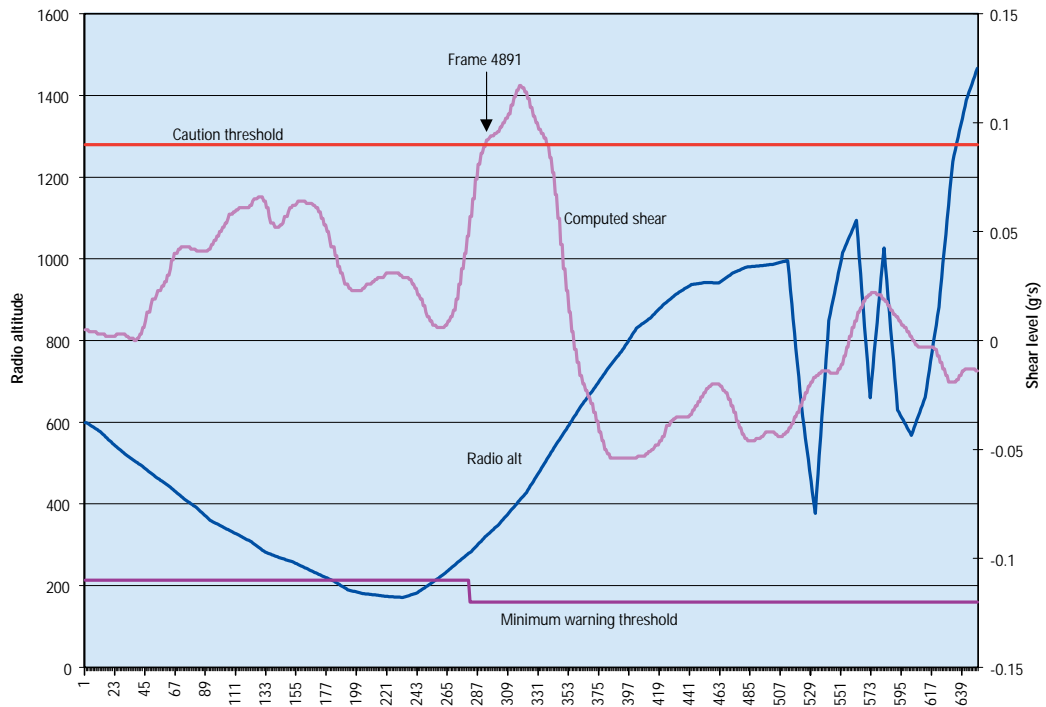
**Figure 1:
Shear level**

As stated above, the windshear caution option was not enabled on the aircraft. If enabled, it would have provided the crew with a windshear caution alert about 24 seconds prior to the first GPWS 'Terrain' warning, and about 31 seconds prior to the GPWS 'Pull Up' alert.

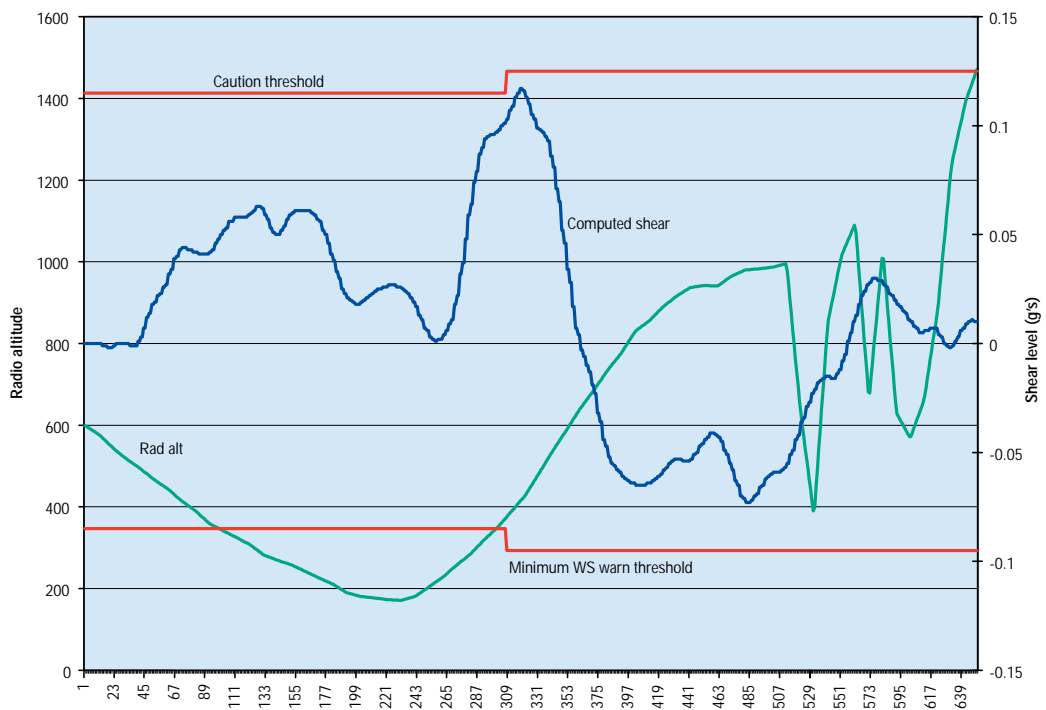
**Figure 2:
Honeywell windshear algorithm**

The recorded flight data was also examined using the Honeywell windshear algorithm. The negative shear level that was derived from that data did not reach the value required for a windshear warning using the Honeywell algorithm. The algorithm also had a higher windshear caution alert threshold than the Boeing algorithm, and provided no caution alert. The Honeywell windshear algorithm is depicted in figure 2.

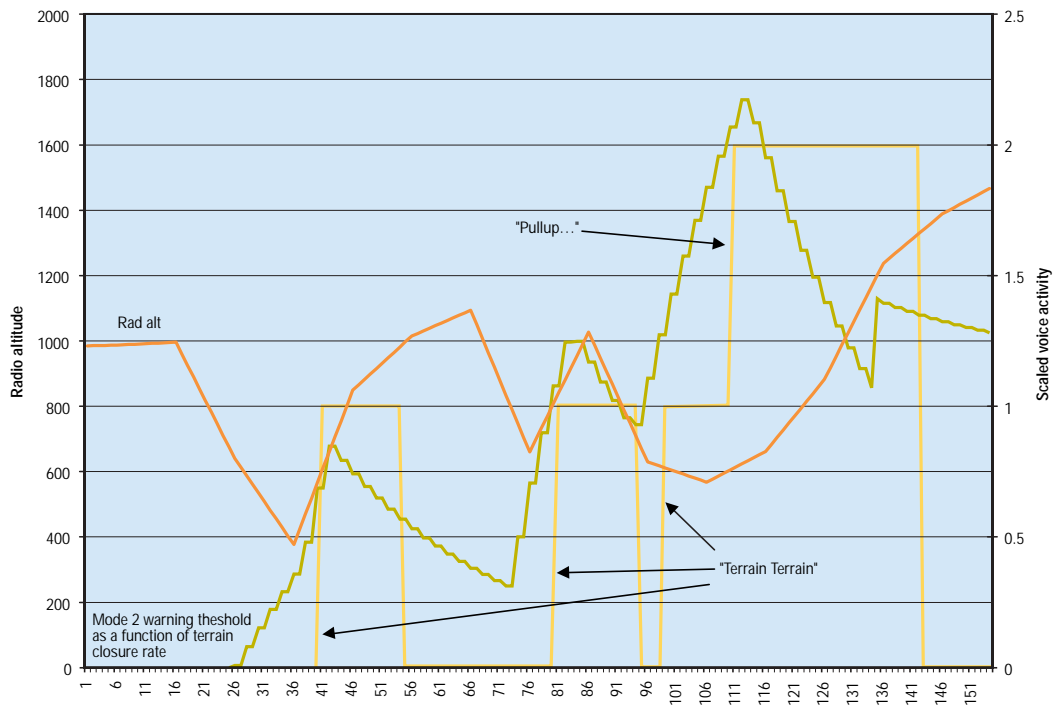
**Figure 3:
GPWS Mode 2 warnings**

When operating in Mode 2, the GPWS monitored radio altitude (radar altimeter) and radio altitude rate of change, barometric altitude, and aircraft configuration. If the Mode 2 terrain closure-rate parameters were exceeded, the GPWS would provide two different aural warnings to the crew. Those were an aural warning of 'Terrain', repeated twice, then by a repeated aural warning of 'Pull Up'. The radio altitude from the flight data was used in a simulation to investigate the GPWS Mode 2 warnings that occurred during the go-around sequence. The simulation resulted in two 'Terrain' aural warnings at 0729:36 and 0729:38 (timeframes 4921 and 4923), and one 'Pull Up' warning at 0729:39 (timeframe 4924), as shown in figure 3.

Another ‘Terrain’ warning was shown as having occurred during the simulation at about 0729:30 (timeframe 4915). During the occurrence, that alert did not actually take place. The simulation used one-second updated radio altitude, rather than 20 Hz in the aircraft, and the different sampling rate resulted in the radio altitude barely ‘nicking’ the warning curve and technically generating that ‘Terrain’ warning.

The recorded flight data revealed that the radio altimeter indicated a loss of altitude on three occasions, signifying a terrain closure rate. The aircraft was gaining altitude at a climb rate of in excess of 2,000 ft/min between 0729:36 and 0729:39 (timeframes 4921 and 4924), during which period the two ‘Terrain’ warnings and the ‘Pull up’ warning sounded. The aircraft’s path over the ground was also examined from the latitude and longitude data plots recorded on the SSFDR, and revealed that the aircraft had not passed over any terrain or man made structures that would have resulted in the radio altimeter registering those height losses. The GPWS Mode 2 warnings did not result from excessive terrain closure rate, and were consistent with ‘technical’ warnings triggered by flight through heavy rain and/or hail.

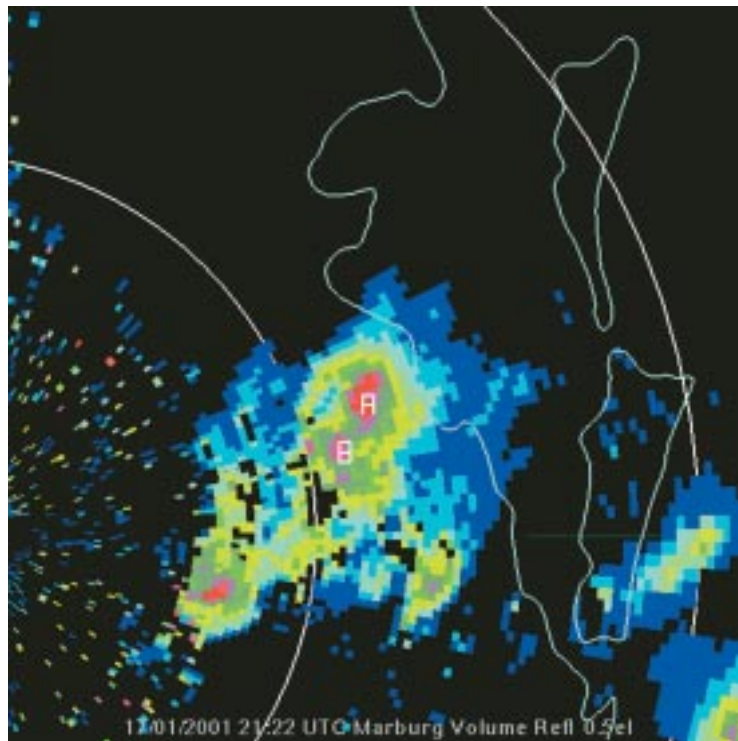
Figure 4:
Marburg Radar – 18 January 2001, 0722 EST

Data from the Marburg weather radar was subsequently examined, and revealed that the thunderstorm was a multicellular storm. It was moving north-east at a speed of about 60 kph, and contained two main reflectivity cells, shown as A and B in figure 4. By 0732, a new cell (C) was evident on the northern flank of the leading cell. Figures 4 and 5 depict the movement of the thunderstorm between 0722 and 0732. The radar range rings shown were 50 km and 100 km from the radar.

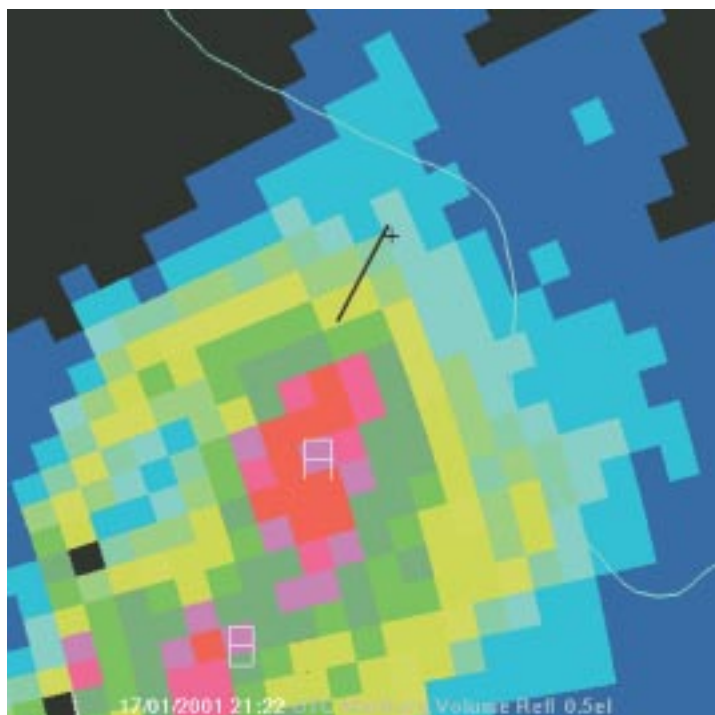
Figure 6:
Marburg Radar – 18 January 2001, 0722 EST expanded data

Figures 6 and 7 are higher resolution images showing the movement of the storm during the same period. The solid black line shows the position of runway 19 at Brisbane aerodrome. The location of the BoM anemometer is shown with a '+', adjacent to the threshold of runway 19. The radar data revealed that thunderstorm cells A and B passed south of runway 19, and that thunderstorm cell C developed over the runway during the period 0722 to 0732.

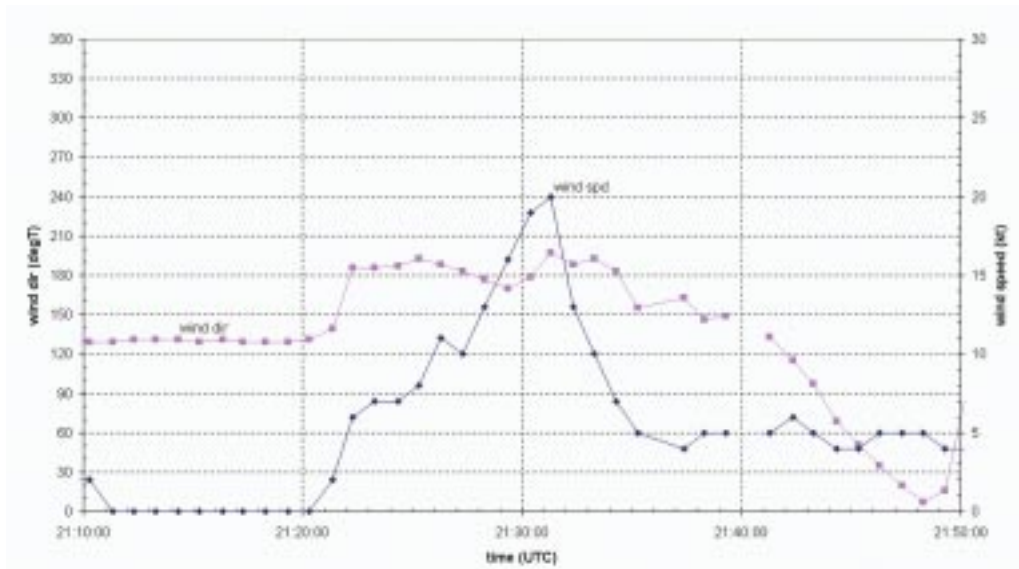
Figure 8:
Brisbane aerodrome anemometer data – 18 January 2000

The BoM anemometer at Brisbane aerodrome was located adjacent to the threshold of runway 19. The 1-minute-mean data from the anemometer revealed that shortly after 0720, the wind speed began to increase. By 0732, it was about 20 kts, with gusts up to 26 kts. During the same period, the wind direction shifted from about 130 degrees to 180 degrees. The wind speed and direction is shown in figure 8, with the time scale in UTC (21:30:00 UTC = 0730 EST).

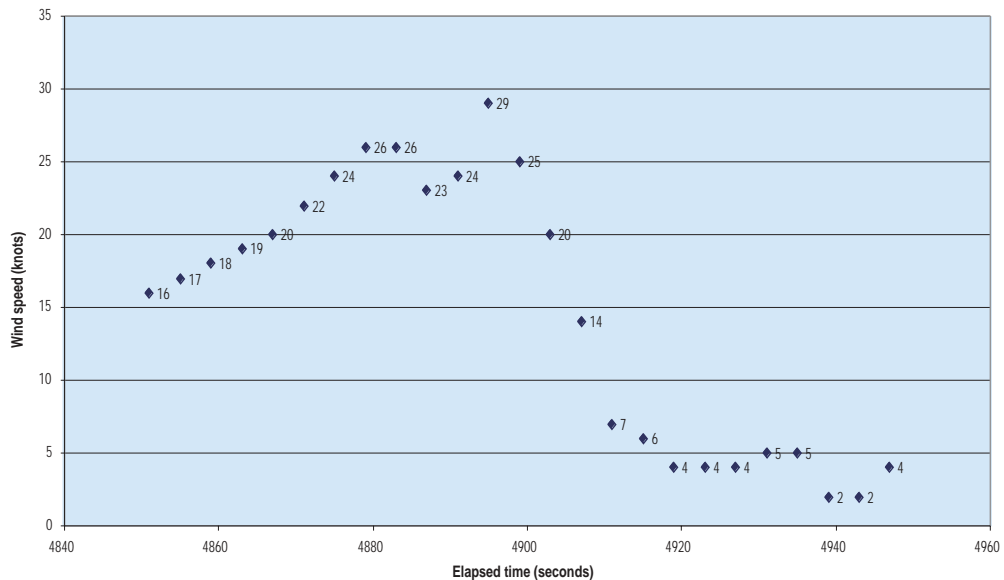
Figure 9:
TJX SSFDR wind speed data

The aircraft's SSFDR wind speed data correlated with the BoM anemometer data, and is shown in figure 9 below (timeframe 4900 = 0729:13 EST)

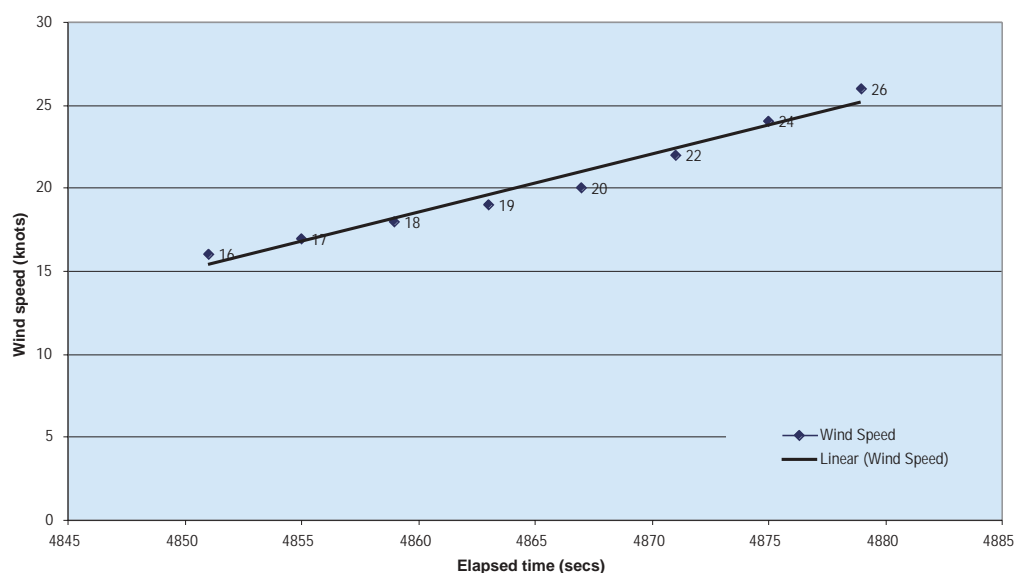
Figure 10:
Increasing headwind

The SSFDR wind speed plots indicated that the aircraft experienced increasing headwind conditions during the missed approach manoeuvre, which were then followed by decreasing headwind conditions. Those conditions were typical of a microburst windshear encounter. In the 30-second interval between 0728:25 and 0728:55 (timeframes 4850 and 4880), the aircraft encountered a steadily increasing headwind from 16 kts to 26 kts. See figure 10.

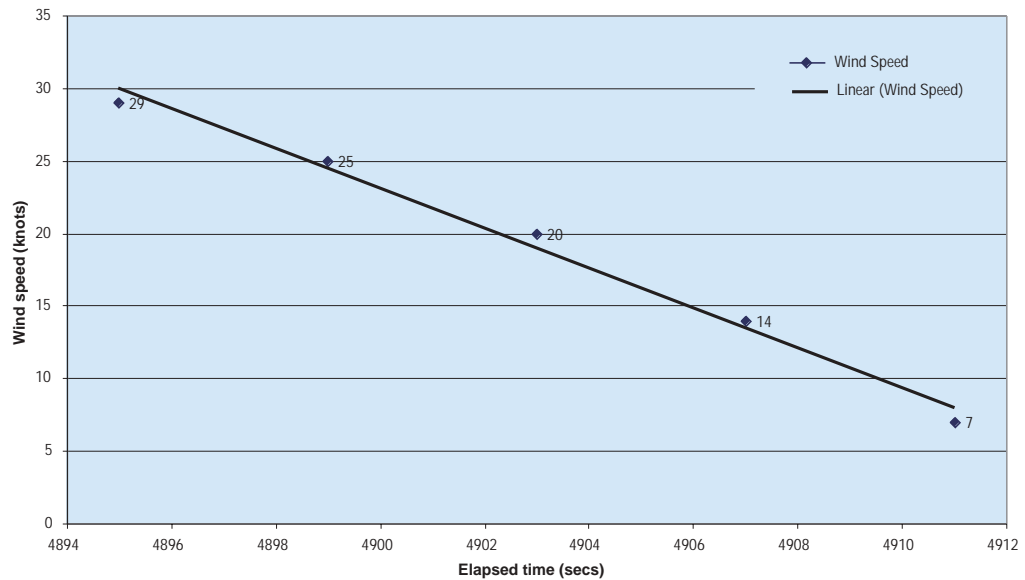
Figure 11:
Decreasing headwind

In the 15-second interval between 0728:55 and 0729:10 (timeframes 4880 and 4895), the headwind fluctuated between 23 and 29 kts, peaking at 0729:10 (timeframe 4895), then during the next 16 seconds, the headwind steadily decreased to seven kts. See figure 11.
