AVIATION INVESTIGATION REPORT

A03O0285

ENGINE POWER LOSS AND FORCED LANDING

CESSNA 172N C-GZLJ

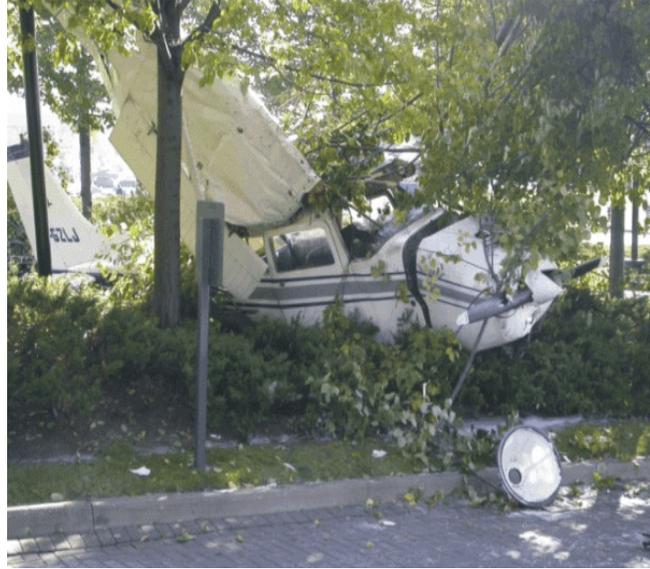
Photo 1. The aircraft at the accident site

1. The pilot was unable to find a suitable landing area and intentionally stalled the aircraft into the trees, resulting in substantial damage to the aircraft.

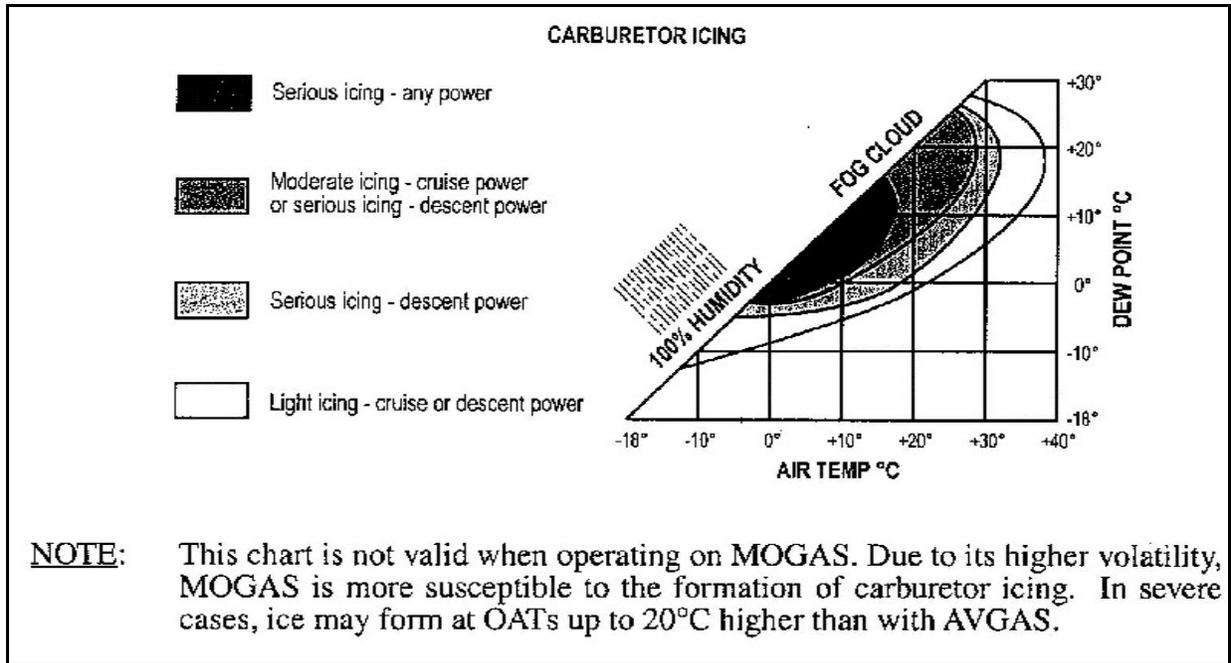
Appendix A—Carburettor Icing Chart²

The carburettor icing graph (Appendix A) was referenced as a guideline to find out if icing conditions existed for the flight. By intersecting the temperature and dew point values on the graph, it was determined that moderate icing conditions existed at the time of the flight. It was also found that the operator's maintenance personnel encountered carburettor icing during full-power ground runs with similar aircraft.

Weather was a factor in this occurrence, because the ambient temperature and dew point values were in the range where moderate carburettor icing could occur. After the engine began to lose power, the pilot applied carburettor heat as per normal procedures, but did not allow enough time for the warmer air to clear any ice that had formed. Further loss of power after carburettor heat application should have been anticipated. Engine performance continued to degrade as more ice accumulated.
