ACCIDENT

Aircraft Type and Registration:	Gulfstream III (G-1159A), N103CD	
No & Type of Engines:	2 Rolls-Royce Spey Mk511-8 turbofan engines	
Year of Manufacture:	1984 (Serial no: 418)	
Date & Time (UTC):	24 November 2014 at 2030 hrs	
Location:	Biggin Hill Airport, Kent	
Type of Flight:	Private	
Persons on Board:	Crew - 2	Passengers - 5
Injuries:	Crew - None	Passengers - None
Nature of Damage:	Aircraft damaged beyond economic repair	
Commander's Licence:	Airline Transport Pilot's Licence	
Commander's Age:	36 years	
Commander's Flying Experience:	4,120 hours (of which 3,650 hours were on type) Last 90 days - 60 hours Last 28 days - 19 hours	
Information Source:	AAIB Field Investigation

Synopsis

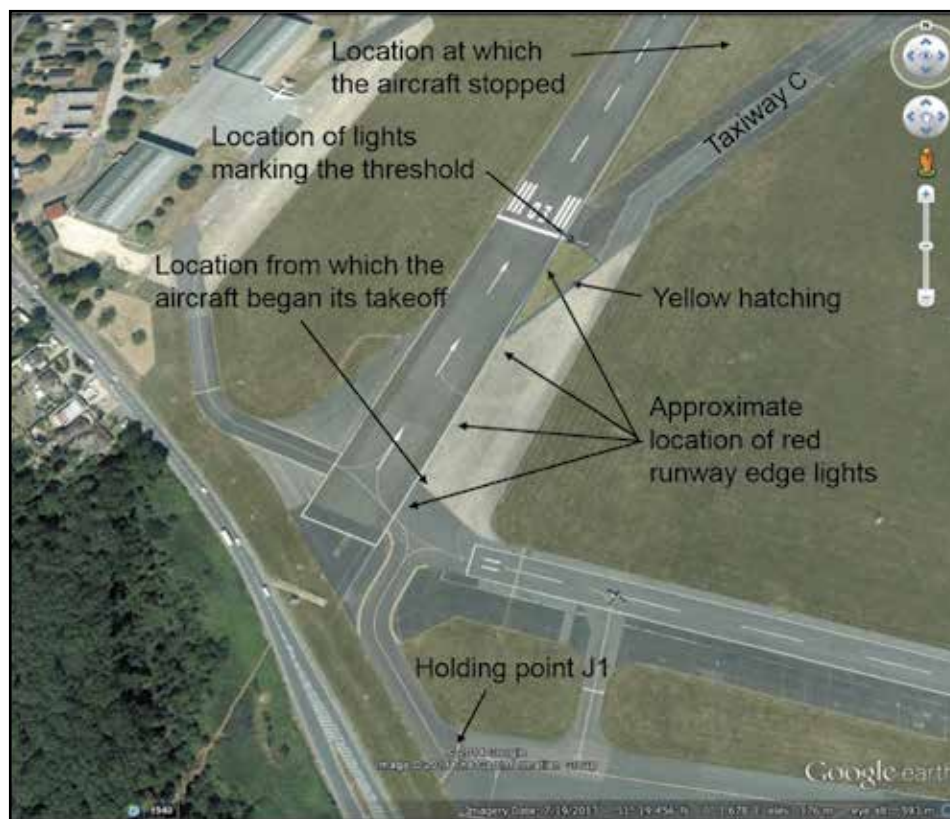
Figure 1

The area near the threshold of Runway 03

Marks made by the aircraft tyres showed that on exiting Taxiway J the aircraft entered the ORP with the left main wheels in line with the red runway edge lights. When the aircraft began its takeoff run, it had passed the first red runway edge light and the next edge light ahead of the aircraft was approximately 46 m away. The aircraft track continued parallel to the runway and 248 m from the start of the ORP the aircraft left the paved area and ran onto the grass. All the wheels sank approximately 0.25 m into the soft ground; however, the depth of the furrow made by the nosewheel varied, indicating that the aircraft was oscillating about the main landing gear. After travelling 120 m across the grass the nose landing gear and radome detached. The aircraft eventually came to a halt 424 m from the start of the ORP, in line with the PAPI. After passing the threshold lights, the left main wheel damaged two of the three white edge lights.

It appeared that the information available to the crew caused them to develop an incorrect expectation of their route to the runway. Both crew members believed that the runway had centreline lighting and, when the first right turn almost lined the aircraft up with some lights, their incorrect expectation was reinforced and they believed that the aircraft was lined up correctly. Cues to the contrary, such as runway edge lights on the other side of the runway, or the fact that the first three lights ahead of the aircraft were red (indicating that they were edge lights before the displaced threshold), did not appear to have been strong enough to make the crew realise that they had lost situational awareness. Figure 8 indicates that the apparent intensity of the white left-side runway edge lights was significantly less than that of the right-side lights, when viewed from the position where the aircraft lined up. This, along with other visual issues relating to contrast and the fog, is a plausible explanation as to why they were not noticed by the crew. The aircraft began its takeoff roll from a location beyond the first red runway edge light and approximately 46 m short of the next light, as shown

in Figure 1. Aircraft structure only obscures approximately the first 13 m of pavement ahead of pilots within a Gulfstream III aircraft and therefore these lights would not have been obscured by the aircraft. However, it is likely that the recessed nature of the red edge lights before the displaced threshold made them less compelling than the elevated white edge lights beyond, which would explain why their significance – that they could only have been runway edge lights – was not appreciated by the flight crew.

Following this accident, reflective studs were installed as a temporary measure to delineate the taxiways and runway access points around the Runway 03 threshold. Blue taxiway edge markers were installed leading from Holding Point J1 to the runway, and alternating yellow/green studs were installed on the taxiway centreline. In addition, a bar of red studs was placed across the southern edge of the ORP, along with taxiway edge markings (see Figure 9), to reduce the risk that crews following the taxiway around the first right turn after J1 would proceed straight ahead, as the aircraft in this accident did.

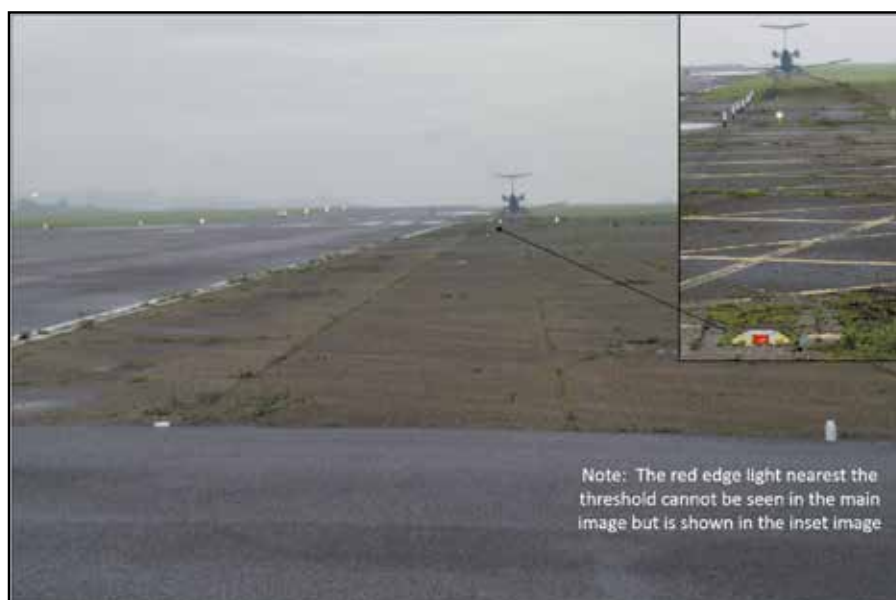
Figure 2

line that marked the edge of the runway. The most northerly light was located 30 m from the threshold of Runway 03 (Figure 2). Beyond the lights marking the runway threshold, white runway edge lights were mounted on poles located in the grass.

Red lighting on the ORP and the ORP's boundary with the taxiway

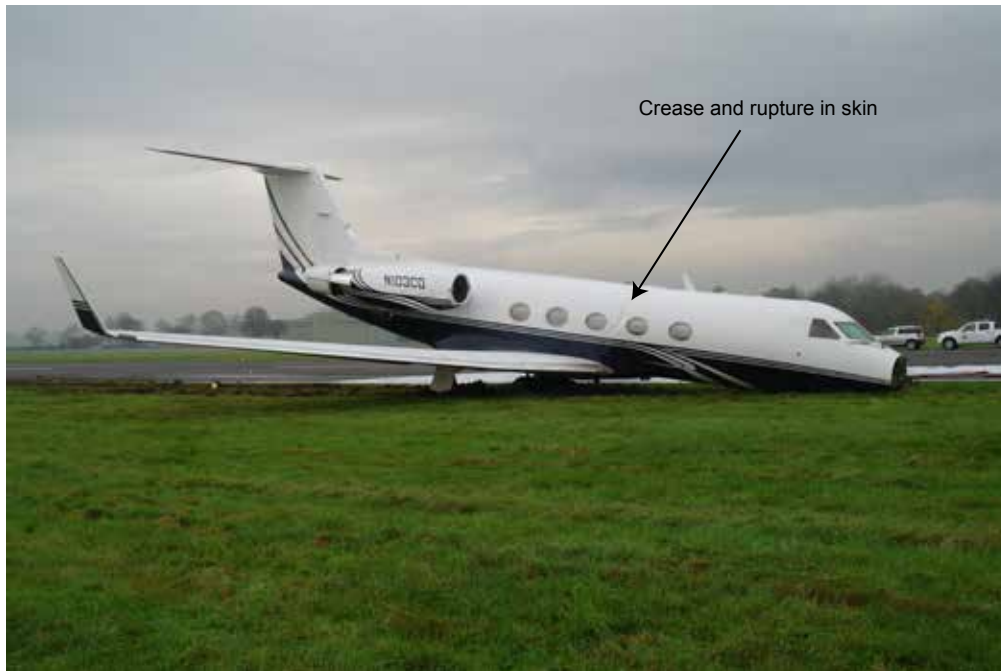
Figure 3

After the nose landing gear separated from the aircraft, it struck the lower fuselage approximately 0.3 m aft of the nose landing gear bay, tearing a hole in the skin 6.5 m long. A number of frames in this area were damaged and all the aerals mounted on the forward lower section of the fuselage were found detached. There was also a crease and rupture in the skin over the top of the fuselage, just aft of the second window in the cabin (Figure 3). The aircraft was assessed as being beyond economic repair.

The aircraft as it came to rest, showing area of skin crease and rupture

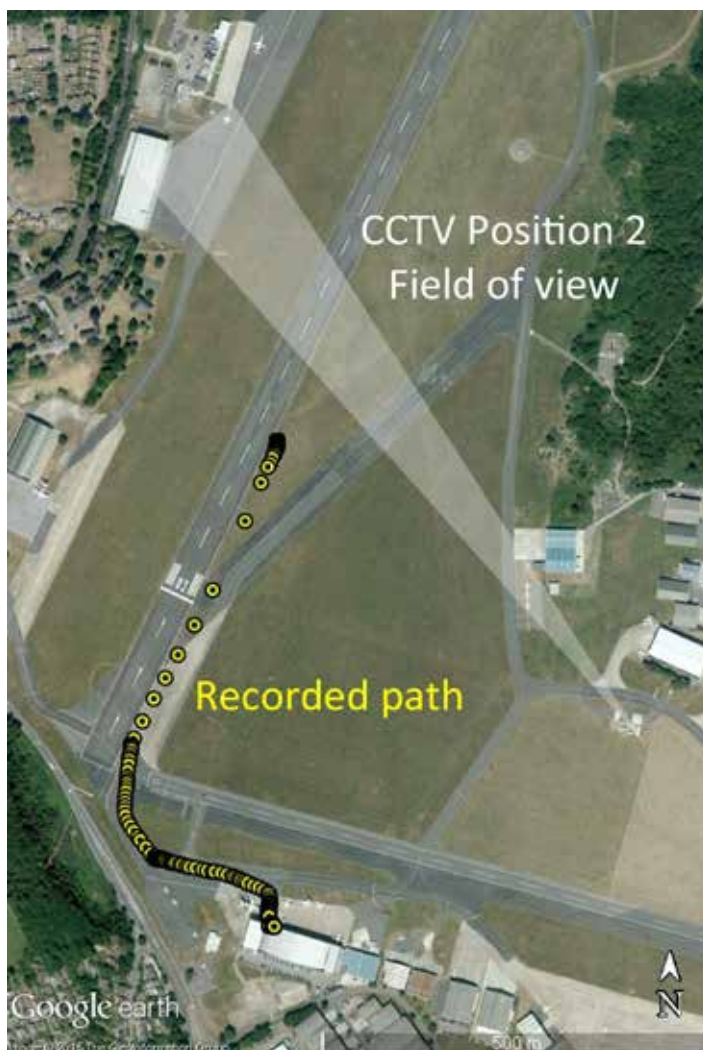
Figure 4

Three iPad tablets were recovered from the aircraft and the path of the aircraft during the attempted takeoff was recorded by 'apps' installed on two of them. These tablets use built-in GPS receivers as part of their positioning capability, which are less effective when used within an aircraft. However, whilst the accuracy of the recorded tracks is not known, the two recordings were largely consistent with each other. One of the recordings started at 1956 hrs but no motion was recorded until 2025 hrs and the motion stopped at the final location of the aircraft at 2030 hrs. The recorded ground speed reached a maximum of approximately 70 kt during this period. The path recorded by the iPads is shown in Figure 4.

Recorded path of the aircraft and relevant CCTV image coverage

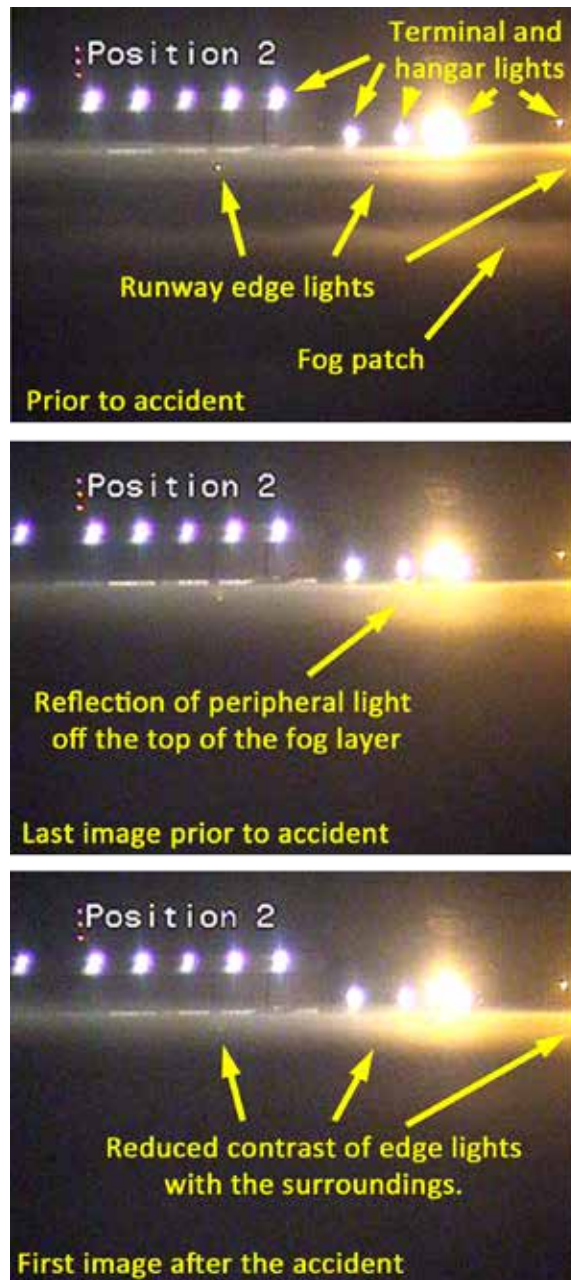
Figure 5 illustrates the low-level fog patches drifting across the airfield during the accident period, and the patches are also prevalent in the rest of the recording, in which their movement is seen more clearly. The CCTV snapshots were taken from the side of the runway, so only the low-intensity omnidirectional components of the runway edge lights were captured, and not the high-intensity directional component as viewed when looking along the runway.

CCTV images from Position 2 taken 1 minute 25 seconds apart

The lights associated with the hangars, terminal and apron areas are significantly brighter than the runway lights. The CCTV images do not fully represent the extent of this as the image brightness of the peripheral lights (such as those at the apron and the terminal) was recorded at the maximum brightness the image can represent. Therefore the contrast in actual brightness was greater than the images in Figure 5 indicate.

The UK AIP states that there is no centreline lighting on Runway 03, and that the pavement width at the beginning of the runway is twice the normal runway width. It recognises the potential for confusion and urges crews to ensure that they have lined up correctly. This information was not available to the crew on their aerodrome charts and both crew members believed that the runway had centreline lighting. Further, the light from those left-side runway edge lights covered in fog would have been scattered, making it harder for the crew to perceive them as a distinct line of lights. The situation is likely to have been made worse by the bright lights reflecting off the top of the fog layer, making the underlying runway lights even harder to see, or swamping them completely as shown in Figure 5.

The CCTV images in Figure 5 show that peripheral lighting can interact with low fog layers to reduce the visibility of underlying aerodrome lighting. Current standards associated with apron lighting only address the minimum light levels required to make the areas safe and there are no standards relating to light spilling into other areas.

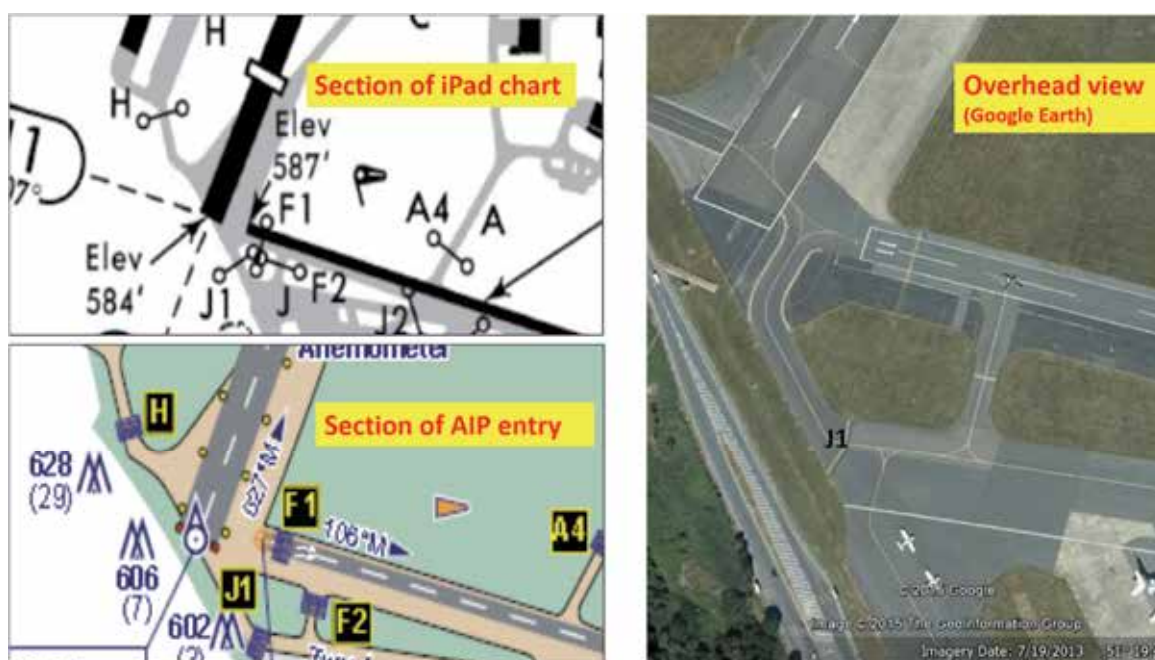
Figure 6

The aerodrome chart used by the crew was contained in an iPad app which was updated through a subscription service with the product supplier. The authoritative source for the aeronautical information contained within the app is the Biggin Hill Airport Aerodrome Chart contained in the UK Aeronautical Information Publication (AIP), maintained by NATS AIS. Sections of the iPad and AIP charts showing the area between Holding Point J1 and the beginning of Runway 03 are shown in Figure 6. The path that an aircraft must follow after passing Holding Point J1 is shown by the yellow taxiway markings in the 'Overhead view' within the figure.

Taxi route from J1 to Runway 03

The information on the aerodrome chart used by the crew, and the source of information in the UK AIP, suggested that the aircraft would be required to taxi in a straight line from J1 to the runway and then make a right turn onto the runway heading. In fact, in order to taxi from J1 onto the runway, an aircraft must: taxi in a straight line; follow a curve to the right onto runway heading but still displaced to the right of the runway itself; turn left towards the runway; and then turn right again onto runway heading.

Following this accident, the chart supplier decided to revise its Biggin Hill Airport Diagram Chart to include the information contained in Section AD 2.20, paragraph 6 (a) of the airport's entry in the UK AIP (see earlier section on Aerodrome information). It decided to include the information in its Chart Change Notices for the UK to cover the period until the revision was issued.

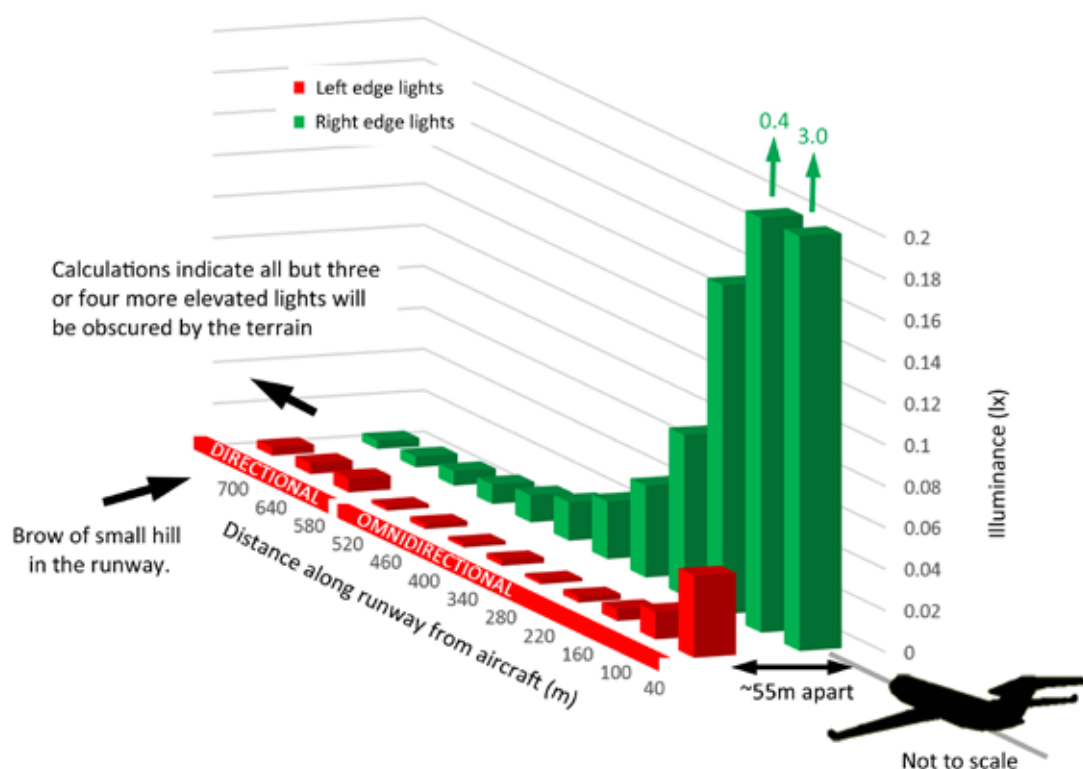
set of edge lights, the pilot will be looking at the highest intensity part of every light along that edge. Edge lights on the other side of the runway will need to be twice as far along the runway, compared to the aircraft-centred scenario, before the main directional beams become visible. This would make the edge lights with which the pilot was aligned a visually compelling line, whereas the corresponding edge lights on the far side of the runway would have been less visible and may not have appeared to the pilot as a line.

To show this point, Figure 8 illustrates the modelled illuminance of the edge lights from the approximate start position of the accident flight, using the minimum light intensity values given in the standards. This assumes the lights were set at 100% power and, as an indicative value, uses 1 km visibility.

Illustration of light intensity of a combined omnidirectional and bi-directional runway edge light, assuming optimal vertical viewing angle and 1 km visibility

It is recommended that the International Civil Aviation Organisation initiate the process to develop within Annex 14 Volume 1, '*Aerodrome Design and Operations*', a standard for runway edge lights that would allow pilots to identify them specifically, without reference to other lights or other airfield features.

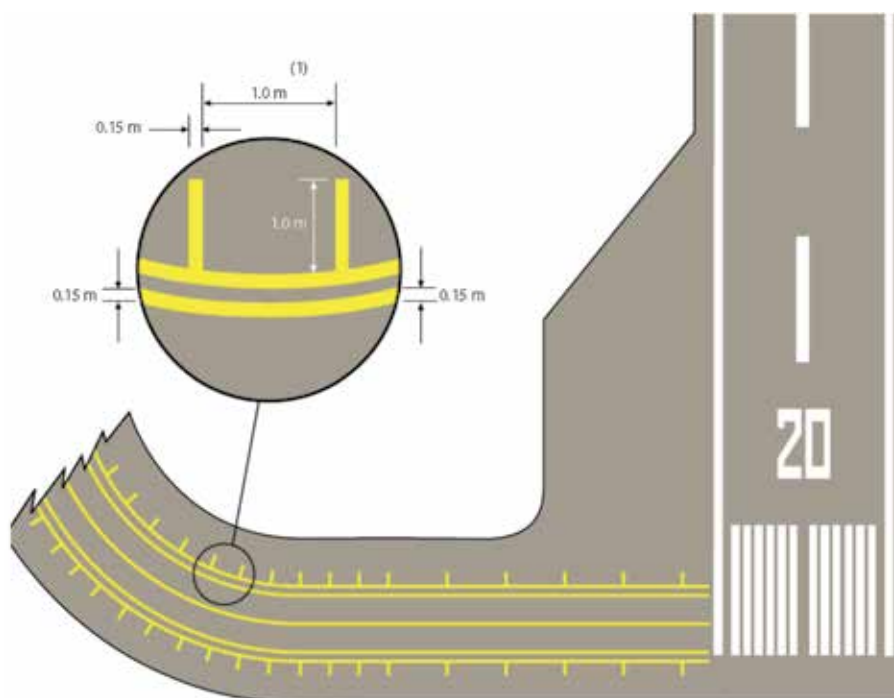
Extract of CAP 168 showing taxiway edge markings at a representative aerodrome

The eastern side of the ORP at the beginning of Runway 03 at Biggin Hill Airport is used as Taxiway C and the boundary between the southern end of the ORP and Taxiway J was not marked as shown in Figure 9 at the time of the accident.
