**AVIATION INVESTIGATION REPORT  
A14W0177**

**RIGHT MAIN LANDING GEAR COLLAPSE**

**JAZZ AVIATION LP (DBA AIR CANADA EXPRESS)  
DHC-8-402, C-GGBF  
EDMONTON INTERNATIONAL AIRPORT, ALBERTA  
06 NOVEMBER 2014**

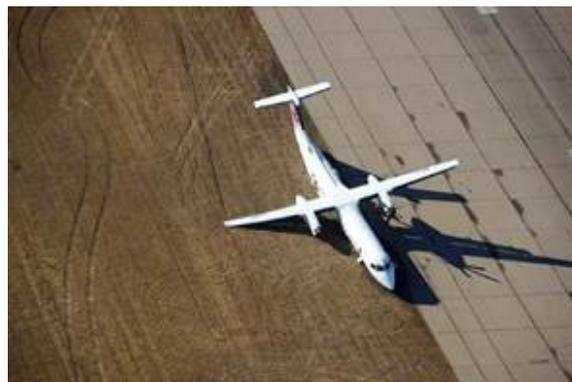
Throughout the approach phase of the landing sequence, the landing gear control panel indicated that the landing gear was down and locked. The aircraft touched down very lightly on Runway 02 at CYEG. As the wheels spun up, a pronounced vibration shook the aircraft 2.4 seconds after initial touchdown; while the nose wheel of the aircraft was still airborne, the right main landing gear (MLG) collapsed. The right-side propeller blades struck the runway, and all were sheared on contact. One large section of a propeller blade penetrated the aircraft cabin next to passenger row 7. At the same time as the propeller contact, the nose landing gear came down hard and its tires ruptured. The aircraft slid slightly to the right and came to a stop off the right edge of the runway, approximately 3200 feet past the touchdown point (Photo 1).

Photo 1. The occurrence aircraft at the accident site

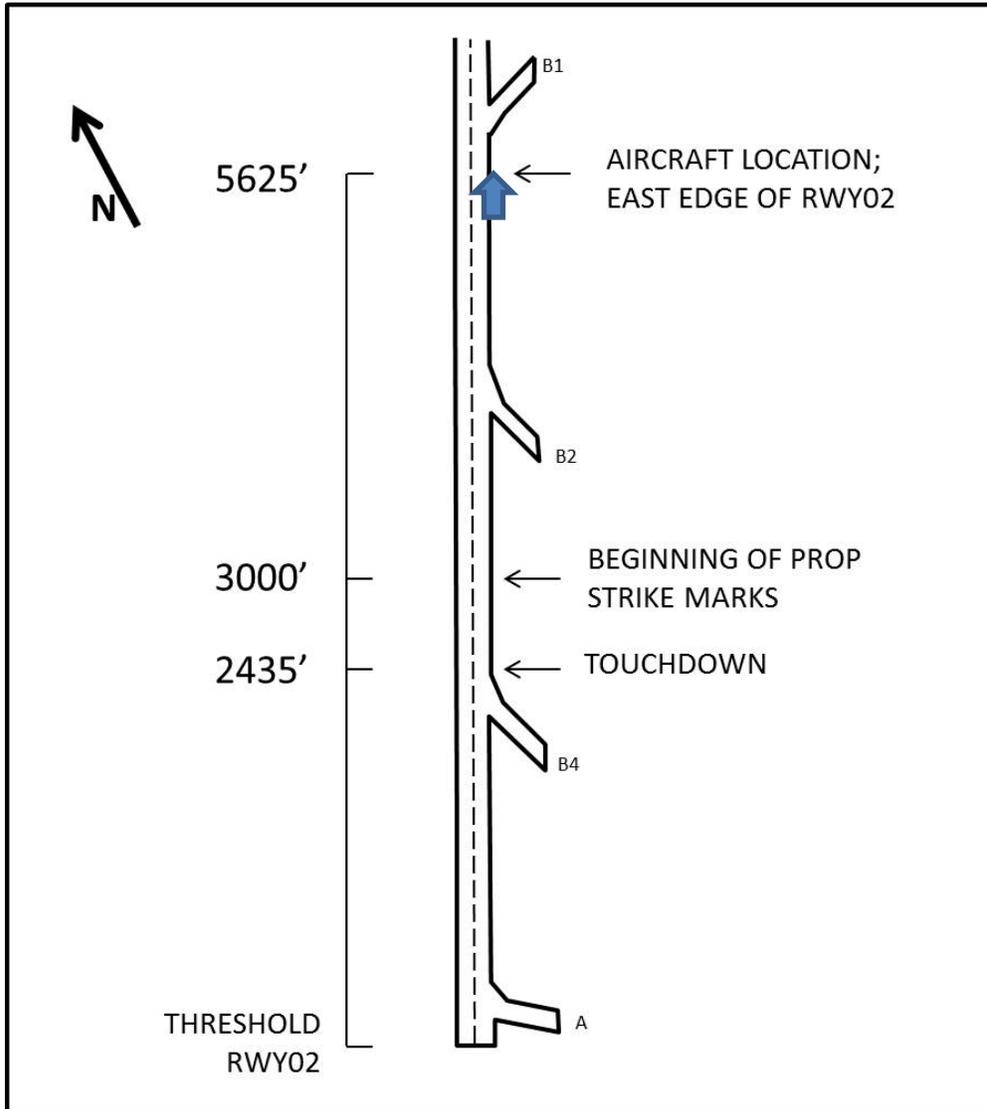
The area of the propeller strike marks was about 40 feet long, with approximately 2 feet between marks (Figure 1). Based on the propeller speed of 1020 revolutions per minute (rpm), which had been briefed by the crew and recorded on the DFDR, these strike marks indicated an approximate ground speed of 120 knots. However, the DFDR recorded an airspeed of 105 KCAS at the time of the collapse, and the DFDR with WOW recorded an airspeed of 118 KCAS just before the collapse.

The aircraft landed slightly right of centre line on Runway 02 at 2435 feet from the threshold. Throughout the landing phase, the landing gear collapse, and the subsequent slide to a stop, the aircraft maintained runway heading. It came to rest 3190 feet after touchdown. The left side main wheels were still on the runway. The left side of the fuselage was on the right-hand edge of the runway asphalt, still parallel to the runway heading. The right wing was touching the ground. The nose landing gear had collapsed rearward during the slide and was approximately 5 feet from the right-hand edge of the asphalt.

Figure 1. Landing path of Jazz 8481 on Runway 02

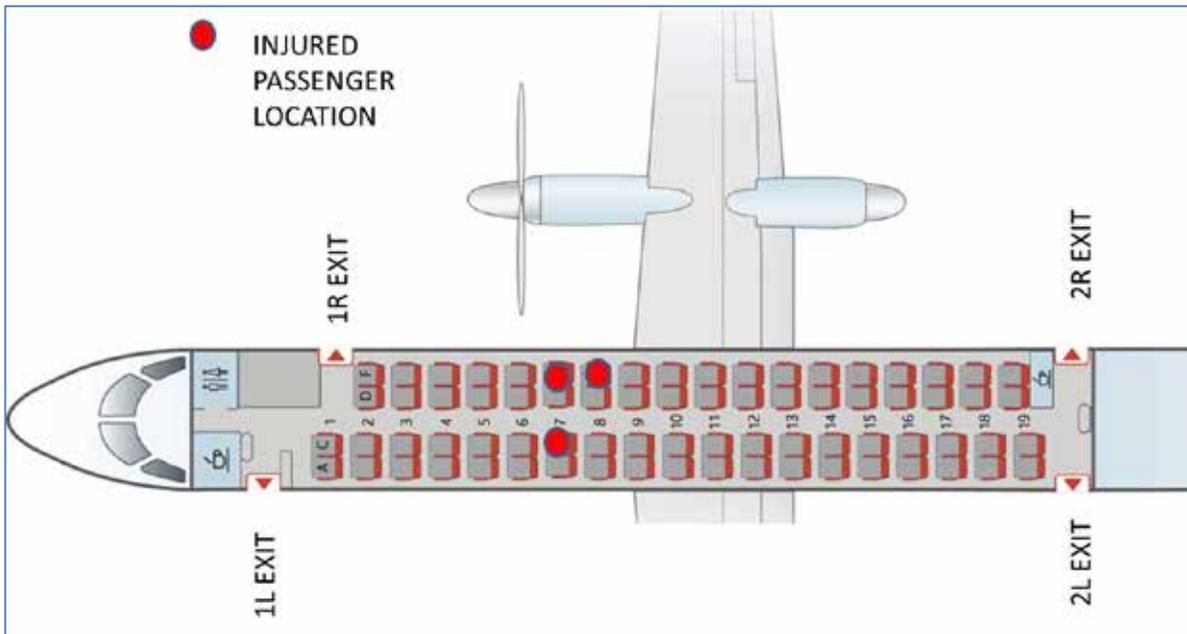
Passengers in seats 7F, 8F, and 7C were injured as a result of the partial propeller blade that punctured the fuselage (Figure 2); these injuries were consistent with plastic pieces in the cabin interior (side wall, window, etc.) blowing into the seating area. There were also blunt-force injuries, abrasions, and small puncture wounds. There were no injuries related to the evacuation.

Figure 2. Jazz 8481 cabin layout showing location of injured passengers

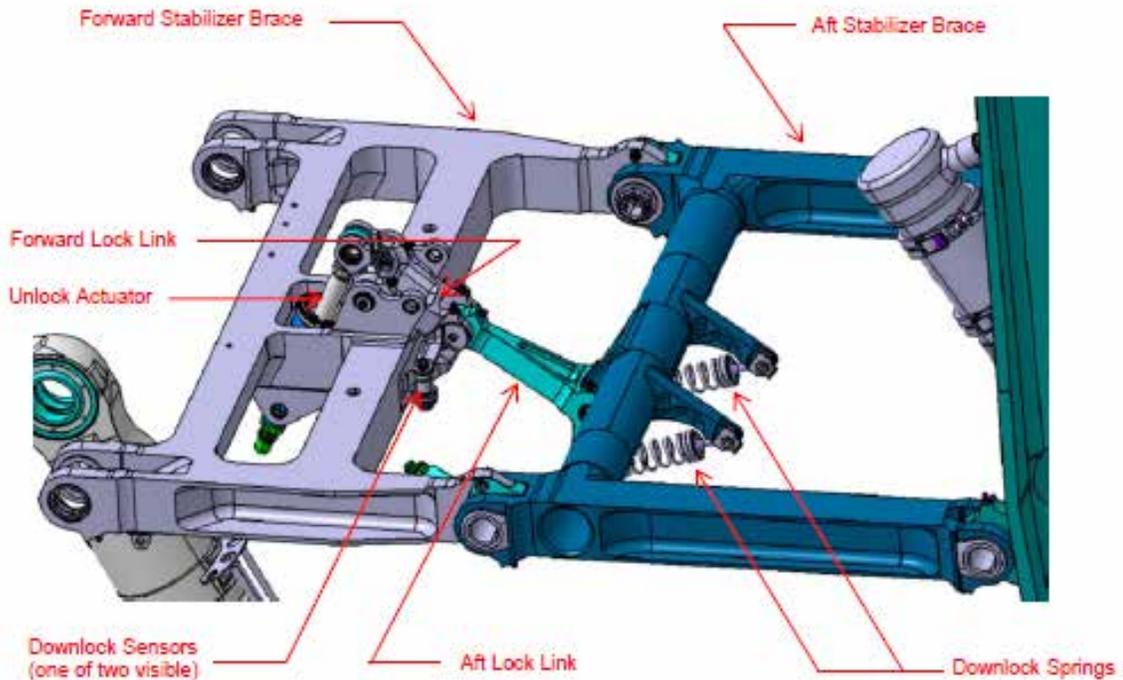
The landing gear stabilizer brace was also inspected and tested according to the ATP at the manufacturer’s facilities. The inspection revealed no anomalies other than a slightly larger-than-normal over-centre measurement; however, this was normal and due to in-service wear. The stabilizer brace was also subjected to rigorous vibration tests; the plan was to subject it to a maximum of 0.29g in the vertical direction (representing the load on the stabilizer brace with the 1248-ounce-inch tire imbalance at 35 Hz). A few resonance sweeps were performed, as well as a number of dwells at various frequencies up to 0.4g; very noticeable vertical vibration at the centre of the brace could be seen at this g level, at the resonant frequency. This was followed by the test spectra according to the planned test. In addition to the test plan, in an attempt to force the brace to unlock, additional cases were run that were not representative of the loads on the brace during the incident. With the unlock actuator in the pressurized condition, the brace was tested at accelerations up to 2g. None of the test cases that were applied resulted in the stabilizer brace coming out of lock; however, the pressurized test jig attachments prevented this in any event.

An unexpected high rotational imbalance was created on the number 3 tire when it failed during takeoff. During landing, the failed number 3 tire was spun by contact with the ground and was maintained at a rotational speed that was the same as or very close to one of the natural frequencies of the main landing gear (MLG). This caused the lock links to trigger (through the proximity sensors gap) the proximity sensor electronic unit (PSEU) to de-energize the solenoid sequence valve (SSV), thereby relieving system pressure from the extend port of the unlock actuator. In this condition, the excessive vibration then caused the lock links to overcome the force from the downlock springs and unlock the stabilizer brace as a result of gear dynamics, which led to collapse of the right MLG.

Zoomed view of the main landing gear stabilizer brace assembly (part no. 46400-27/-29) (Source: UTC Aerospace Systems)
