National Transportation Safety Board Aviation Accident Final Report

Location:	Nashville, TN	Accident Number:	DCA16LA032
Date & Time:	12/15/2015, 1730 CST	Registration:	N649SW
Aircraft:	BOEING 737 3H4	Aircraft Damage:	Substantial
Defining Event:	Landing gear collapse	Injuries:	138 None
Flight Conducted Under:	Part 121: Air Carrier - Scheduled

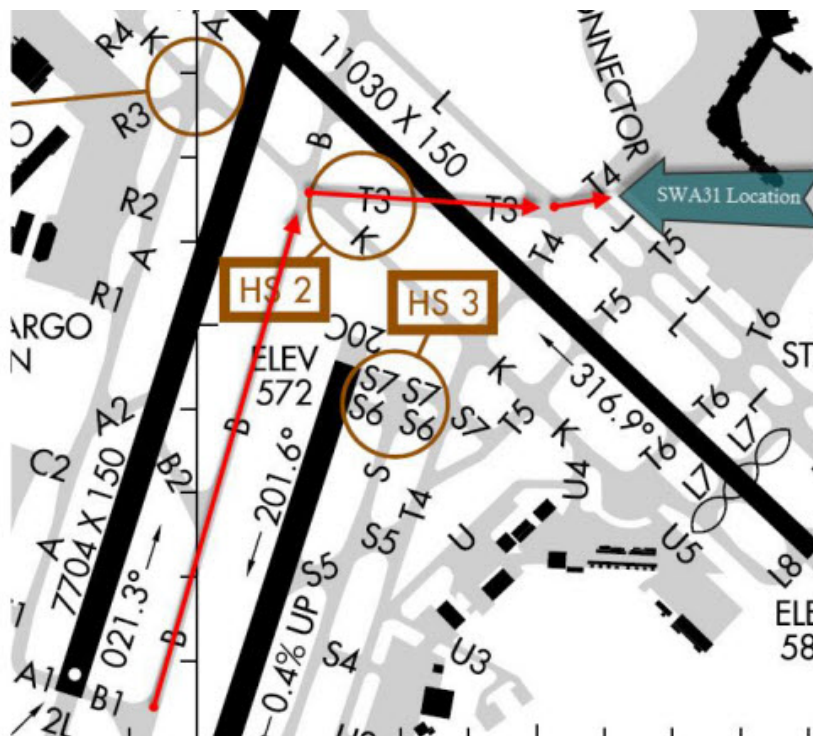
Figure 1 - Taxi route

The airplane landed normally on runway 20R and exited at taxiway B2. ATC instructed the flight to taxi to the ramp (gate C20) via taxiway B, T3, and T4. (Figure 1)

The captain reported he used landing lights to assist in the taxi along B and T3 and then extinguished the landing lights as the airplane crossed runway 13/31, but left the taxi lights on. Video surveillance footage was consistent with the captain's report. The flight crew reported that they had difficulty locating taxiway T4 as it appeared dark and there was glare from the terminal lights ahead. About 15 seconds prior to the excursion the airplane began a left turn briefly to a heading of about 065 degrees. Taxiway T4 was oriented about 045 degrees. Crew reports, and the cockpit voice recorder (CVR) recording, indicate the crew was searching for the turn to the ramp when flight data recorder (FDR) data and video surveillance footage indicated the airplane then turned back to the right to a heading of 090 degrees, consistent

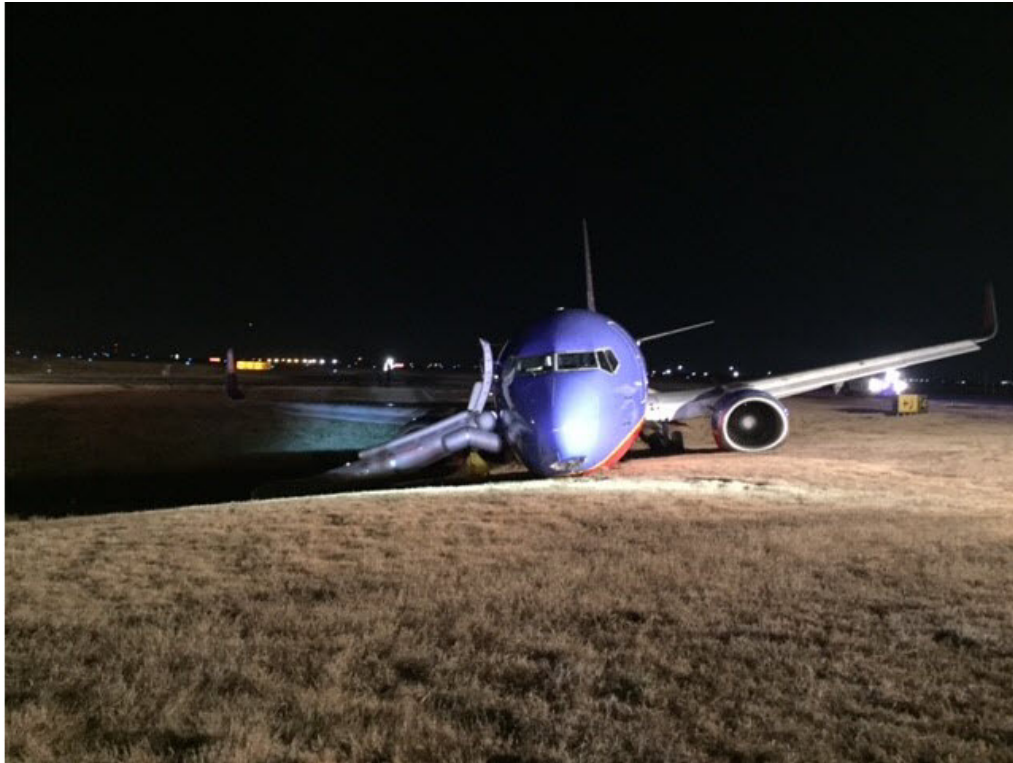
Figure 2 - Aircraft resting position

with the heading toward gate C20. Three seconds later the airplane exited the taxiway into a grassy area with a large drainage ditch, east of the intersection of taxiways T4 and J. The nosegear collapsed, and the airplane came to rest angled to the right, on the left nacelle, right wing tip, and nose. (Figure 2)

The nose landing gear collapsed in a rearward direction resulting in substantial damage to frames, stringers, and the bulkhead aft of the nose gear well. Additional minor damage to engine nacelles, fairings, and skin was also found.

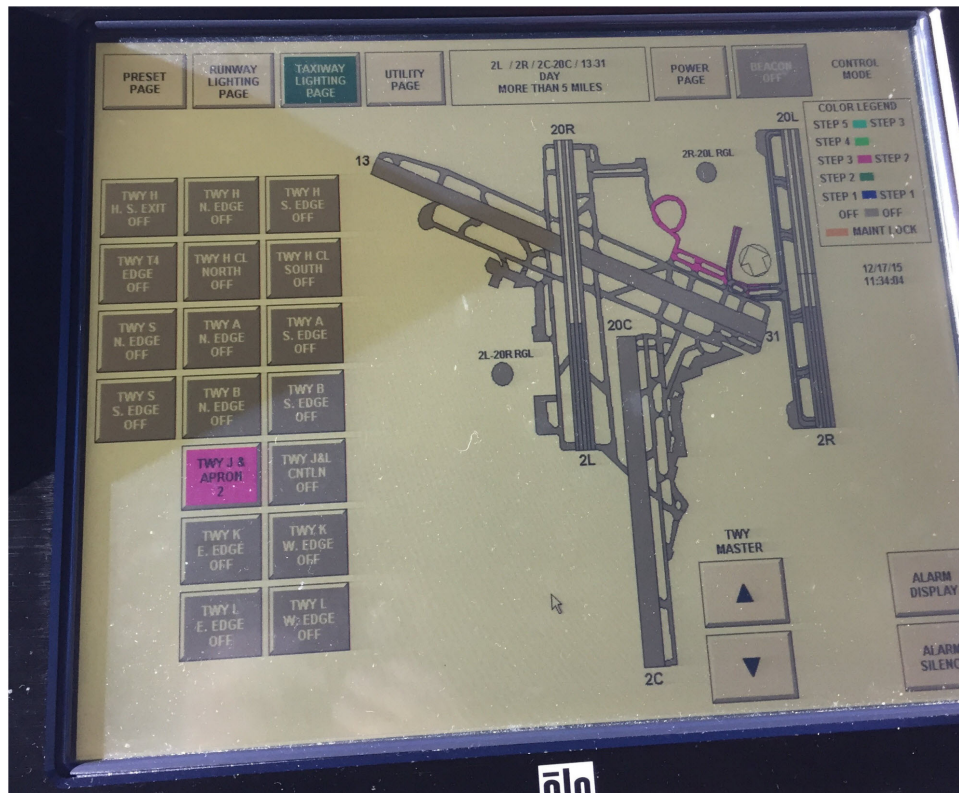
Figure 3 - Lighting panel

Contributing to the accident was the operation of the screen-saver function on the lighting control panel that prevented the tower controllers from having an immediate visual reference to the status of the airfield lighting.

The airfield lighting panels (Figure 3) were owned by the Metropolitan Nashville Airport Authority (MNA) and were operated using software installed in 2010. The airfield lighting was operated in accordance with requirements contained in FAAO 7110.65, Air Traffic Control, and a letter of agreement between the control tower and MNA dated December 16, 2013.

The lighting panels had a screensaver mode that caused the screen to go black after approximately five minutes if the panel was not accessed by a controller.

ATCT staff informed investigators that as a result of past complaints regarding the brightness of the green taxiway centerline lights on taxiways H, J, L, and T6, BNA tower controllers routinely turn off the centerline lighting. On the date of the accident the facility had not received any specific request to turn off the centerline lights; however, prior to the event, the controller in charge (CIC) attempted to turn off the centerline lights as a matter of routine. In doing so, the CIC inadvertently turned off the "TWY J & Apron 2" selector.

Subsequent to the accident, Nashville ATCT modified their standard operating procedure regarding responsibility for taxiway lighting and eliminated the lighting panel screensaver function.
