## Collision with a runway vehicle during pushback

<b>Aircraft</b>	Embraer 190 registered F-HBLF
<b>Date and time</b>	19 April 2014 at about 07 h 50 <sup>(1)</sup>
<b>Operator</b>	Régional
<b>Place</b>	Paris Charles-de-Gaulle Airport (95)
<b>Type of flight</b>	Public transport, commercial operations, passengers
<b>Persons on board</b>	Captain, copilot, 3 cabin crew, 98 passengers
<b>Consequences and damage</b>	Lower part of fuselage severely damaged

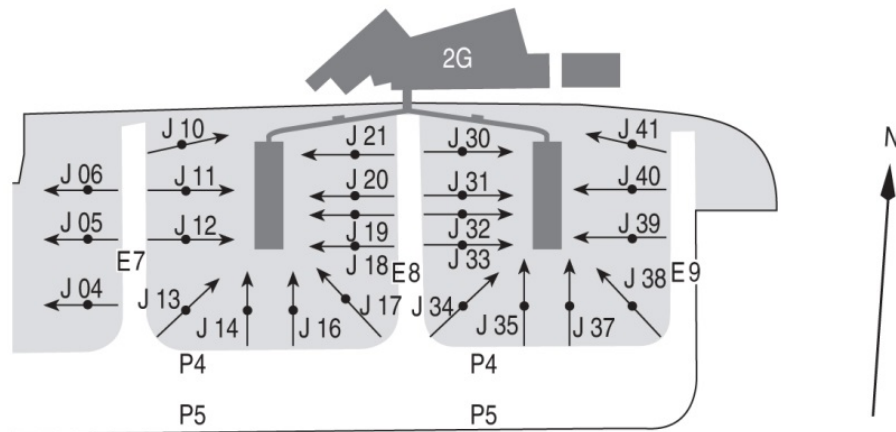
Figure 1 - Plan of aeroplane stands, terminal 2G (CDG)

The crew of F-HBLF called the "De Gaulle Trafic" frequency to ask for approval for pushback from stand J10 at terminal 2G for a flight bound for Clermont-Ferrand Auvergne airport (63). The apron management services agent asked them to push back facing east.

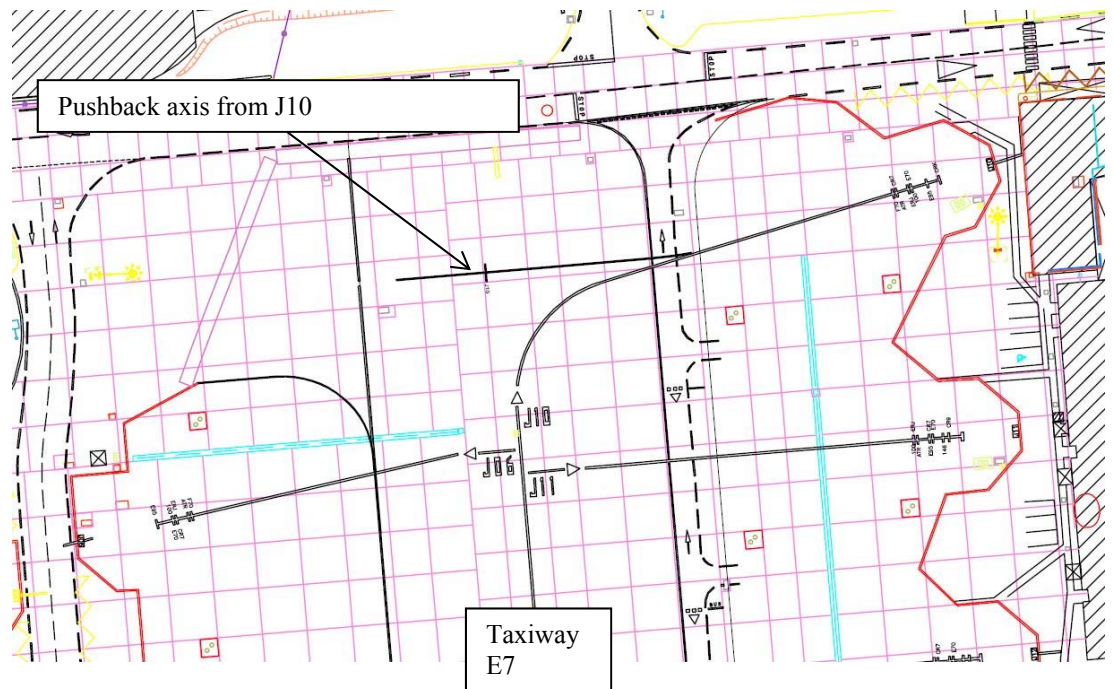
Figure 2 - detail of stands and daytime ground lighting

During the pushback, the crew of F-HBLF started the aeroplane's two engines, which stabilised at ground idle. Following the pushback from J10, the aeroplane was on the axis specified in the documentation (see below).

In order to position the aeroplane on the centreline of taxiway E7, the tug driver had to make the aeroplane make a turn of about 90° with a short turn radius. To do this, he positioned his tug at approximately 90° to the aeroplane axis. When the tug began to pull the aeroplane, the safety cotter pins on the tow bar coupling head broke. The coupling head was then only connected to the tow bar by an axle around which it could pivot horizontally.
