AVIATION INVESTIGATION REPORT A16O0149

Risk of collision

Porter Airlines Inc., DHC-8-402, C-GKQA
and

Jazz Aviation LP (dba Air Canada Express),
DHC-8-402, C-GXJZ

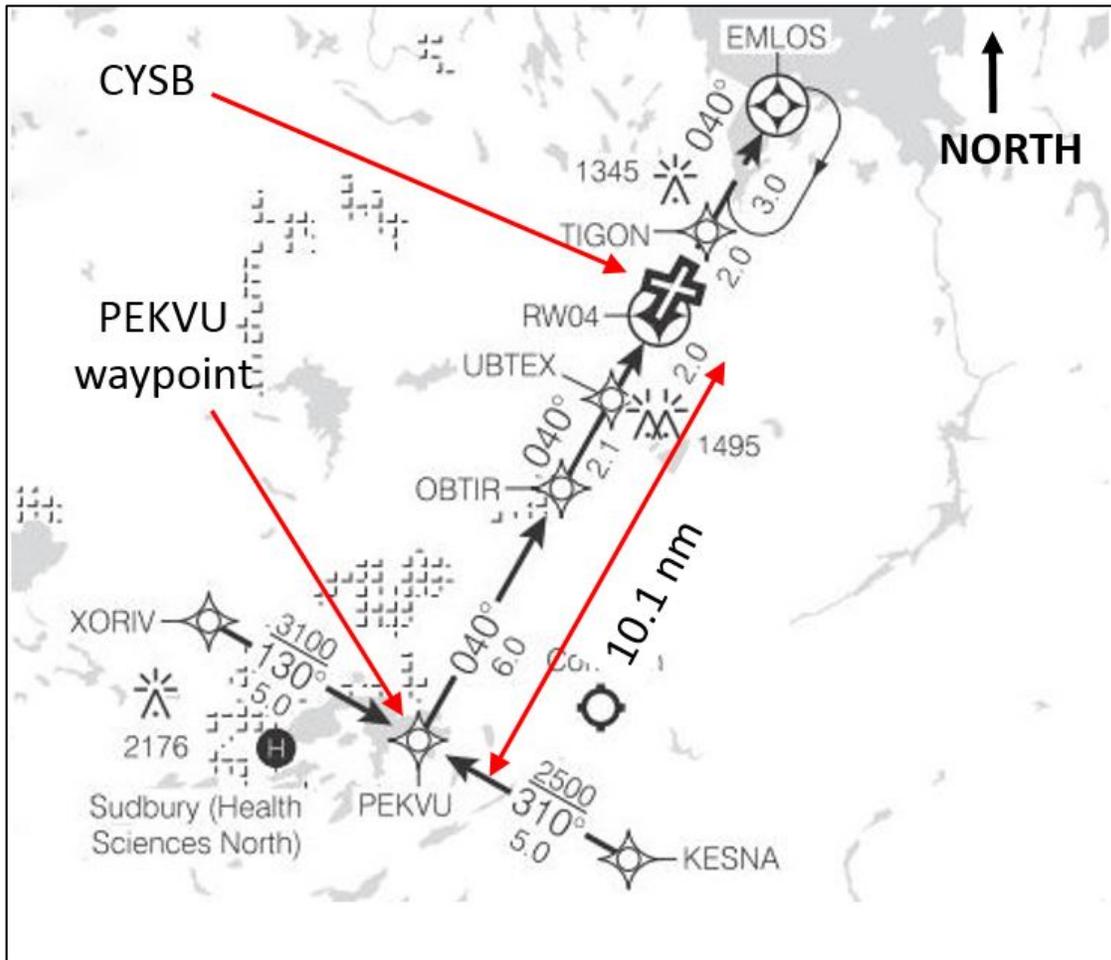
At CYSB, the same runway surface serves as both Runway 04 and Runway 22; its designated number is determined by the direction of takeoff or landing (Appendix A). Runway 22 was the active runway³ when POE533 was approaching CYSB from the south. However, the North Bay controller,⁴ who was located at the Toronto Area Control Centre (ACC), authorized POE533 to fly direct via the PEKVU initial approach waypoint. PEKVU is located at 10.1 nautical miles (nm) final on the area navigation (RNAV) approach⁵ to Runway 04, and is situated on the extended runway centreline for departures from Runway 22 (Figure 1 and Appendix B).

Figure 1. Plan view of the RNAV Runway 04 approach chart, showing PEKVU initial approach waypoint (Source: NAV CANADA, *Canada Air Pilot*, Instrument Procedures, Ontario CYSB RNAV [GNSS] RWY 04, with TSB annotations)

At 0959:30, when JZA604 became airborne, POE533 was approximately 17.3 nm south of the airport, proceeding directly to the PEKVU initial approach waypoint and descending through 6700 feet.

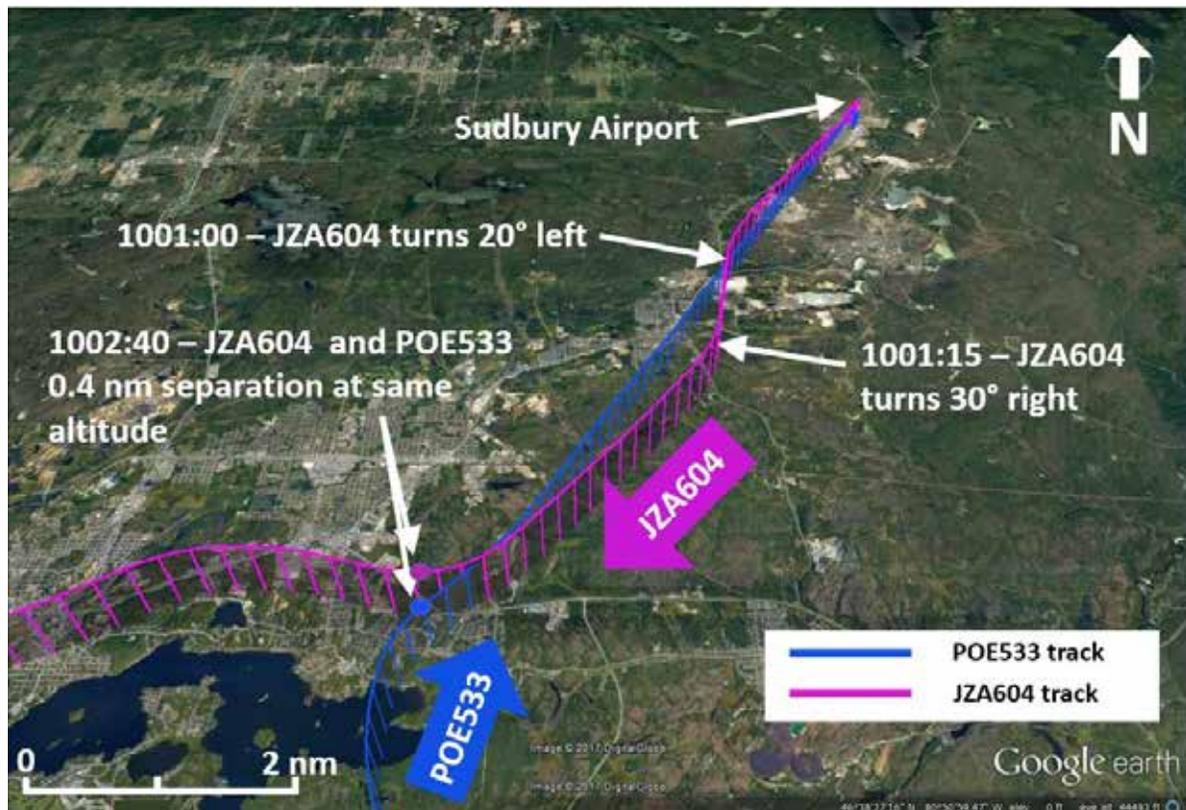
At 1001, JZA604 turned left (east), 20° from the runway extended centreline, which was also the approach path for Runway 04 (Figure 2). The North Bay controller had not been informed of this turn or noticed it on the radar, and subsequently suggested¹² that JZA604 turn 30° to the right (west). The controller then informed JZA604 of POE533's position.

Figure 2. Flight tracks of JZA604 and POE533 (Source: Google Earth, with TSB annotations)

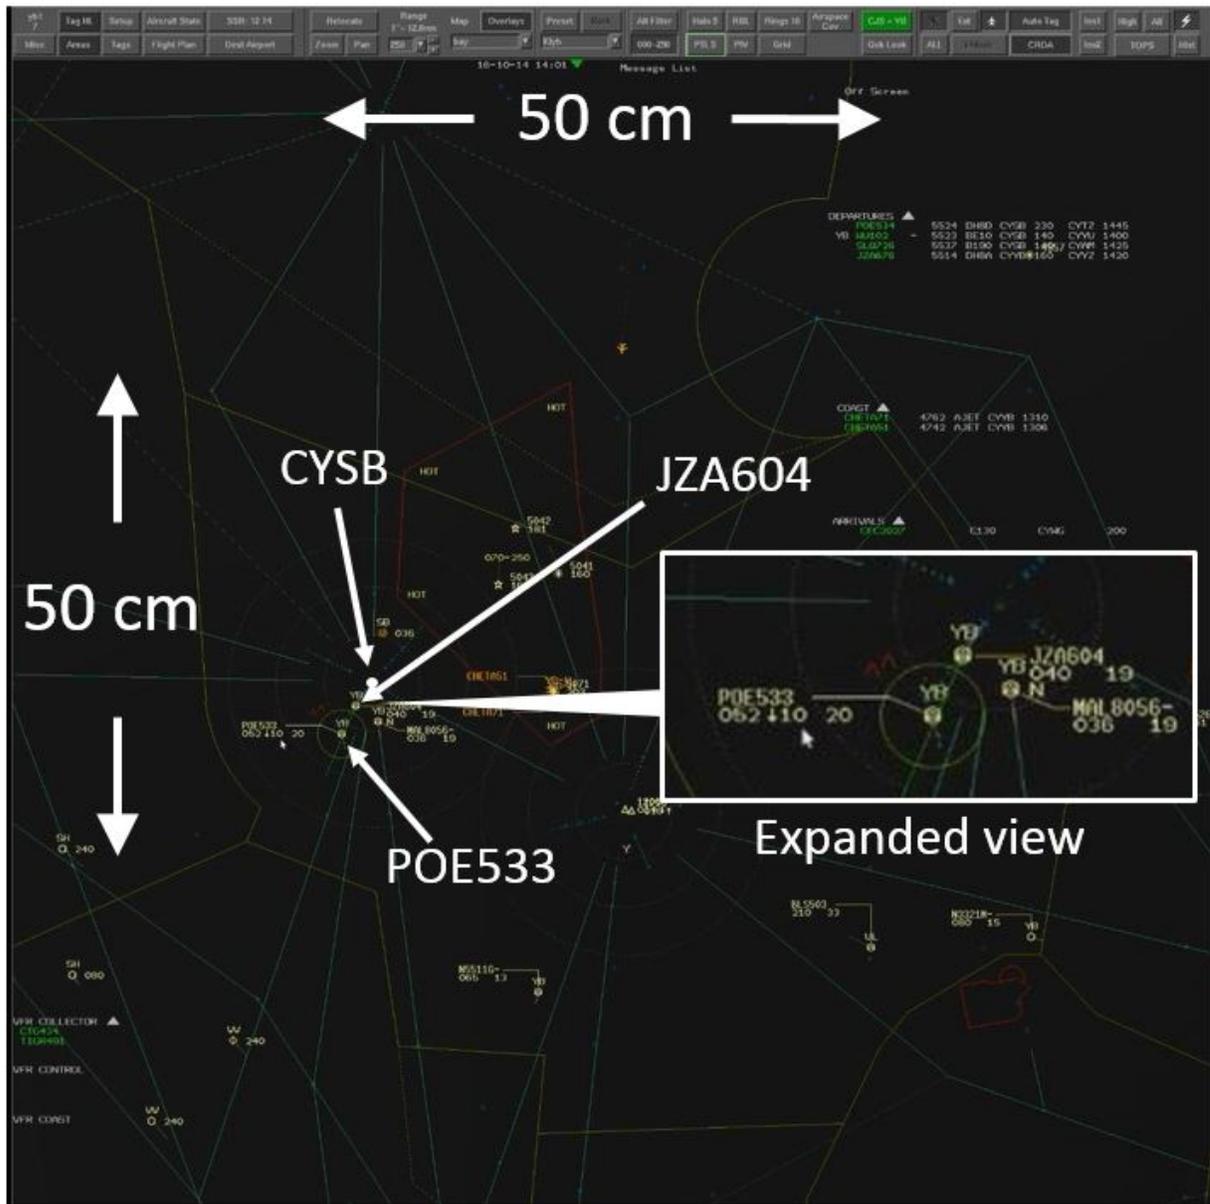
At the time of the occurrence, the CSiT used by the North Bay controller displayed altitude information for both POE533 and JZA604, along with their present-position symbols. Given the large area of the North Bay Sector, the CSiT range was set to 250 nm, whereby 1 cm of screen resolution was equal to approximately 5 nm. This setting enabled the controller to see the entire sector (Figure 3). However, if a target makes a small heading change while the range is set to this scale, it will not be immediately apparent on the screen.

Figure 3. Screenshot of the North Bay controller’s Canadian Automated Air Traffic System situational display at 1001:30 (Source: NAV CANADA, with TSB annotations)
