Flight path management occurrence involving Boeing 737, VH-VZZ

near Canberra Airport, Australian Capital Territory, 13 March 2017

ATSB Transport Safety Report
Aviation Occurrence Investigation
AO-2017-030
Final - 14 March 2018

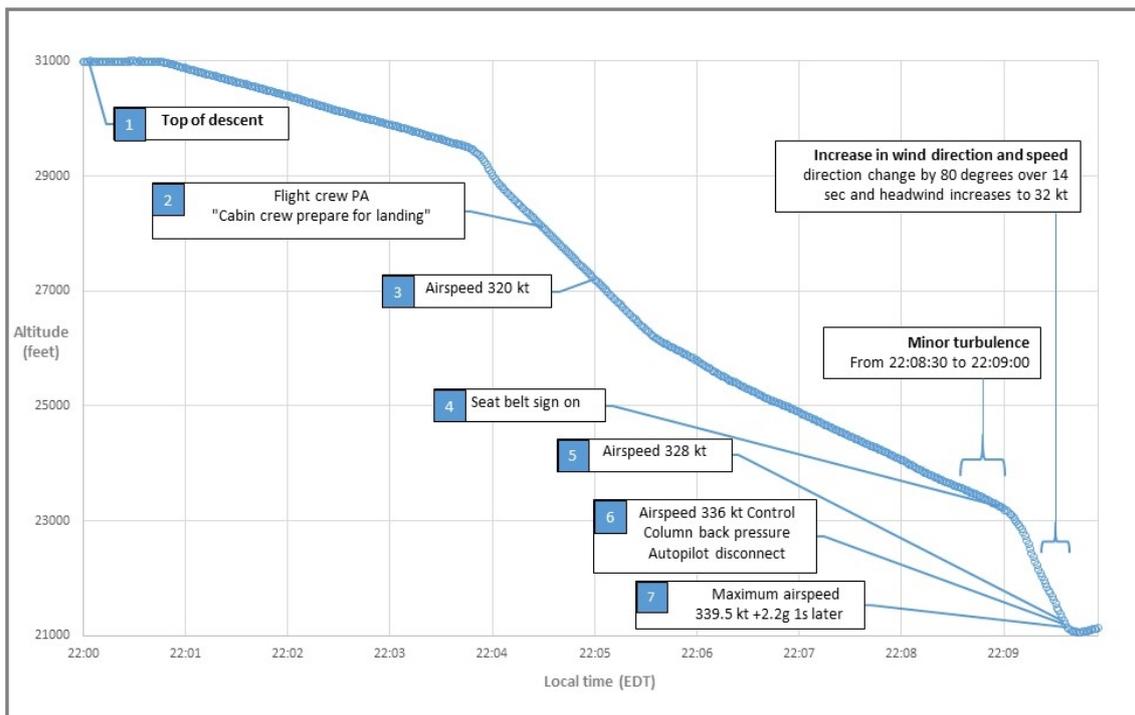
Figure 1: Diagram showing actions, conditions, and events during the aircraft's descent

At about 2200, the flight crew informed ATC that descent from flight level (FL) 310³ had commenced and reported some light to moderate turbulence (Figure 1). Shortly after, ATC informed the flight crew that there would be a runway change to 35.

When VZZ descended through FL 220 (about 30 seconds after the ‘fasten seat belt’ sign was switched on), the wind direction changed by about 80 degrees, resulting in a head wind increase from 15 kt to 32 kt. That in turn led to the airspeed increasing through 325 kt, and the PF applying control column backpressure to avoid exceeding V_{MO} . About 1 second after the maximum control column force was applied, the autopilot disengaged and the G-Load⁴ peaked at 2.2 g. The pilot monitoring reported that they were checking the instrument approach, as a result of the change to runway 35, when they heard the autopilot disengage tone and saw the speed of the aircraft increasing toward V_{MO} .

At 2209:36, as the airspeed began increasing above 325 kt, the control column was pulled back and the autopilot disengaged at 2209:40. About 1 second after maximum control column force, the G-load peaked at 2.2 g and the aircraft pitch angle changed from -1.58° to 2.29°. The aircraft reached a maximum speed of 339.5 kt, 0.5 kt below V_{MO} .

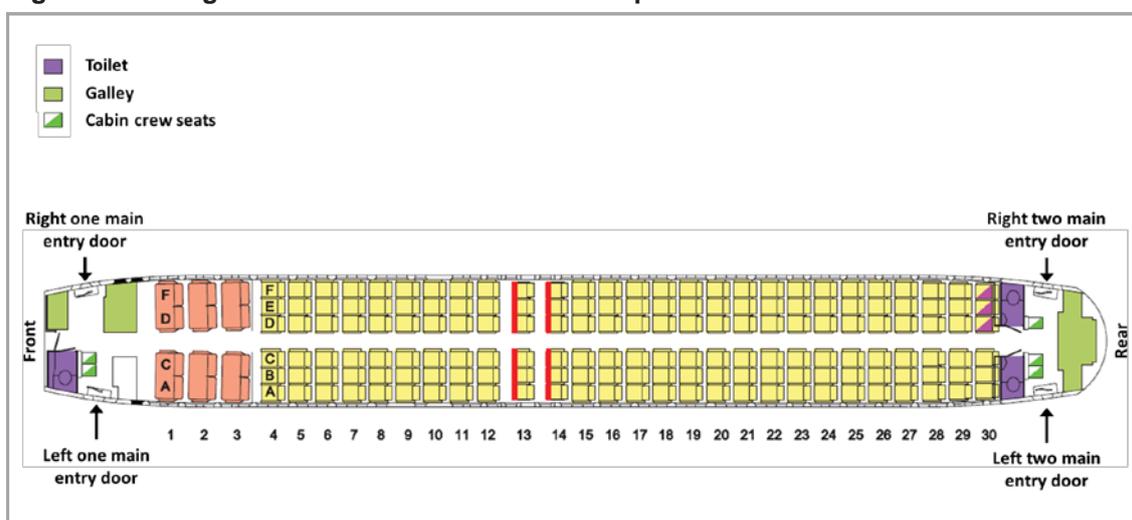
Figure 2: Boeing 737-800 VH-VZZ aircraft seat map

At that time, a cabin crew member was passing row 22 on her way back to the rear of the cabin (Figure 2). The aircraft’s movement due to the turbulence was such that she needed to hold onto the overhead lockers as she walked along the aisle. About 15 seconds later, she reached the rear galley, closed a stowage latch, and secured a rubbish bin in preparation to be seated in the left cabin crew seat.

The cabin crew member recalled that, while standing in the rear galley and preparing for arrival, she felt the cabin floor drop and then quickly come up. The force due to the aircraft’s movement resulted in the cabin crew member fracturing her leg. The cabin crew member seated in the right rear seat assisted the injured cabin crew member.
