Report 07-005	Raytheon 1900D, ZK-EAN and Saab-Scania SF340A, ZK-FXA,	29 May 2007
INCORPORATING	critical runway incursion, Auckland International Airport	
Report 07-009	Raytheon 1900D, ZK-EAH and Raytheon 1900D, ZK-EAG,	1 August 2007
	critical runway incursion, Auckland International Airport

**Raytheon 1900D, ZK-EAN and
Saab-Scania SF340A, ZK-FXA**

critical runway incursion

Auckland International Airport, 29 May 2007

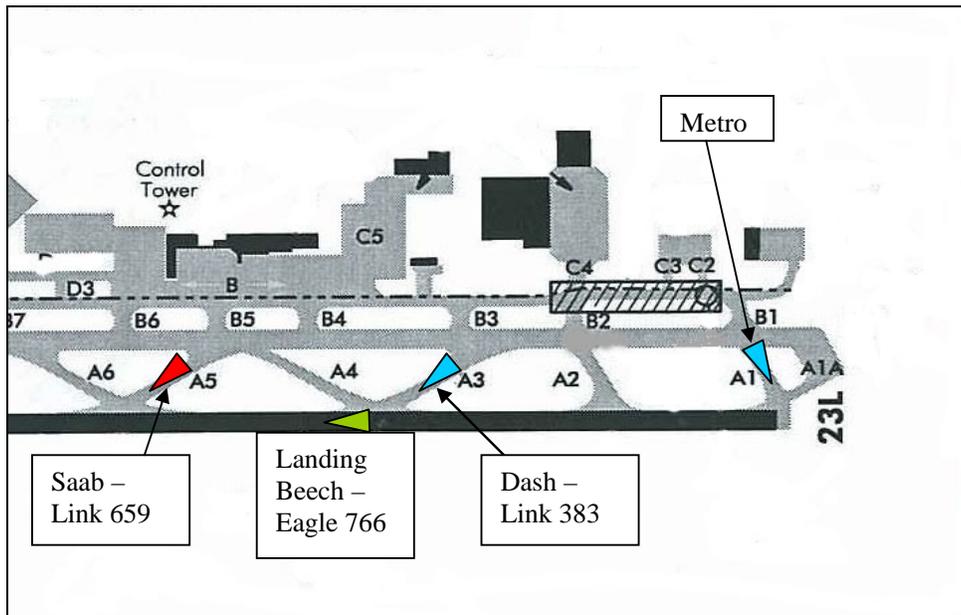
Figure 2
Relevant traffic at 1333 on 29 May 2007

- 1.1.9 The aerodrome controller discussed with the ground controller whether to depart an aircraft in the gap between Eagle 766 and the next arrival. The ground controller suggested Link 659 and pointed towards the Saab. However, the aerodrome controller was looking towards the approach area and touchdown zone, beyond taxiway A3. Taxiway A5 was about 70° right of where the aerodrome controller was looking.

- 1.1.10 The aerodrome controller decided to depart the Dash in the gap and at 1333:11, after Eagle 766 had passed taxiway A3, transmitted: “659, if you can take an immediate, line up runway 23L”. The ground controller saw that the aerodrome controller was looking towards the Dash when the clearance was given and immediately reminded the aerodrome controller that Link 659 was

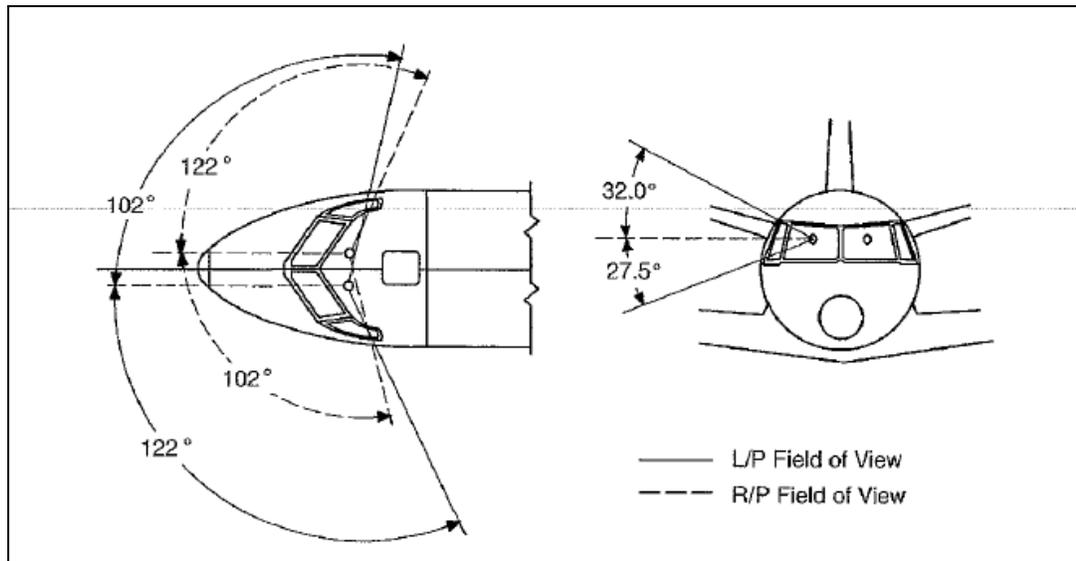
Figure 3
External vision angles from Saab pilots' seats
 (Source: Saab SF340A aircraft operations manual.)

1.3.1 The Saab aircraft operations manual showed that the external vision angle for a pilot was 122° in azimuth when looking out the same side of the aircraft (see Figure 3). During the investigation, it was found that nearly 140° could be seen if a pilot leaned forward and turned in the seat. Both Saab pilots said that when holding on angled taxiways such as A3 at Auckland they could not see the active runway threshold.

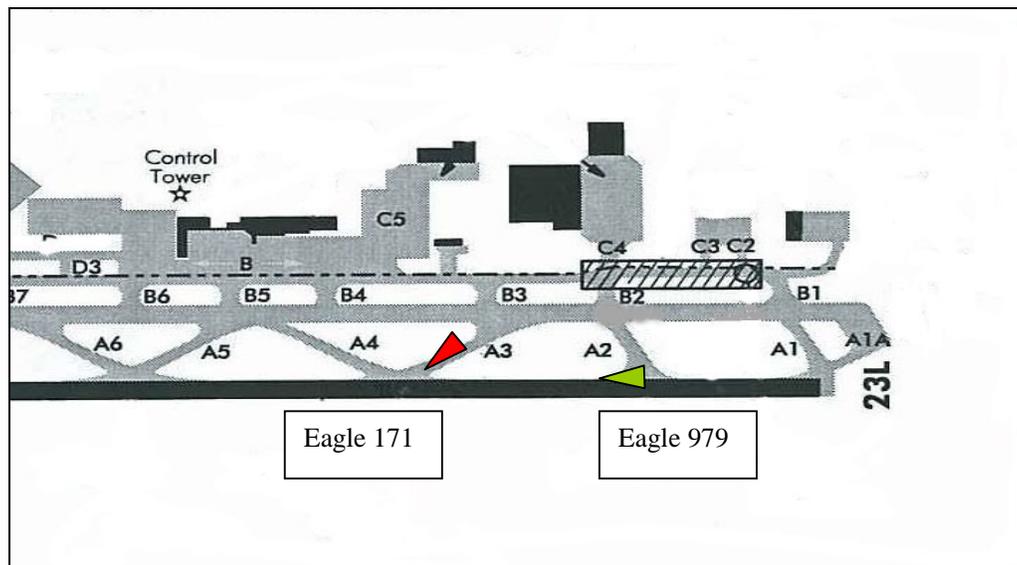
Figure 4
Relevant traffic at 0758 on 1 August 2007

- 1.5.7 The first officers of both Eagle 979 and Eagle 171 read back the take-off clearance at the same time. The format for a clearance read-back ends with the aircraft call sign, and both "seven one" and "seven nine", in that order, could be heard on the Tower recording. The first officer of Eagle 979 said that he heard "seven one" after he had finished his read-back, which he thought was strange, but he did not suspect crossed transmissions.

- 1.5.8 The aerodrome controller said that he heard the crossed transmissions, but he did not associate them with either Eagle flight. He had looked away from the runway to assess the weather, and then instructed the light aircraft to change frequency. He did not see Eagle 979 start its take-off or Eagle 171 move towards the runway. The aerodrome controller’s attention was brought back to the runway when he heard someone transmit “Eagle alpha hotel, hold!”
