Summary Report

Aircraft type	Boeing 767-424 ER	N68061
Operator/owner	United Airlines Inc., Attn: Treasurer Willis Tower, 233 S Wacker Dr, Chicago, IL 60606-7147, USA	
Flight crew	One pilot in command (PIC), two first officers (FOs)	
Licences	Issued by the American Federal Aviation Authority (FAA)	
Location	Audincourt, France	
Coordinates	N 47° 27' 30" / E 6° 45' 00"	Altitude 19,325 ft AMSL ¹
Date and time	23 rd August 2017, 10:27 UTC (LT = UTC + 2 h)	
Type of operation	Commercial	
Flight rules	Instrument flight rules (IFR)	
Departing from	Zurich Airport (LSZH)	
Destination	Washington Dulles International Airport (KIAD), USA	
Flight phase	Take-off and climb	
Type of serious incident	Loss of pressure in the cabin	
Injuries to persons	None	
Damage to aircraft	Minor	Burst air duct in the equipment cooling system
Third-party damage	None

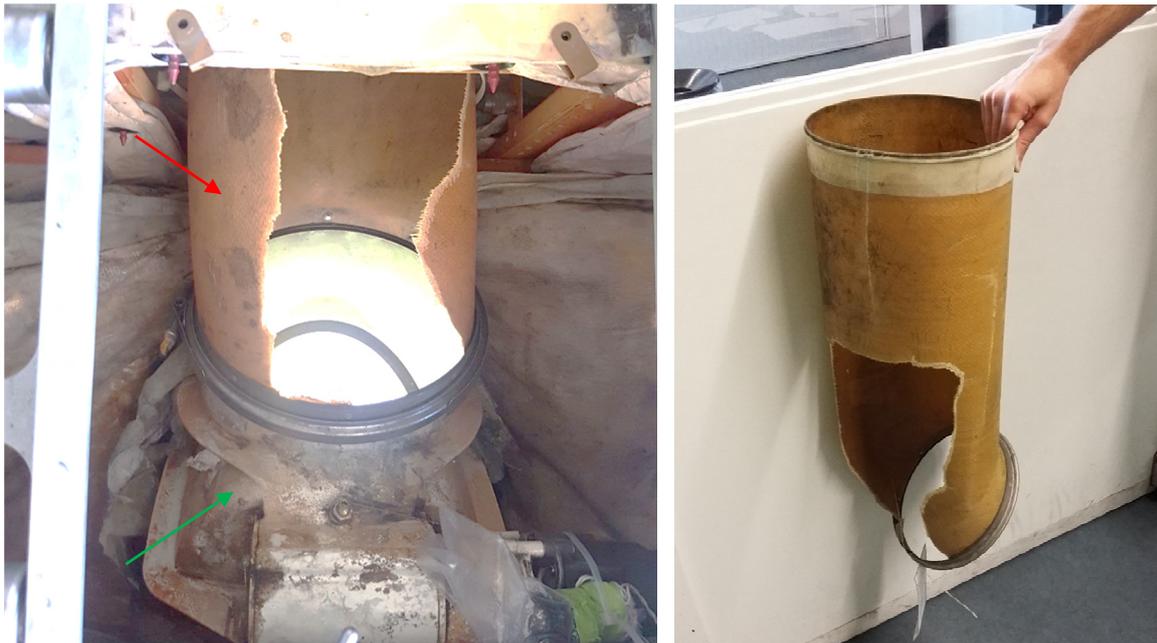
- The equipment cooling overboard exhaust valve was fully open.
- The electrical connector on the equipment cooling overboard exhaust valve was unplugged.
- The air duct connected to the equipment cooling overboard exhaust valve was severely damaged (see Illustration 1).
- No fragments of the damaged air duct were found in the aircraft.
- The rotary switch on the equipment cooling panel in the overhead panel was in the STBY position.

Illustration 1: The damaged air duct (red arrow) connected to the equipment overboard exhaust valve (green arrow). The image on the right shows the removed damaged air duct.

The air duct to the equipment cooling overboard exhaust valve is not designed to withstand larger pressure differences as the valve is designed to normally be closed during flight. In the present case with an open valve, the air in the air duct could escape into the atmosphere unhindered. The crew stated that the pressure in the cabin stabilised upon switching the selector switch from AUTO to STBY and that the cabin altitude began to slightly decrease again. This can probably be attributed to the fact that in the new configuration the cabin air was no longer being actively conveyed across the aircraft by a fan.

It seems obvious that the air duct was not able to withstand the increased strain resulting from the occurring pressure difference and therefore burst.

The mix-up by the technician, who deactivated the wrong valve in the open position, was the cause of the serious incident. The approach of working from memory, without taking a written form of the operating procedures described in the MEL with him, was identified as a contributory factor during the investigation.

- information about the incident was passed to all SR Technics stations to be forwarded to all technicians;
- the ensuring that the corresponding documentation for all maintenance work is available at the aircraft;
- introduction of a two-man principle when carrying out maintenance work in accordance with the MEL.
