INCIDENT

Aircraft Type and Registration:	i) DHC-6 Twin Otter Series 310, G-BVVK ii) Embraer EMB-145EU, G-EMBV
No & Type of Engines:	i) 2 Pratt & Whitney PT6A-27 turboprop engines ii) 2 Allison AE 3007/A1/1 turbofan engines
Year of Manufacture:	i) 1980 ii) 2001
Date & Time (UTC):	29 August 2006 at 0932 hrs
Location:	Glasgow Airport
Type of Flight:	i) Commercial Air Transport (Passenger) ii) Commercial Air Transport (Passenger)
Persons on Board:	i) Crew - 2 Passengers - 16 ii) Crew - 4 Passengers - 25
Injuries:	i) Crew - None Passengers - None ii) Crew - None Passengers - None
Nature of Damage:	i) None ii) None
Commander's Licence:	i) Air Transport Pilot's Licence ii) Air Transport Pilot's Licence
Commander's Age:	i) 45 years ii) 36 years
Commander's Flying Experience:	i) 5,796 hours (of which 2,130 were on type) Last 90 days - 146 hours Last 28 days - 55 hours ii) 4,200 hours (of which 3,300 were on type) Last 90 days - 210 hours Last 28 days - 70 hours

Information Source:	AAIB Field Investigation

Synopsis

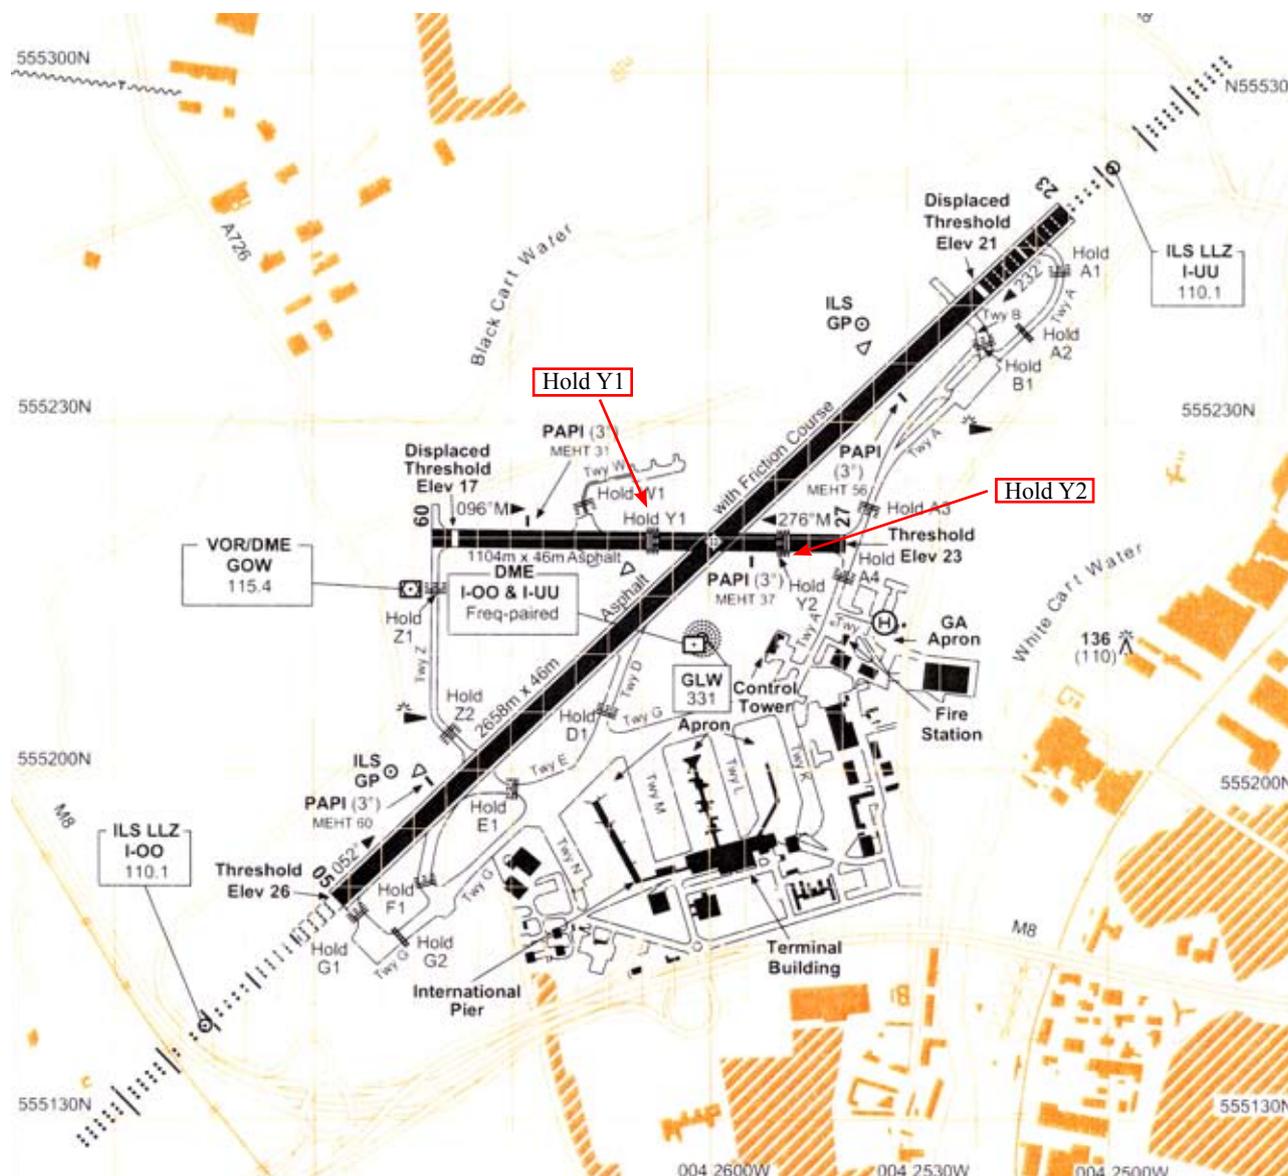
Figure 1
Glasgow International Airport

A DHC6 Twin Otter aircraft was stationary at the Y1 holding point (see Figure 1), at Glasgow Airport. Its flight crew had correctly acknowledged a clearance from ATC to cross Runway 23, which was the active runway, after the landing Embraer 145. The DHC-6 crew having discussed some training issues, thought that the

Embraer 145 had landed and began to taxi towards Y2. As they were about to cross Runway 23 the commander saw the Embraer 145 about to touch down and reversed the aircraft back towards Y1.

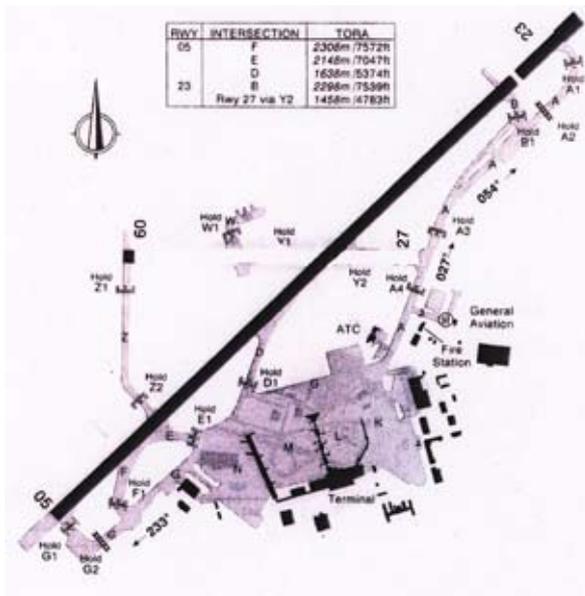
Figure 2
Visual mode

With Visual mode selected for Runway 05/23, only the runway surface area is monitored as shown in Figure 2. When LVP mode for Runway 05/23 is selected the additional areas of the holding points to the runway edge as well as the runway(s) surface is monitored as shown in Figure 3. When both Runways 05/23 and 09/27 are in use, the Cross Runway operations mode should be selected. With Runway 05/23 and Cross Runway mode selected, an additional defined area covers the 09/27 runway surface between the Y1 and Y2 holding points as well as the Runway 05/23 surface area. This area is shown in Figure 4.

At the time of the incident visual operations were in progress and only Runway 05/23 was in use with the Visual mode selected on the RIMCAS. After the DHC-6 had landed, Runway 09/27 was being used as a taxiway and not as a runway so no Cross Runway mode was required. Without the Cross Runway mode selected, no alert was activated when the DHC-6 crossed the Y1 holding point towards the runway. The defined area

The visual controller and ATCO colleagues were not aware that when only Runway 05/23 or 09/27 was in use with Visual mode selected, the areas between the holding points and the runway edge were not defined

areas. The actual defined area in the Visual mode is shown at Figure 2 but their perception of the defined area is illustrated at Figure 3.

NATS took immediate action to ensure that controllers had the correct understanding of the capabilities of the RIMCAS. This particularly included the defined areas covered by the various RIMCAS modes which were available. Shortly after the incident, NATS also extended the operational areas of the RIMCAS system to include an area beyond the runway edge towards each holding point. This action has not resulted in an increase in false or spurious alerts.

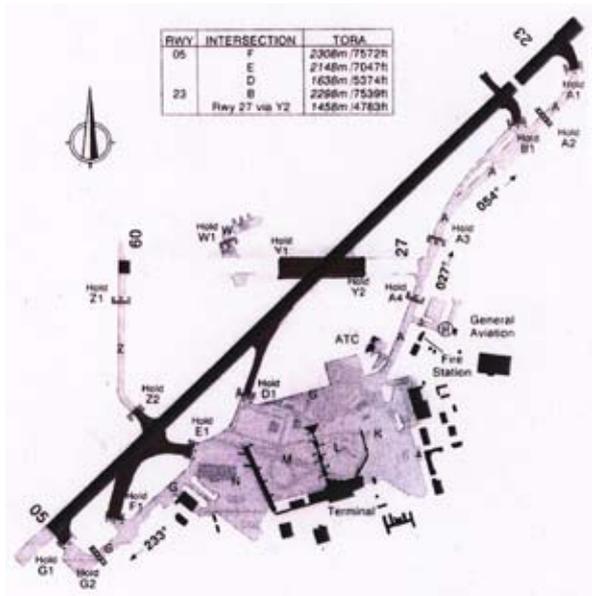
Figure 3
LVP mode

covered by the Cross Runway operations mode, which would have created an alert when the DHC-6 crossed Y1 is shown at Figure 3.
