SERIOUS INCIDENT

Aircraft Type and Registration:	Airbus A319-111, G-EZAW
No & Type of Engines:	2 CFM 56-5B5/P turbofan engines
Year of Manufacture:	2006 (Serial no: 2812)
Date & Time (UTC):	3 July 2017 at 1931 hrs
Location:	Munich Airport, Germany
Type of Flight:	Commercial Air Transport (Passenger)
Persons on Board:	Crew - 6 Passengers - 149
Injuries:	Crew - None Passengers - None
Nature of Damage:	Damage to the nose and right main landing gear
Commander's Licence:	Airline Transport Pilot's Licence
Commander's Age:	41 years
Commander's Flying Experience:	11,179 hours (of which 9,300 were on type) Last 90 days - 192 hours Last 28 days - 35 hours
Information Source:	Aircraft Accident Report Form submitted by the pilot and further enquiries by the AAIB

Synopsis

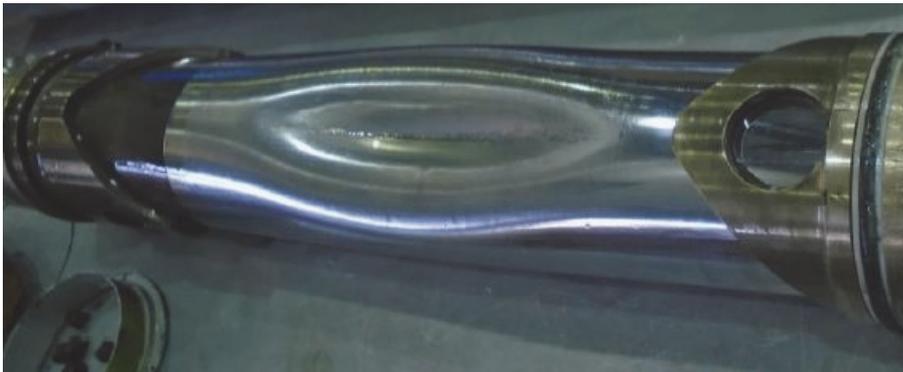
Figure 1

The aircraft was inspected for a Severe Hard Landing as required by the manufacturer's Aircraft Maintenance Manual. This inspection revealed damage to the nose landing gear and the right main landing gear as well as some cracking of the paint and sealant in the nose gear bay and avionics bay. The inspection showed there was no other damage to the aircraft.

On the advice of the manufacturer, all three landing gears on the aircraft were replaced and sent for detailed inspection. These inspections revealed that both the nose landing gear and the right main landing gear had suffered excessive loads during the landing and could not be returned to a serviceable condition. The nose landing gear shock-absorber cylinder was found buckled (Figure 1) with the barrel and forestay lower arm pin found to be out of tolerance. The right main landing gear sliding tube and shock-absorber were also found to be outside acceptable tolerances when measured. The left main gear was undamaged.

Nose landing gear shock absorber cylinder

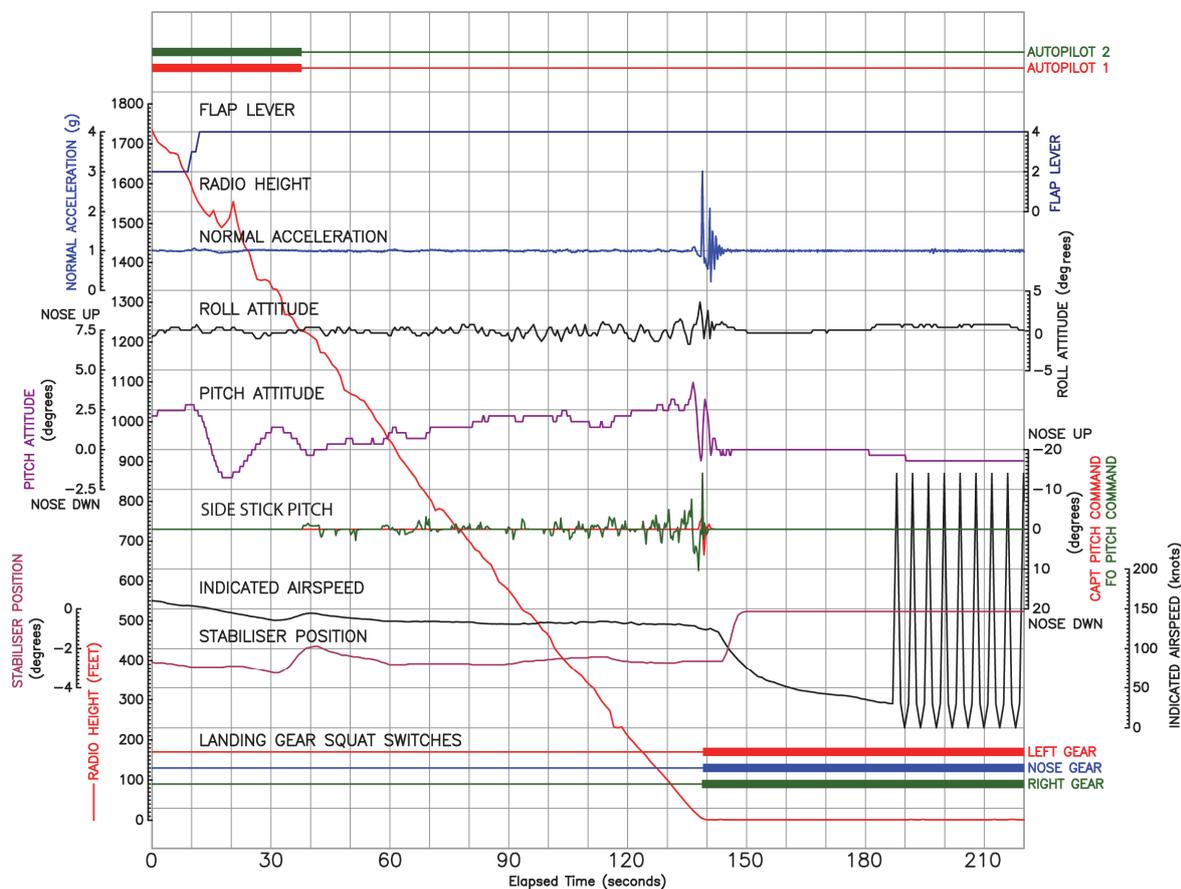
Figure 2

The data (Figure 2) shows the aircraft established on a stable ILS approach, correctly configured and at the approach speed. At 1,228 ft radio altitude, the AP and A/THR were disconnected. As the aircraft approached 30 ft radio altitude, there was a forward sidestick input and the pitch attitude began to decrease. The aircraft reached close to 1° nose-down less than a second before touchdown. At around 10 ft radio altitude, the PM applied a small amount of aft stick but this had a negligible effect on the pitch attitude and touchdown.

The LOAD <15> report showed that, at touchdown, the aircraft's attitude was 0.7° nose-down with a slight roll to the right, and its rate of descent was 11.9 ft/sec. The maximum recorded vertical acceleration was 3.01 g.

Salient FDR parameters for the approach and touchdown
