Transportation
Safety Board
of Canada

Air Transportation Safety Investigation Report A19A0012

LOSS OF CONTROL DURING ROLLOUT

Air Canada
Boeing 767-375, C-FTCA
Halifax/Stanfield International Airport, Nova Scotia
04 March 2019

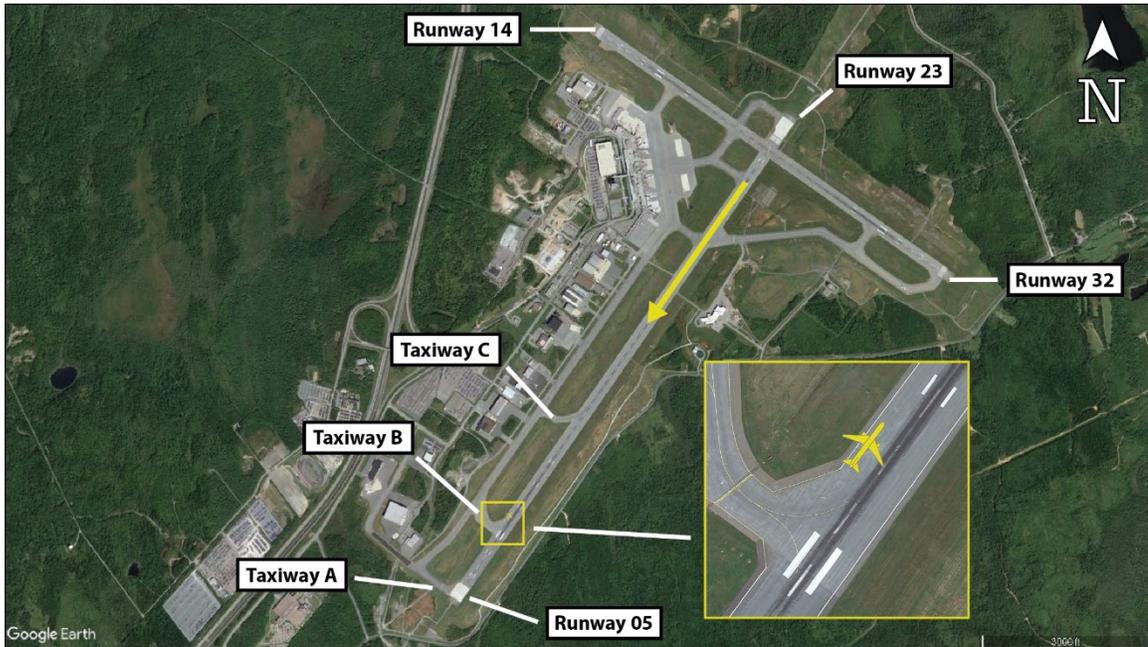
The aircraft landed within the first third of the runway at an airspeed of about 140 knots. After touchdown, the crew used full reverse and auto-braking on the first portion of the runway as they had understood from communications with air traffic control that it was the end portion of the runway that was slippery. As the aircraft slowed and the crew reduced reverse thrust, the braking action was noted to become nil. When the aircraft slowed through about 15 knots, the aircraft began to slide. The captain attempted asymmetrical reverse thrust to correct weathervaning⁶ due to a loss of steering authority. The crosswind pushed the aircraft sideways, causing the nose wheel to roll into the snow off the right edge of the runway. This caused the forward motion of the aircraft to be translated into a slow sideways drift and clockwise rotation on the icy runway. Pushed by the crosswind, the aircraft rotated 180°, coming to rest facing the opposite direction, with all the wheels on the paved portion of the runway. At 1831, the crew called the Halifax tower controller to report that the aircraft was stopped on the runway, facing the wrong way (figures 1 and 2). The crew also asked the controller to not allow any aircraft to land on the runway.

Figure 1. Airport diagram with arrow depicting direction of landing, with inset image showing orientation of the aircraft when it came to rest (Source: Google Earth, with TSB annotations)

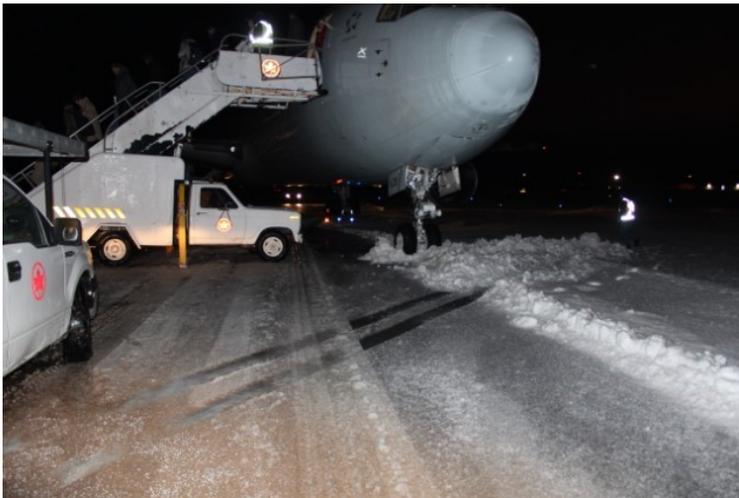
Figure 2. Occurrence aircraft after coming to a stop (Source: TSB)

Before landing, the crew involved in the occurrence had been informed that the runway was very slippery, and that an aircraft that had just landed was barely able to stop by the end of the runway. Therefore, the crew prepared to apply aggressive deceleration early in the landing roll, by using reverse thrust and autobraking, to minimize exposure to the end portion of the runway, which they understood to be very slippery. The aircraft lost deceleration as it passed Taxiway C. As the aircraft was nearing Taxiway B, it was blown sideways on the icy runway, and control of the aircraft was lost.
