**FINAL INVESTIGATION REPORT ON
INCIDENT TO M/s AIR INDIA LTD. AIRBUS A320 AIRCRAFT
VT-ESE, ON 04.10.2017 AT SURAT.**

**OFFICE OF DIRECTOR OF AIR SAFETY (WESTERN REGION)
GOVERNMENT OF INDIA
Mumbai 40099**

1	Aircraft	Type	AIRBUS A320-231
		Nationality	INDIAN
		Registration	VT-ESE
2	Owner & Operator	M/s AIR INDIA LTD.	
3	Pilot – in –Command	ATPL	
	Extent of injuries	NIL	
4	Date & Time of Incident	04.10.2017 / 0146 UTC	
5	Place of Incident	VASU (Surat Airport, Surat)	
6	Co-ordinates of Incident site	N 21 07.0 ; E 072 44.5	
7	Last Point of Departure	VIDP (Indira Gandhi International Airport, Delhi)	
8	Intended place of landing	VASU (Surat Airport, Surat)	
9	No. of Passengers on board	145	
10	Type of Operation	Scheduled Revenue Flight	
11	Phase of Operation	Landing	
12	Type of Incident	Runway excursion

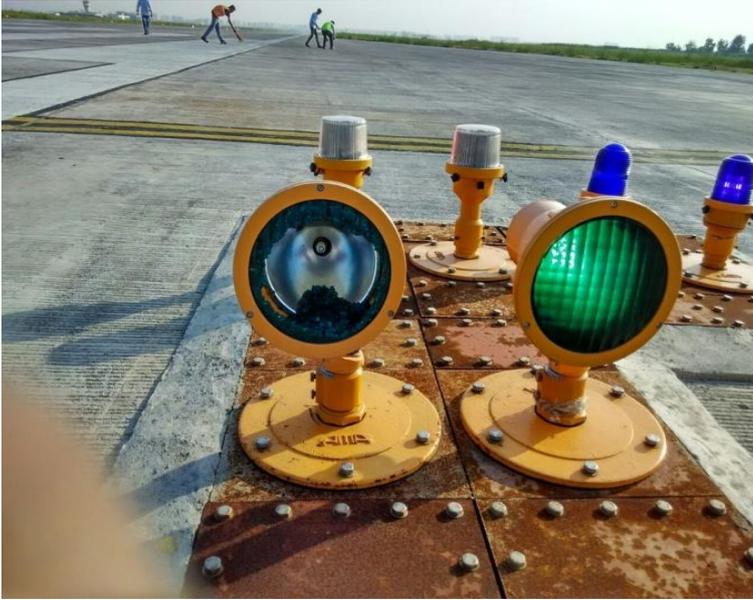
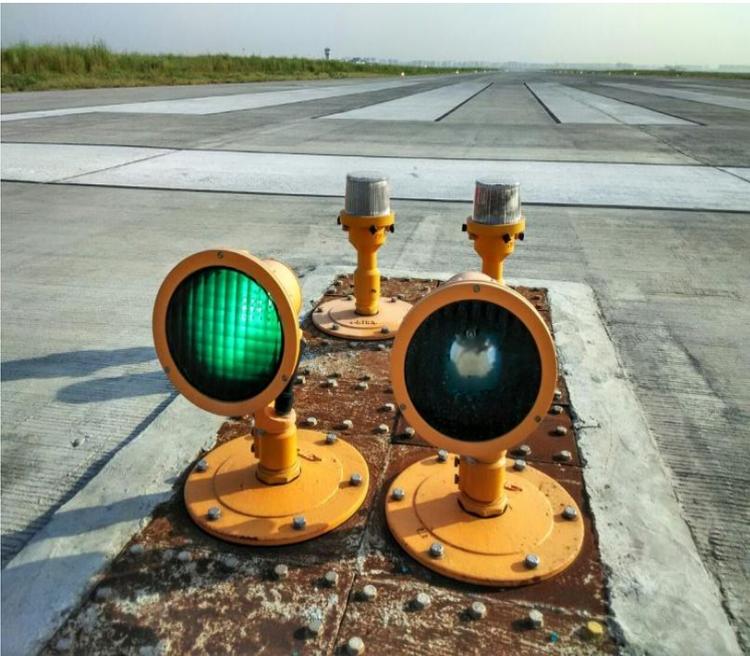
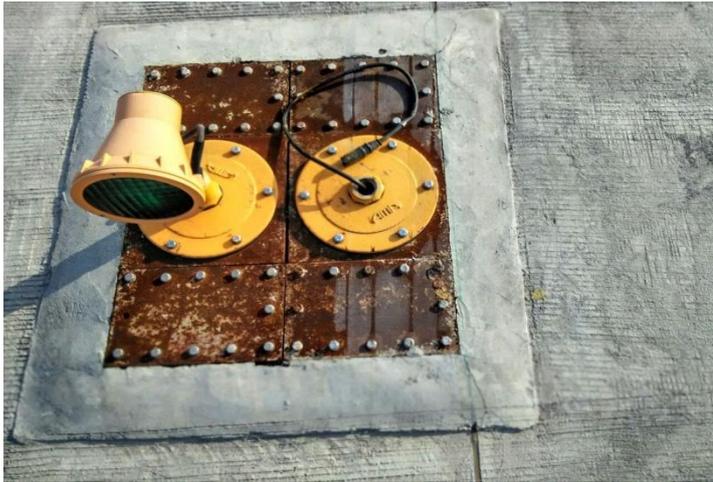
Figure A: Damage to runway lights.

The aircraft overshoot the runway and damaged 01 runway end light and two threshold lights of runway 22 at Surat.

The aircraft was continuously high and fast during the final approach. The crew continued the approach although the approach was not stabilized by 500ft RA. The g value recorded at touchdown is 1.15 and the landing weight was 60t which are within limits. Immediately on touchdown, maximum manual braking and maximum reversers were used by the PIC to bring the aircraft to stop. The aircraft travelled near to the runway end lights and then initiated the turn to backtrack damaging the runway lights.

19. Maximum braking and MAX reverser were used by the crew after touchdown.
20. The aircraft stops near to the runway end lights and backtracks resulting in damage to runway end light and threshold lights.

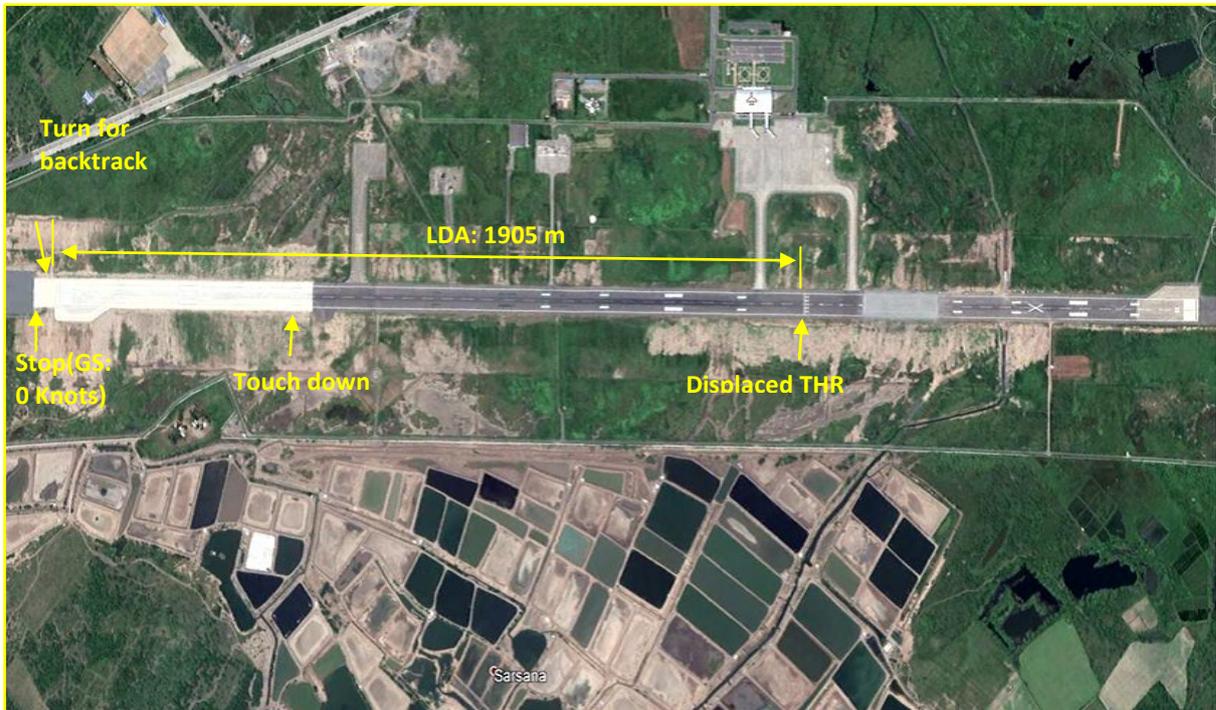
Figure C: Pictorial description of aircraft movement (Approx).

The aircraft being fast and high during the approach was unstablized. Further the aircraft floating on the runway has lead to the aircraft touching down much ahead of the displaced threshold.

The rate of descend is found to be above 1000ft/min up till a radio height of 185 ft as against the stabilization criteria required at 500 ft. The approach speed is observed to be higher than Vapp of 135 knots throughout the approach. The aircraft was at 1029ft at 2DME against 840ft as published in the NOTAM. The aircraft was not stabilized by 500ft RA. The flare was initiated by increasing pitch from 1.8 degree at 01:46:07 at 38 ft RA. After 05 seconds the pitch reached to 5.6 degree and the aircraft was at approx 7 ft RA at 01:46:12. Subsequently there are variations in pitch angle and the aircraft floats on the runway for approx 07 seconds. As per SOP, the auto throttle was disconnected at 20ft RA and the thrust lever angle reads zero degree subsequently. The aircraft touched down approximately 12sec after the initiation of flare. The aircraft touched down on runway at approx 1300m ahead of the displaced threshold.

17. The auto-throttle was disengaged at 20ft RA.
18. The aircraft touched down 12 seconds after initiation of flare, approx 1300m ahead of the displaced runway threshold. Hence leaving only marginal runway available to stop the aircraft.

1. M/s Air India may reiterate the safety circular highlighting the incident advising all crew to carry out go around when approach is not stabilised.
2. Any other action as deemed fit by DGCA, HQ with reference to Para 3.2.
