Investigation report

C7/2006L

Veering Off the Runway at Seinäjoki Airport on 11 December 2006

OH-ATB

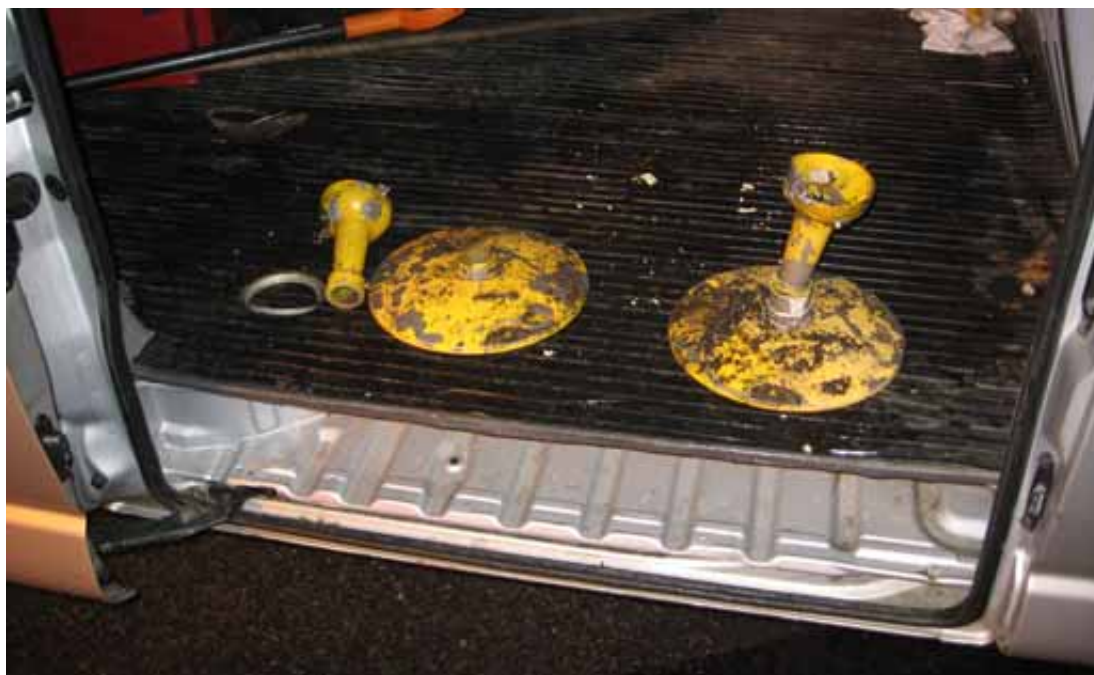
Figure 1. Broken runway edge lights

Airport maintenance detected the wheel ruts on the runway shoulder as well as the two broken runway edge lights. The first light that was struck was completely separated from its base. The second light was bent. The AFIS officer reported this information to the captain.

Two high intensity runway edge lights were damaged on the left side of runway 32 (appendix 2). The outermost wheel on the left main landing gear struck runway edge light no. 49, 720 m from the threshold. This light separated from its base and flew farther away. The wheels of the left main landing gear passed on both sides of the following runway edge light, no. 50. This light, 780 m from runway 32 threshold, was bent. Since the next aircraft to land in Seinäjoki was on its way, the lights were repaired between 22:00-23:00.

9. The left main landing gear hit two runway edge lights. The first light (720 m from runway 32 threshold) broke loose and was flung off. The second light (780 m from threshold) was bent.

Immediately after the occurrence Seinäjoki airport maintenance inspected and photographed the damage to the runway lights. Because the next aircraft was expected to arrive before midnight the damage was repaired by then.

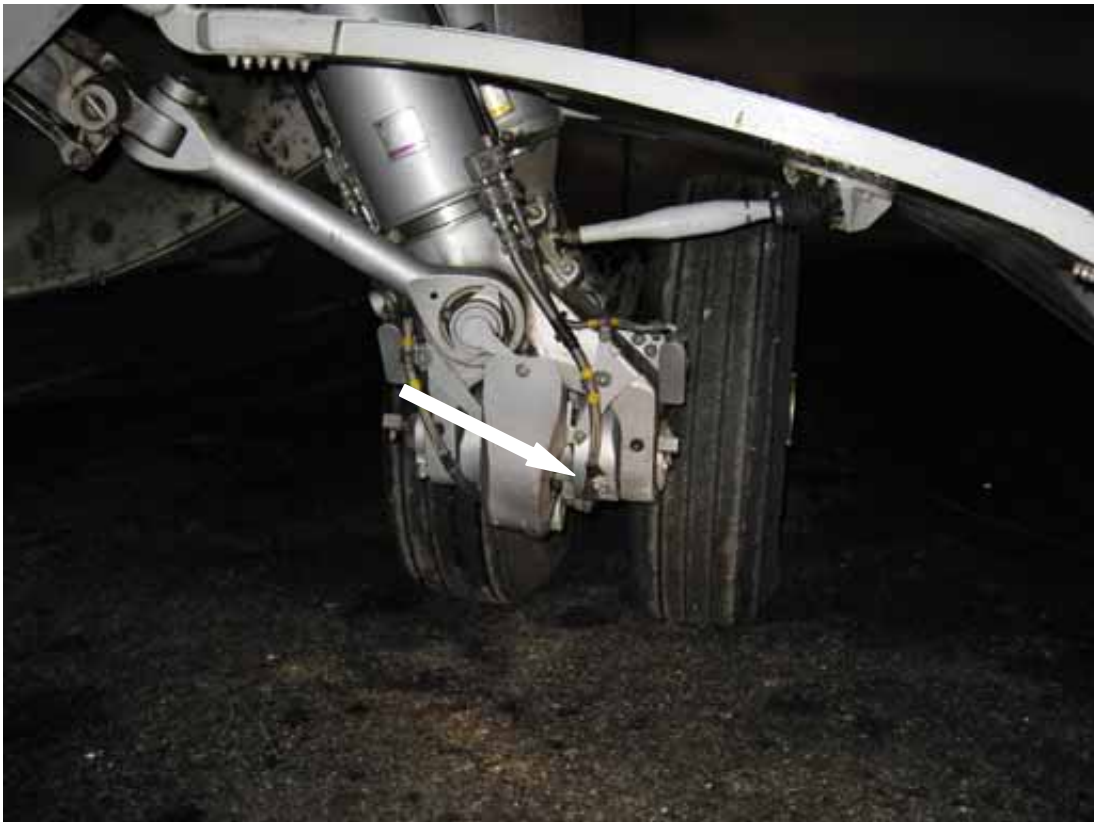
As they were taxiing to the apron, the co-pilot reported that the left main landing gear anti skid warning light was on. When it became apparent that they had hit something, the captain disengaged the CVR circuit breaker to ensure that the recorded data be saved. The flight crew checked the aircraft and noticed the damage on the left main landing gear. The captain reported this to the company. After the damage was noted the passengers disembarked. The following leg of the flight to Kokkola was cancelled.

A mechanic from the company's maintenance department flew on the night flight from Helsinki to Seinäjoki. He inspected the landing gear and the damage. He detected that the anti skid wiring was cut. Furthermore, the landing gear also displayed some minor damage (section 1.2). Pursuant to the Minimum Equipment List (MEL) it was possible to use the aircraft in scheduled traffic even with the anti skid system out of service. The aircraft stayed overnight in Seinäjoki and resumed service on the morning of 12 December, when it was flown to Helsinki as a scheduled flight.

Figure 2. The damage detected on the left main landing gear. The arrow points the damaged anti skid wiring.

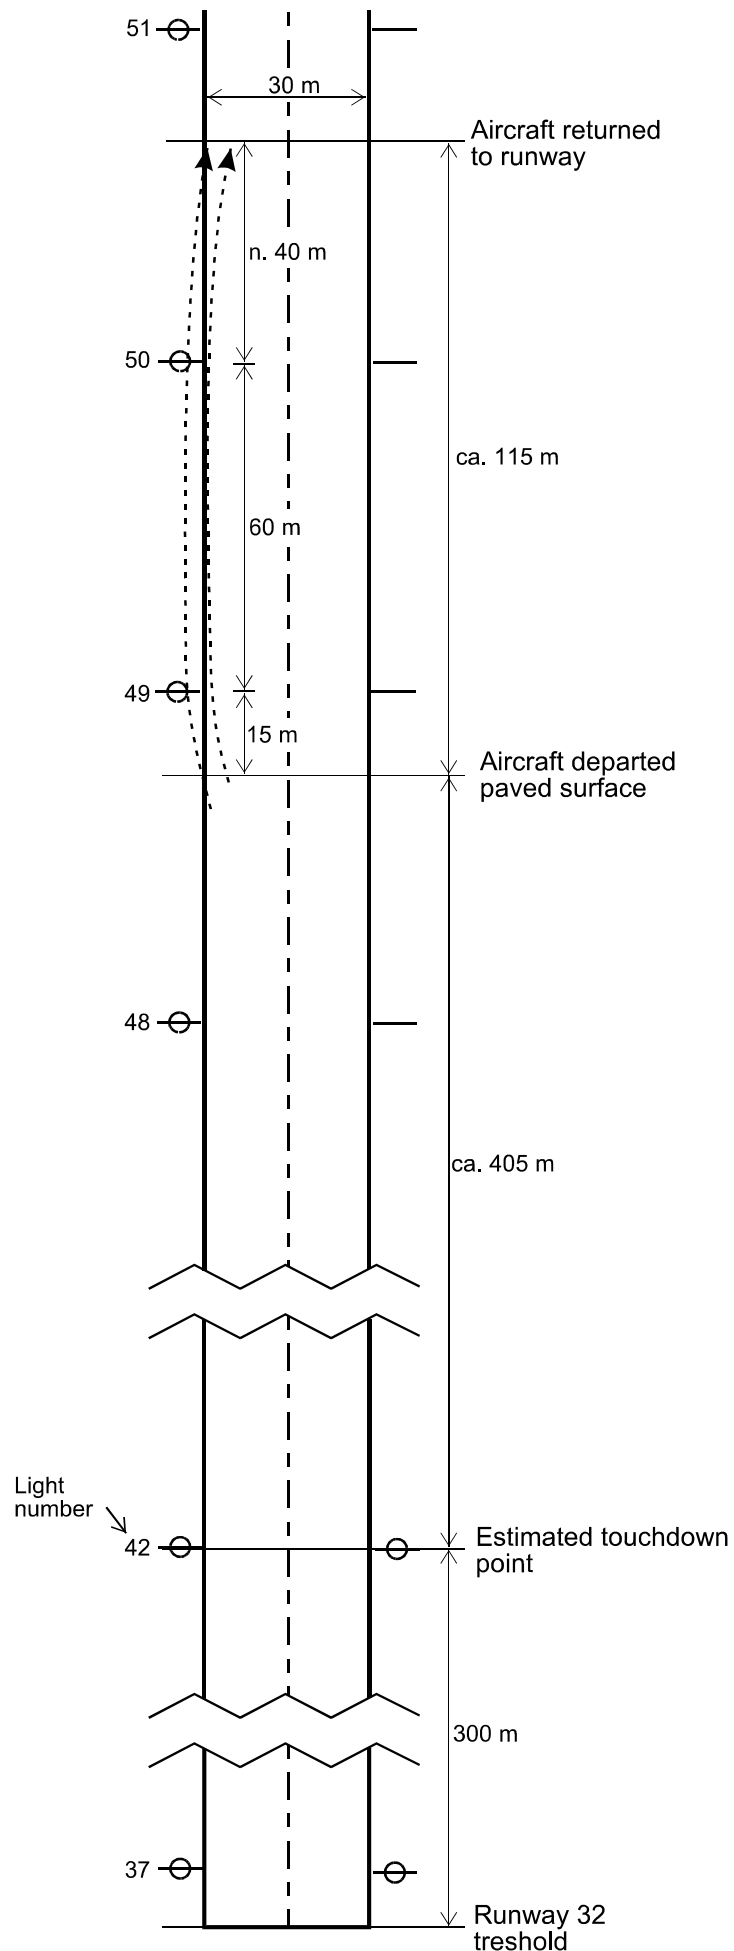
A diagram illustrating how the aircraft veered off the runway

The left main landing gear travelled approximately 115 m on the gravel, 2.2 m from the edge of the pavement at most. The gravel shoulder was wet and here and there the wheels left 2-4 cm deep ruts in the sandy gravel. No nose wheel marks were detected. Two runway edge lights were broken and the left main landing gear anti skid wiring was cut. The captain managed to turn the aircraft back onto the runway by using nose wheel steering. The co-pilot said that when he saw the captain struggling to keep the aircraft under control, he helped a little by applying the right wheel brake and by pushing the control wheel fully to the front and left. They recounted that at this stage they still did not know whether they had departed the paved section of the runway.

1. Wheel marks on the runway shoulder begin ca. 15 m before light fixture no. 49. The shoulder is approximately 2.5 m wide. The distance from the edge of the pavement to the light fixture is 1.4 m.
2. Light no. 49 was flung off because the left main landing gear hit it.
3. Wheel ruts continue almost directly toward light fixture no. 50. The maximum distance of the tracks from the edge of the pavement is ca. 2 m.
4. Landing gear wheels pass on both sides of light no. 50. The impact cuts the anti skid wiring.
5. The aircraft returns to the runway approximately 40 m past light no. 50.
6. There are no nose wheel tracks.
7. The main landing gear track gauge is 4.1 m. The track between the nose wheel and the main landing gear is 2.05 m.
