ACCIDENT

Aircraft Type and Registration:	Airbus A321-231, G-MARA
No & Type of Engines:	2 International Aero Engine V2533-A5 turbofan engines
Year of Manufacture:	1999
Date & Time (UTC):	28 July 2008 at 2145 hrs
Location:	Manchester International Airport, Greater Manchester
Type of Flight:	Commercial Air Transport (Passenger)
Persons on Board:	Crew - 8 Passengers - 159
Injuries:	Crew - None Passengers - None
Nature of Damage:	Nose landing gear internal shock absorber assembly severely distorted
Commander's Licence:	Airline Transport Pilot's Licence
Commander's Age:	39 years
Commander's Flying Experience:	6,930 hours (of which 1,545 were on type) Last 90 days - 200 hours Last 28 days - 79 hours
Information Source:	AAIB Field Investigation

Synopsis

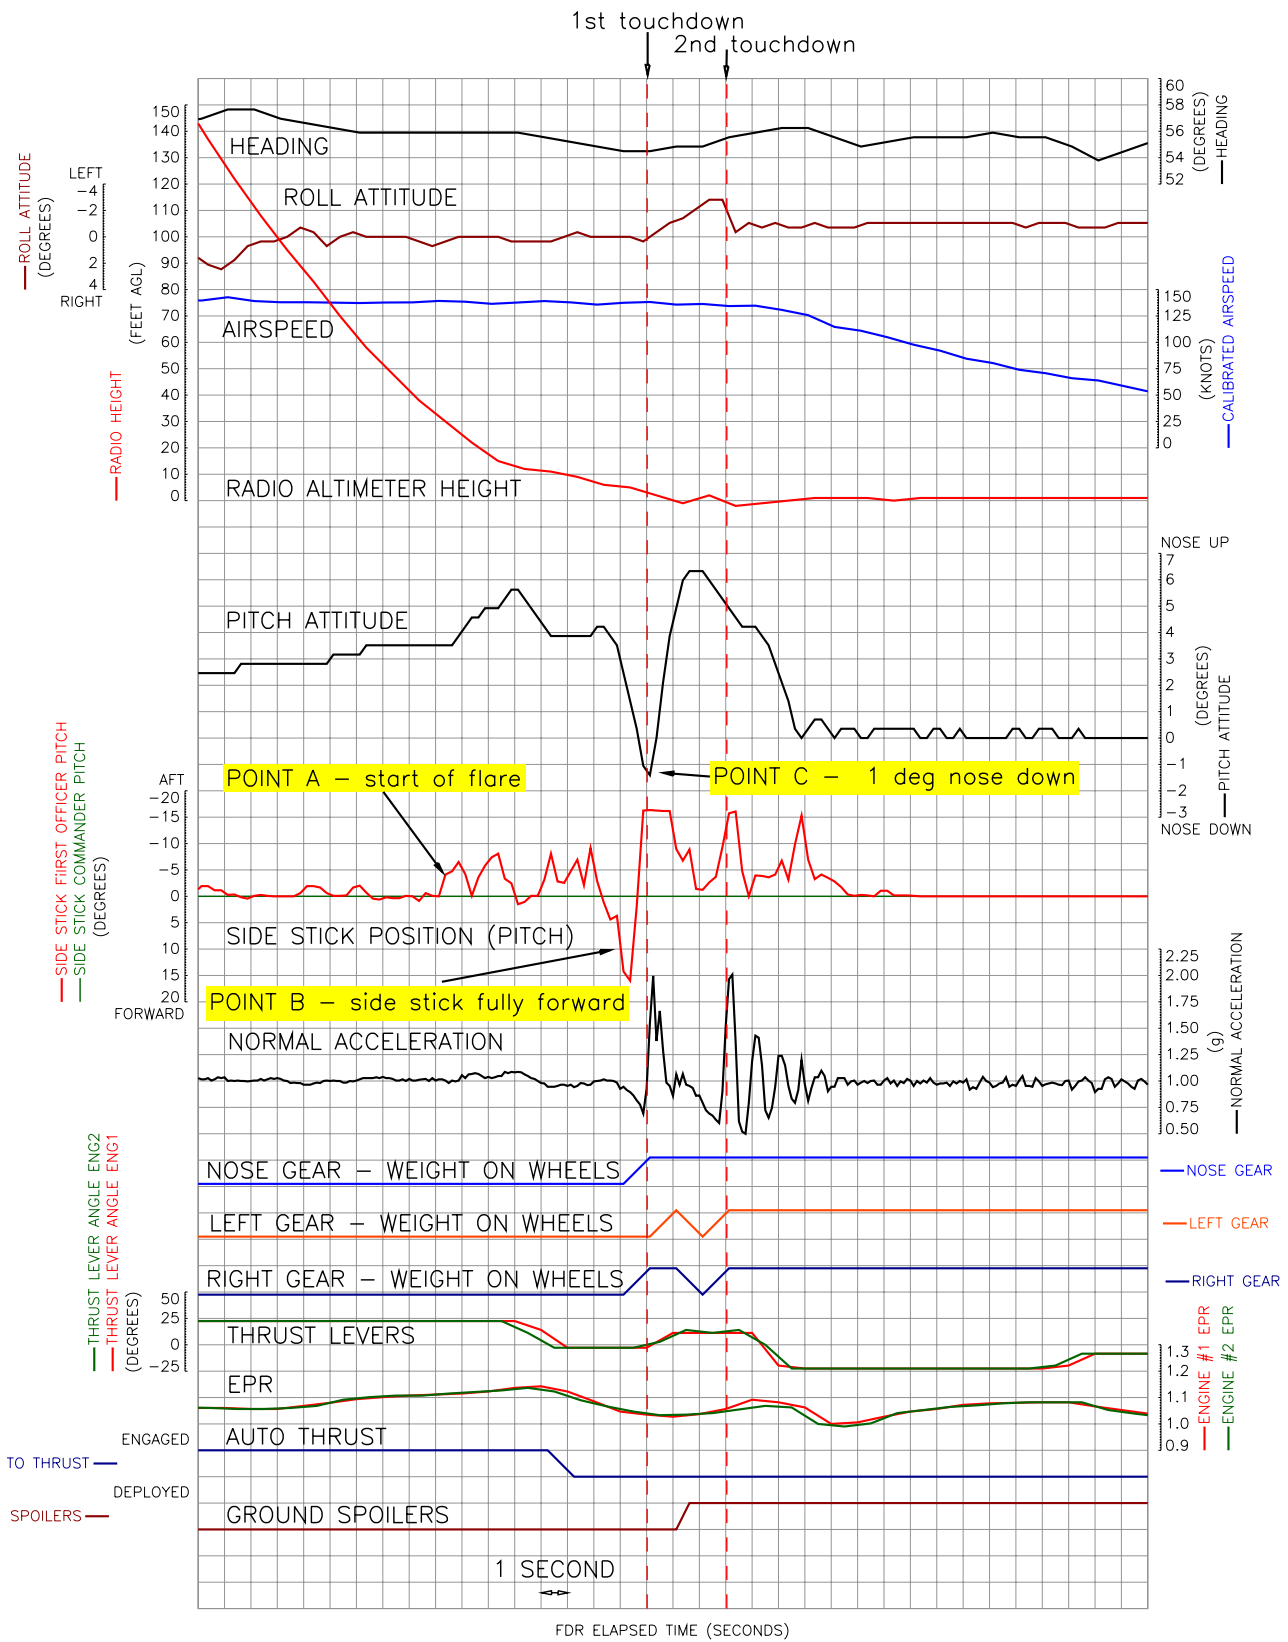
Figure 1
Salient FDR Parameters
(Incident to G-MARA on 28 July 2008)

The aircraft remained stabilised on the ILS approach and, at a height of about 35 ft, the co-pilot started to flare the aircraft, Figure 1, Point A. The initial part of

the flare appeared normal, with the thrust levers being retarded and the aircraft pitch attitude being stabilised at about 4° nose-up; roll attitude was wings level and the airspeed was 135 kt. As the aircraft closed to within about 10 ft of the runway, the co-pilot's sidestick was moved rapidly to the fully forward position, before moving to the fully aft position, Figure 1, Point B. The aircraft responded, de-rotating rapidly at 4.5°/second before touching down at a pitch attitude of about 1° nose down, Figure 1, Point C. A peak normal acceleration of 1.99g was recorded as both the nose and right main gear oleos compressed within one second of each other; the left main gear oleo compressed less than a second later. The aircraft then bounced, indicated by the extension of both main gear oleos and change in normal acceleration to less than 1g. The aircraft remained airborne for just over a second, during which the co-pilot attempted to reduce the aircraft sink rate by applying full aft sidestick and advancing the thrust levers; however, the aircraft touched down on the main gear with a normal acceleration of 2g. The thrust levers were then fully retarded. The spoilers had deployed automatically on landing and reverse thrust and manual wheel braking were applied. There had been no movement of the commander's sidestick during the entire approach and landing phase. Aircraft gross weight at touchdown was 63,133 kg.

Following the initial bounced landing, the aircraft had pitched to 6° nose up and both main gear oleos extended. However, the nose landing gear indicated that it was still compressed, when it could not have been in contact with the ground. Subsequent analysis of the FDR data confirmed that none of the LOAD <15> report limits had been exceeded. At a landing weight of 63,133 kg, a LOAD <15> report would have been triggered if the radio altimeter-derived descent rate and normal acceleration limits of 9 ft/sec and 2.6g had been exceeded. At the

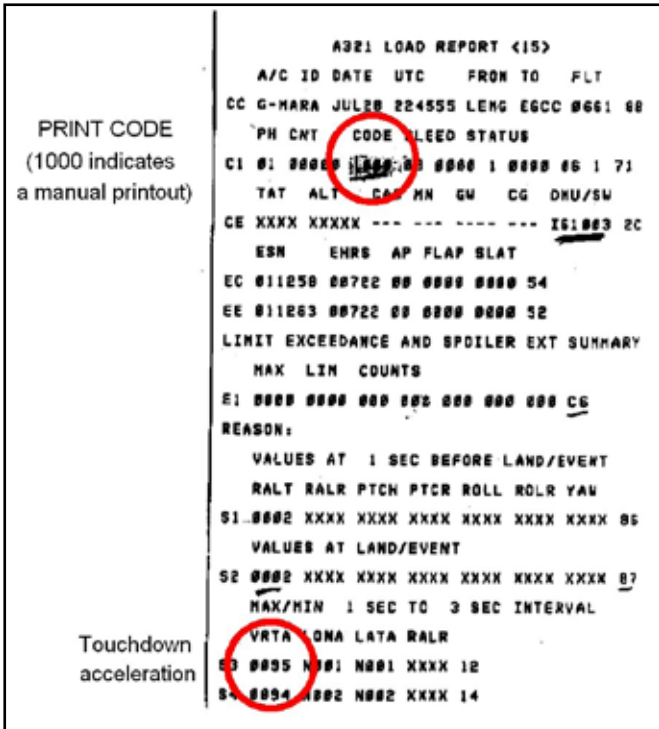
Figure 2

A LOAD <15> report for the incident landing was manually generated by the maintenance staff and printed, Figure 2. The AMM details:

The printed report apparently recorded the maximum touchdown acceleration (VRTA) as 0.95g. However, the DMU was manufactured by Teledyne Controls and loaded with software part number FLY2240A1BXX312. The manufacturer later confirmed that with this software standard a manually generated LOAD <15> report would not contain stored parameters from a previous landing and that the parameter values actually related to the aircraft being parked at Manchester.

Teledyne Controls DMU G-MARA post-landing manually generated LOAD <15> report

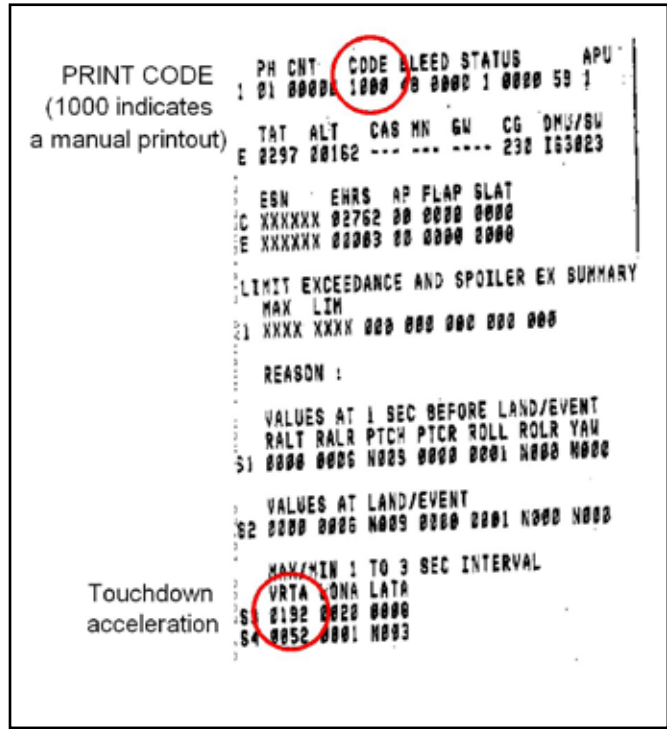
Figure 3

outstations, there was no facility to read out the FDR or QAR. A manually generated LOAD <15> report was printed, Figure 3. The report appeared to provide data from the landing, with both the acceleration and radio altimeter descent rate being below AMM limits. The aircraft was subsequently released back into service. Upon return to the operator's main base, the QAR was read out. Data from the QAR confirmed that the manually generated report had contained the landing information. The aircraft was equipped with a different DMU from that on G-MARA; this DMU was manufactured by Sagem Avionics, part number ED45A300, software part number 360-03795-015, data base V1423. Following the findings from the G-MARA event, the operator inspected the other aircraft for damage but none was found.

Following a review of the AMM hard/overweight inspection procedure, it was identified that the subtask that checked for, and printed, a LOAD <15> report contained a note reflecting that a manually generated LOAD <15> report was not to be used to confirm if a hard/overweight landing had occurred. A manually generated LOAD <15> report may be identified by the Trigger code 1000 appearing on row C1 of the report, Figures 2 and 3.

Sagem Avionics DMU Post-landing manually generated LOAD <15> report

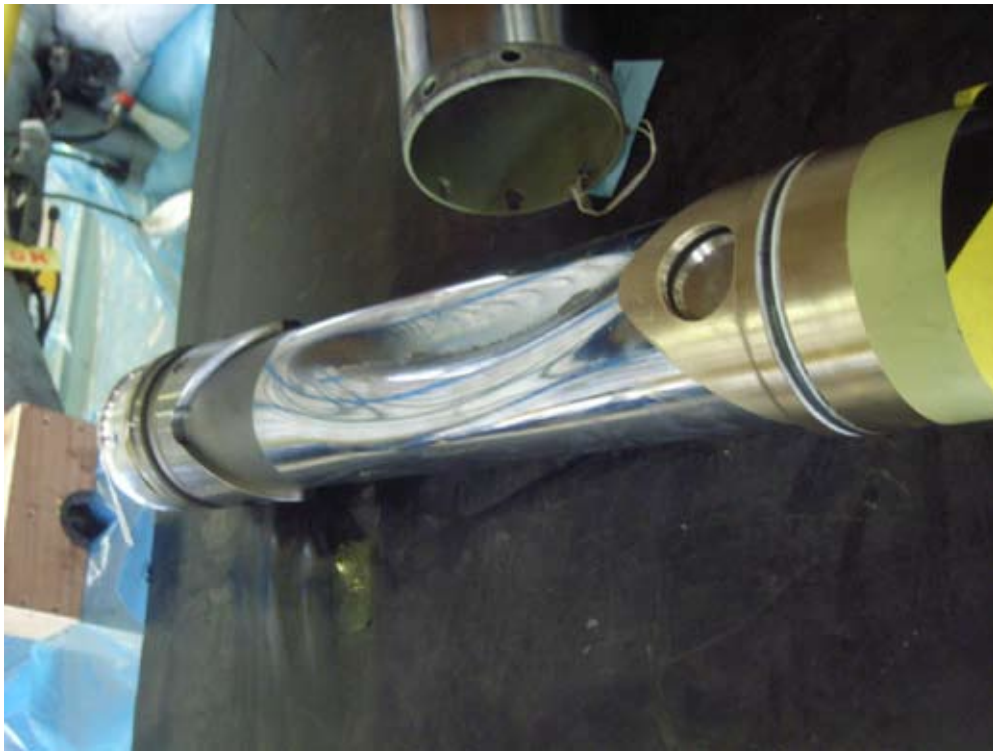
Figure 4

Discussions with the landing gear manufacturer revealed that they had previously seen similar damage to the inner cylinder of nose landing gear legs, Figure 4. They advised that the collapse of the inner cylinder is the direct result of very high damping pressures which act between the inner and outer cylinders, which typically occur during a very hard three point landing⁴,

or a nose gear first landing. The damage only occurs when the certificated design criteria for the landing gear is grossly exceeded.

View of damaged inner cylinder

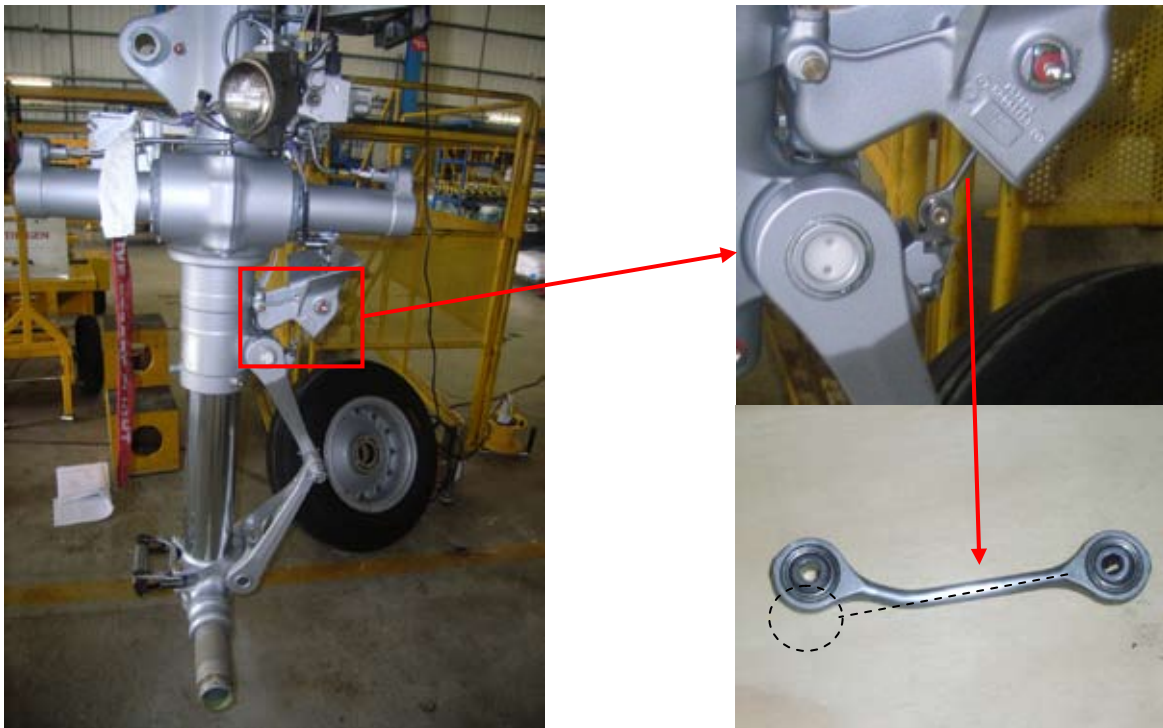
Figure 5

Previous analysis of the link rod which moves the target for the gear-extended proximity sensor through its range of movement showed that, in cases of full leg compression, it is possible for the link rod to be bent by contact with the fixed leg. On this occasion, the rod was bent and witness marks were present on both the rod and the fixed leg which confirmed that contact had occurred, Figure 5.

The landing gear manufacturer identified a number of previous cases where the link rod had been found bent, attributing this to a lack of greasing and ingress of dirt, causing the bearings to seize and impart bending loads

View of replacement nose gear leg showing location of link rod and bent link rod from incident leg

The only visual indication that the nose landing gear had been fully compressed was the bent proximity target link rod. An inspection for such damage is not referred to in the AMM and such damage is not readily apparent.

It is recommended that Airbus include a specific reference in the AMM to inspecting the nose landing gear proximity target link rod for damage as, due to the landing gear geometry, it is a likely indicator of full nose landing gear compression.

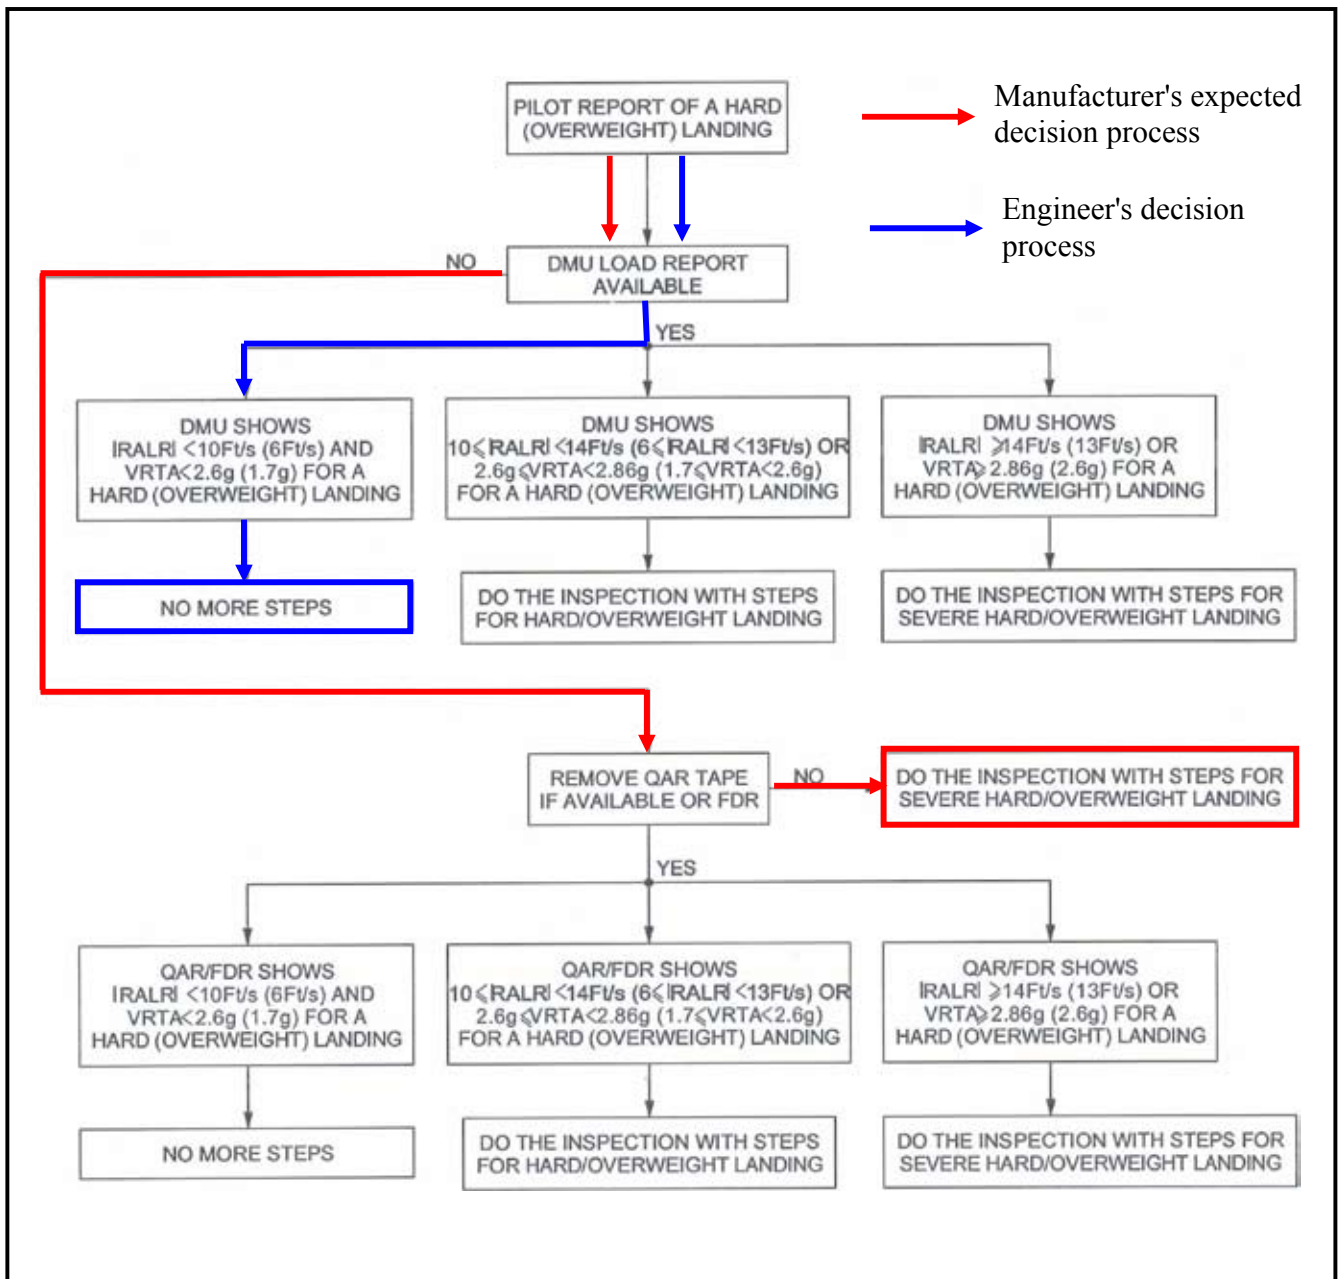
Figure 6

On arrival, after the G-MARA flight crew reported the suspected hard landing to the engineer, he followed the AMM process to determine the level of inspection required using the inspection flow chart, Figure 6. The aircraft manufacturer's intended decision making process and that of the engineer's, is illustrated.

Flow chart for determining category of hard/overweight landing

The procedure for determining the level of inspection does not cover all situations and can, as in this case, be interpreted in a different way from that intended by the manufacturer. The DMU LOAD <15> report will only be produced if the recorded parameters exceed pre-determined values. The manufacturer's use of the flow chart implies that a report will be produced even if the parameters are not exceeded. Had the QAR or FDR been replayed as part of the decision making process, the data would also have shown that neither the descent rate nor the normal acceleration limits had been exceeded and, therefore, no inspection would have been required.
