FINAL REPORT

**AIRBUS A380-800, REGISTRATION 9V-SKA
PUSHBACK INCIDENT IN SINGAPORE CHANGI AIRPORT
10 JANUARY 2008**

AIB/AAI/CAS.046

**Air Accident Investigation Bureau of Singapore
Ministry of Transport
Singapore**

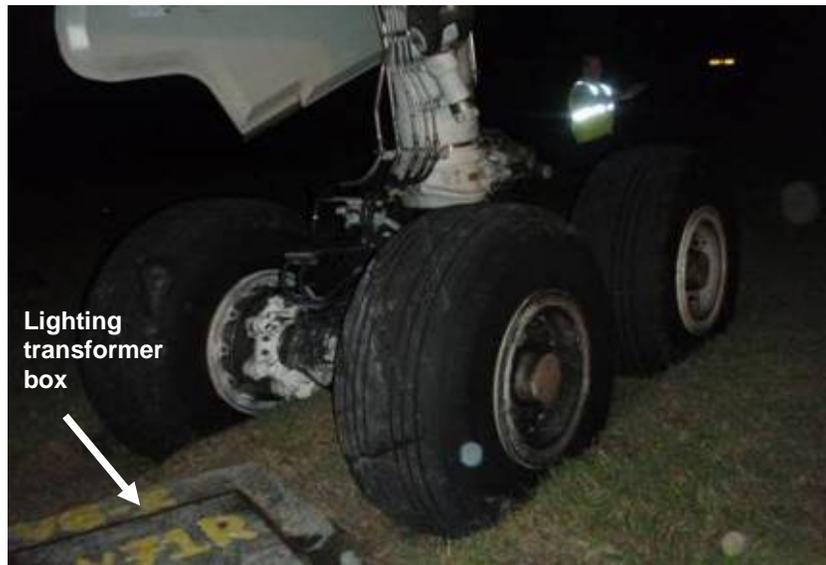
1.1.2 Following clearance by the air traffic control, the aircraft was pushed back by an air tug. It was to be pushed back onto Taxiway WA (Twy WA) facing south. During the pushback, the right wing landing gear and part of the right body landing gear departed from the paved surface of Twy WA. The right wing landing gear rolled over a concrete airfield lighting transformer box onto the grass verge (**Figure 2**). Owing to the weight of the aircraft, the ground under the wing gear wheels sank to about 25 cm below the top of the transformer box. This caused the aircraft to tilt slightly to the right.

Figure 2. Right wing landing gear and the concrete airfield lighting transformer box

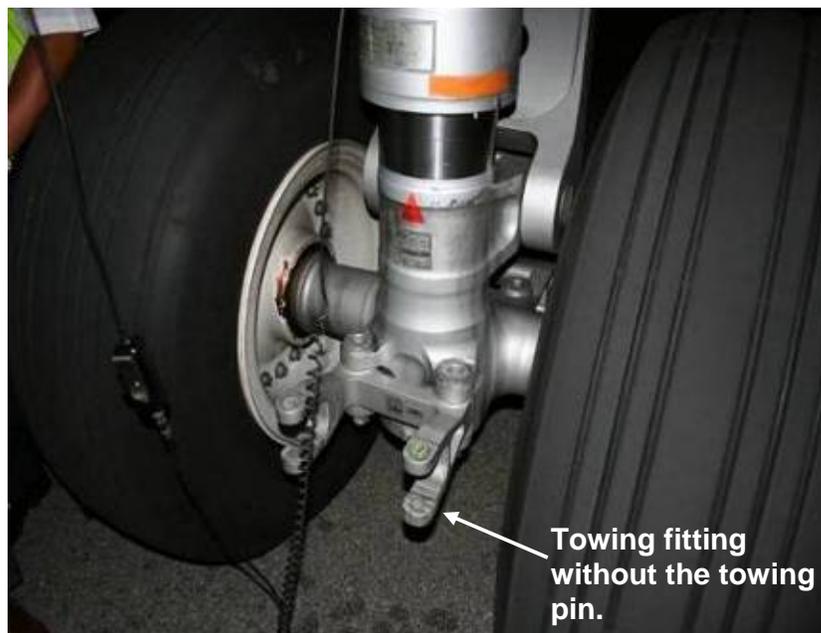
- 1.1.3 The driver tried to pull the aircraft out of the unpaved ground. During the pulling, the fuse pins attaching the towing pin¹ to the towing fitting on the aircraft nose landing gear (NLG) sheared (**Figures 3, 4 and 5**). Together with the tow bar, the towing pin was detached from the NLG and the aircraft was thus separated from the air tug. The aircraft was otherwise not damaged. Damage to the air tug is described in paragraph 1.2.

Figure 3. Nose gear towing fitting with the towing pin missing

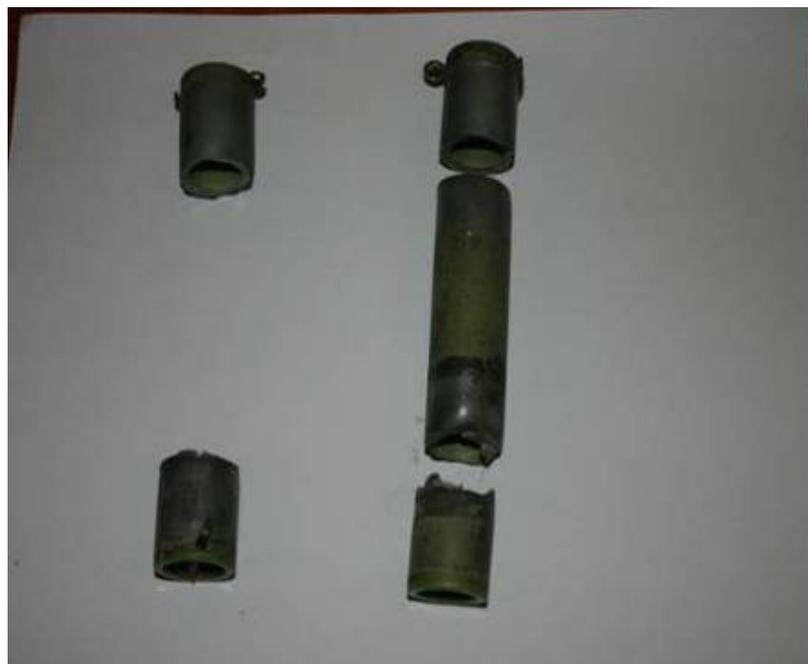
Figure 5. Sheared fuse pins of the towing fitting

1.13.1.1 According to Airbus, the shear strength of the fuse pins that connected the towing pin to the NLG was designed to be about 20 percent higher than that of the shear bolts on the tow bar. In this incident, the shear bolts on the tow bar did not shear. Instead, it was the fuse pins that had sheared.

1.13.1.2 Airbus found that the sheared fuse pins met its specification and that the pins sheared at about the predicted shear force of 715 MPa.

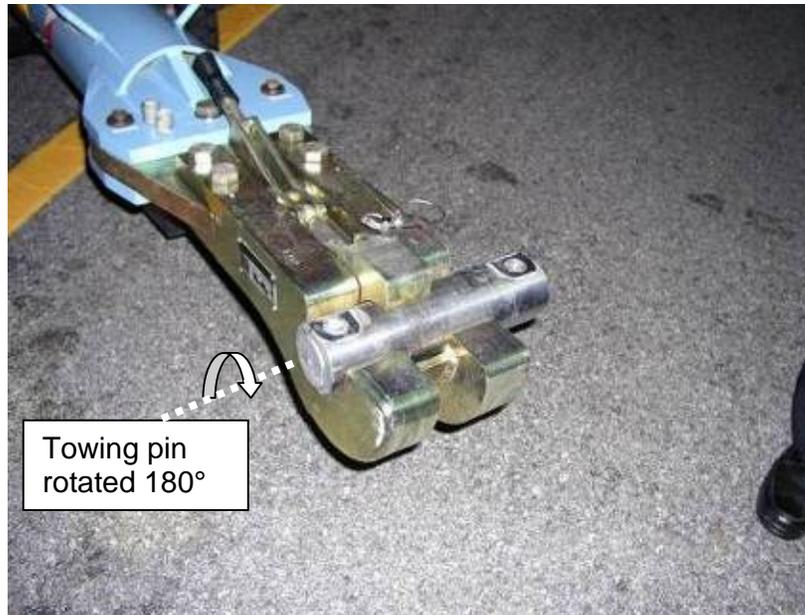
- 1.2.2 The detached towing pin was held in the clamp of the tow bar. The pin was found to have rotated 180° about its longitudinal axis from its original orientation (**Figure 6**). It could not be determined when and by whom the pin was disturbed.

Figure 6. Tow bar clamp holding towing pin detached from towing fitting and rotated 180°

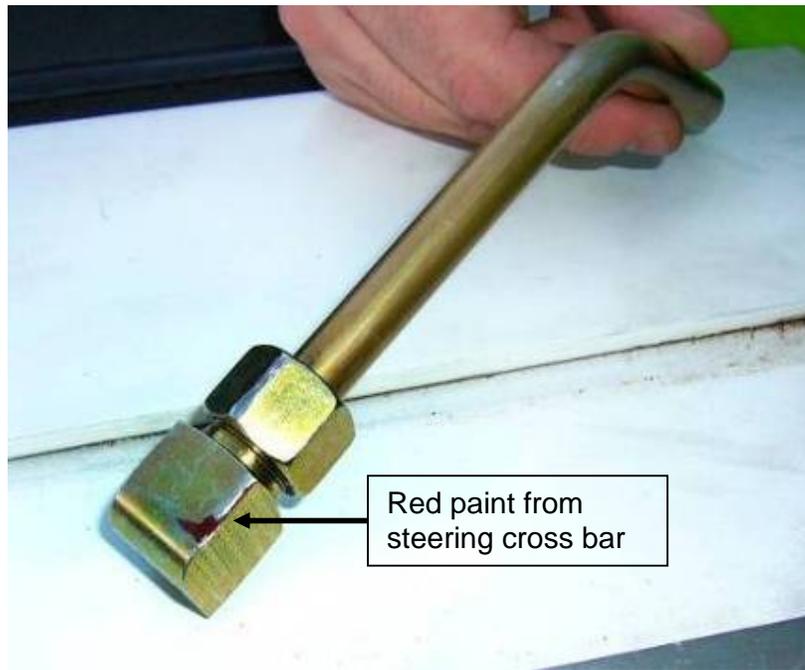
- 1.2.5 The hydraulic elbow connector (near the steering cross bar of the air tug's rear wheels) that was attached to a hydraulic relay valve was broken, resulting in hydraulic fluid leaking onto Twy WA.

- 1.2.6 The clearance between the steering cross bar of the rear wheels and the broken hydraulic elbow connector was about 6 mm. The broken elbow connector had a paint smear. The colour of smear was similar to that of the steering cross bar nearby (**Figure 7**). This suggests that the steering cross bar and the elbow connector had come into contact with each other, probably when the air tug juddered at the moment it became separated from the NLG, and that the elbow connector broke as a result of the contact.

Figure 7. Red paint smear on the broken elbow connector

- 1.2.8 The air tug's hydraulic system was checked after the broken elbow connector was replaced. No hydraulic leaks were found.
- 1.2.9 The air tug was also found to be serviceable and roadworthy in post-incident tests. There were no problems with the steering system, the front and rear brakes systems, the parking brakes, the accelerator and the tyres. There was no evidence of any pre-existing problems with the air tug that could have affected the handling and control of the vehicle.

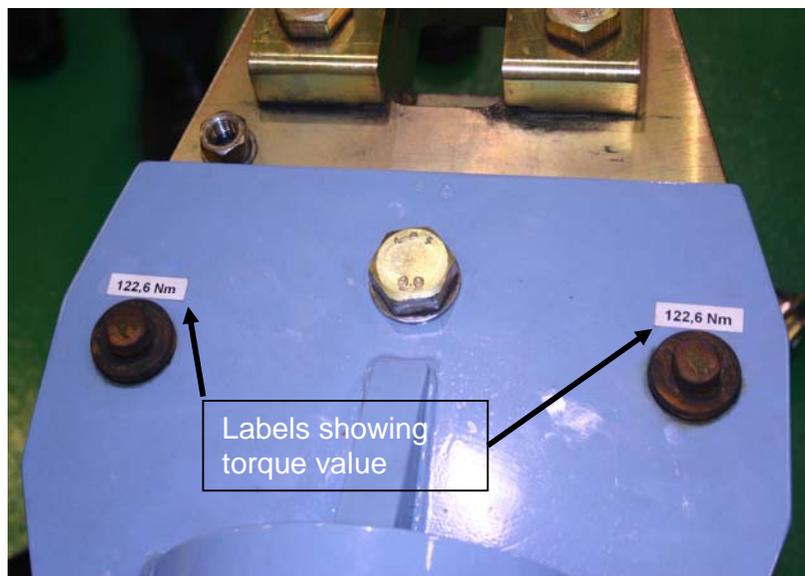
1.13.2.1 During the investigation, it was found that one of the two shear bolts on the tow bar could be loosened at almost zero torque. The other bolt could be loosened at 5 Nm (about 44 lb-in). A check on a second tow bar of the same design yielded similar low torque values for the shear bolts.

- 1.13.2.2 According to the tow bar manufacturer, the two shear bolts on the tow bar were required to be tightened to a torque value of 122.6 Nm (about 90 lb-ft) and this torque value was indicated on the tow bar. (See **Figure 8**.) When the shear bolts are tightened (preloaded) to this torque value, the shear bolts will shear at a certain shear force. If the shear bolts are over-tightened, they will break earlier at a lower shear force. If the shear bolts are under-tightened, they become "too loose" in the bushes, then there is a risk that they will shear at a higher shear force.

- 1.13.2.3 Interviews with the equipment maintenance personnel revealed that the bolts were merely tightened using a ratchet wrench or a spanner. The bolts were not tightened with a torque wrench. One of the equipment maintenance personnel was not aware that the shear bolts needed a torque value of 122.6 Nm. He produced a torque wrench for a torque value of 20 Nm (175 lb-in) rather than one for the 122.6 Nm needed.

Figure 8. Labels on the tow bar showing the required torque value

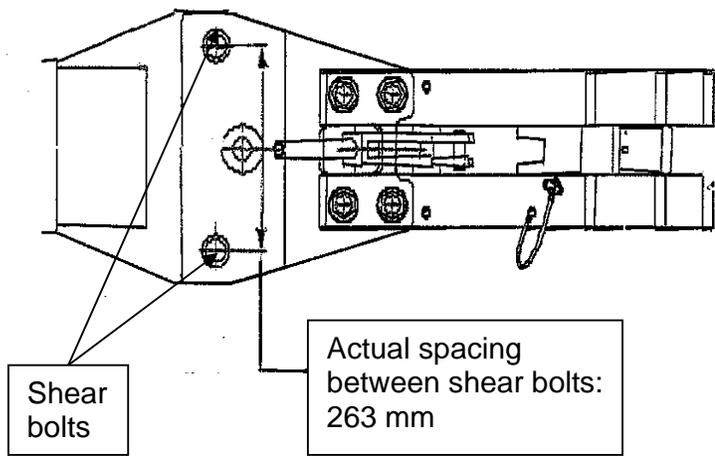
- 1.13.2.5 Airbus specification for the distance between the shear bolts on the tow bar was 154.8 mm. The actual spacing between the two shear bolts on the tow bar was found to be 263 mm (**Figure 9**). The greater spacing could have affected the shearing characteristics of the shear bolts.

Figure 9. Spacing between the two shear bolts on tow bar

- 2.4.4 The spacing between the two shear bolts (263 mm) on the tow bar was wider than that specified (154.8 mm) by the aircraft manufacturer.
- 2.4.5 The shear bolts on the tow bar involved in the incident could be loosened at torque values that were much lower than the required preload. The lowered torque values could have been a result of the bolts working loose due to tow bar usage or improper tightening or both. The reduced tightness resulted in lower preload on the shear bolts, causing the shear bolts to require higher than normal force to shear, and this high force might have resulted in the fuse pins' strength being exceeded before the shear bolts' strength was exceeded.

2.4.6 The wider spacing between the shear bolts could have affected the shearing characteristics of the shear bolts and compounded the under-tightening of the shear bolts in causing the pre-mature failure of the fuse pins.

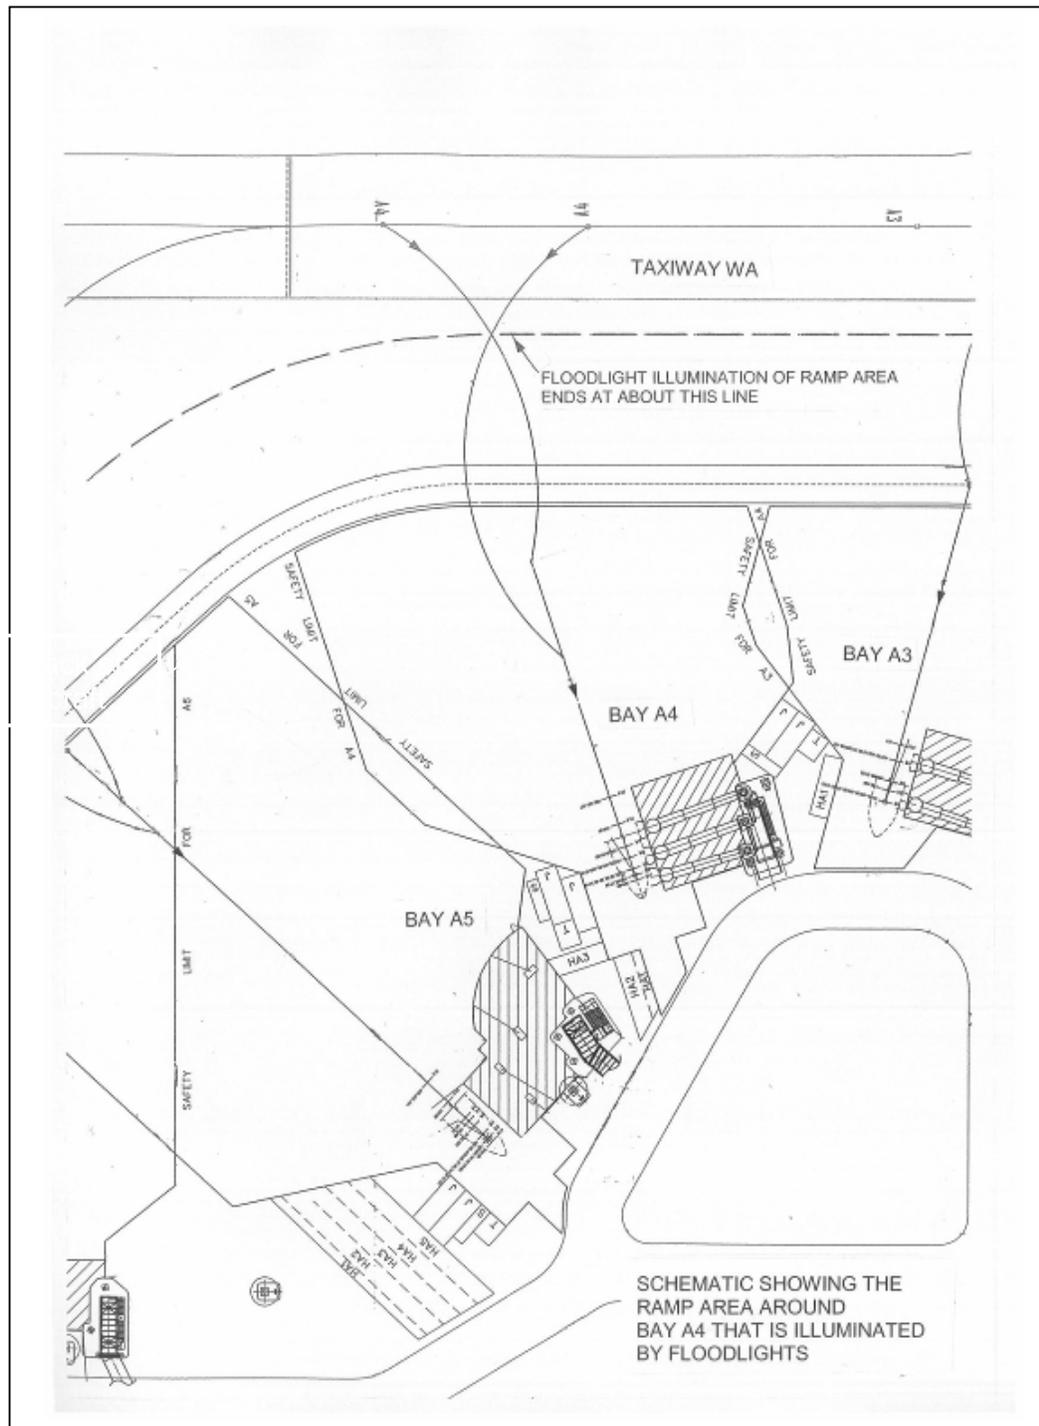
Schematic showing illuminated areas of the apron around Bay A4

1.7.5 The bay had painted yellow (lead-in) lines which lead to and from the centreline of Twy WA. The lines were in good condition. Under the apron floodlight, the lines could be seen from the air tug driver's position all the way from where the aircraft was parked up to the intersection of the two curved yellow lead-in lines (near the edge of the taxiway). (See **Appendix 1.**)

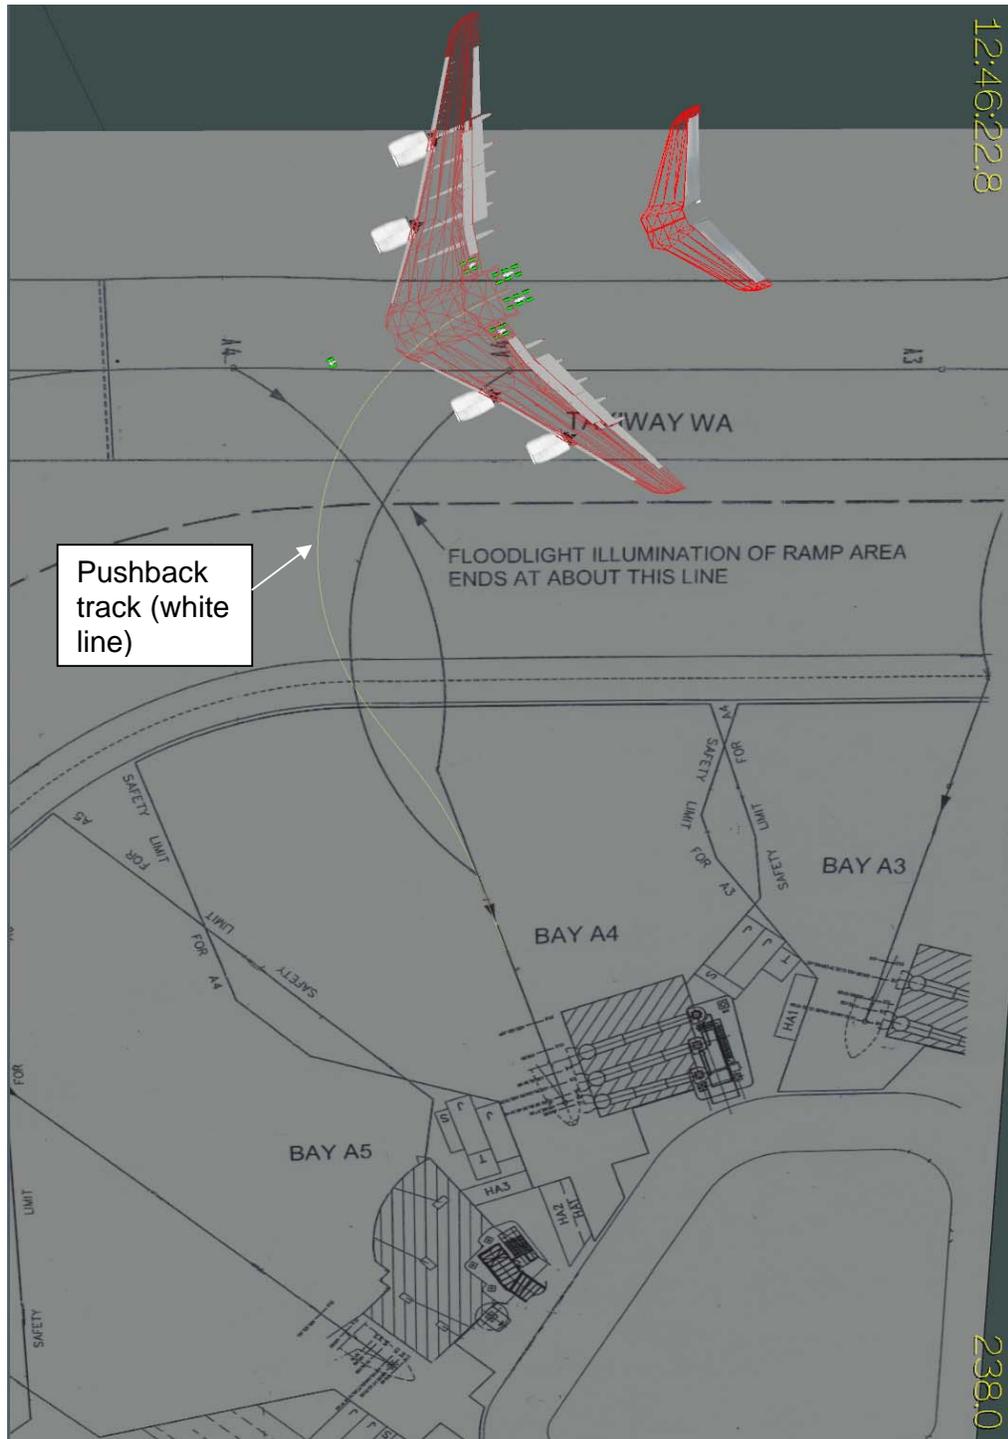
Pushback track of the aircraft

1.8.2 The pushback path shown in **Appendix 2** was reconstructed with data from the flight data recorder. The reconstructed path was consistent with the observation that the aircraft had deviated from the yellow lead-in line during the pushback.

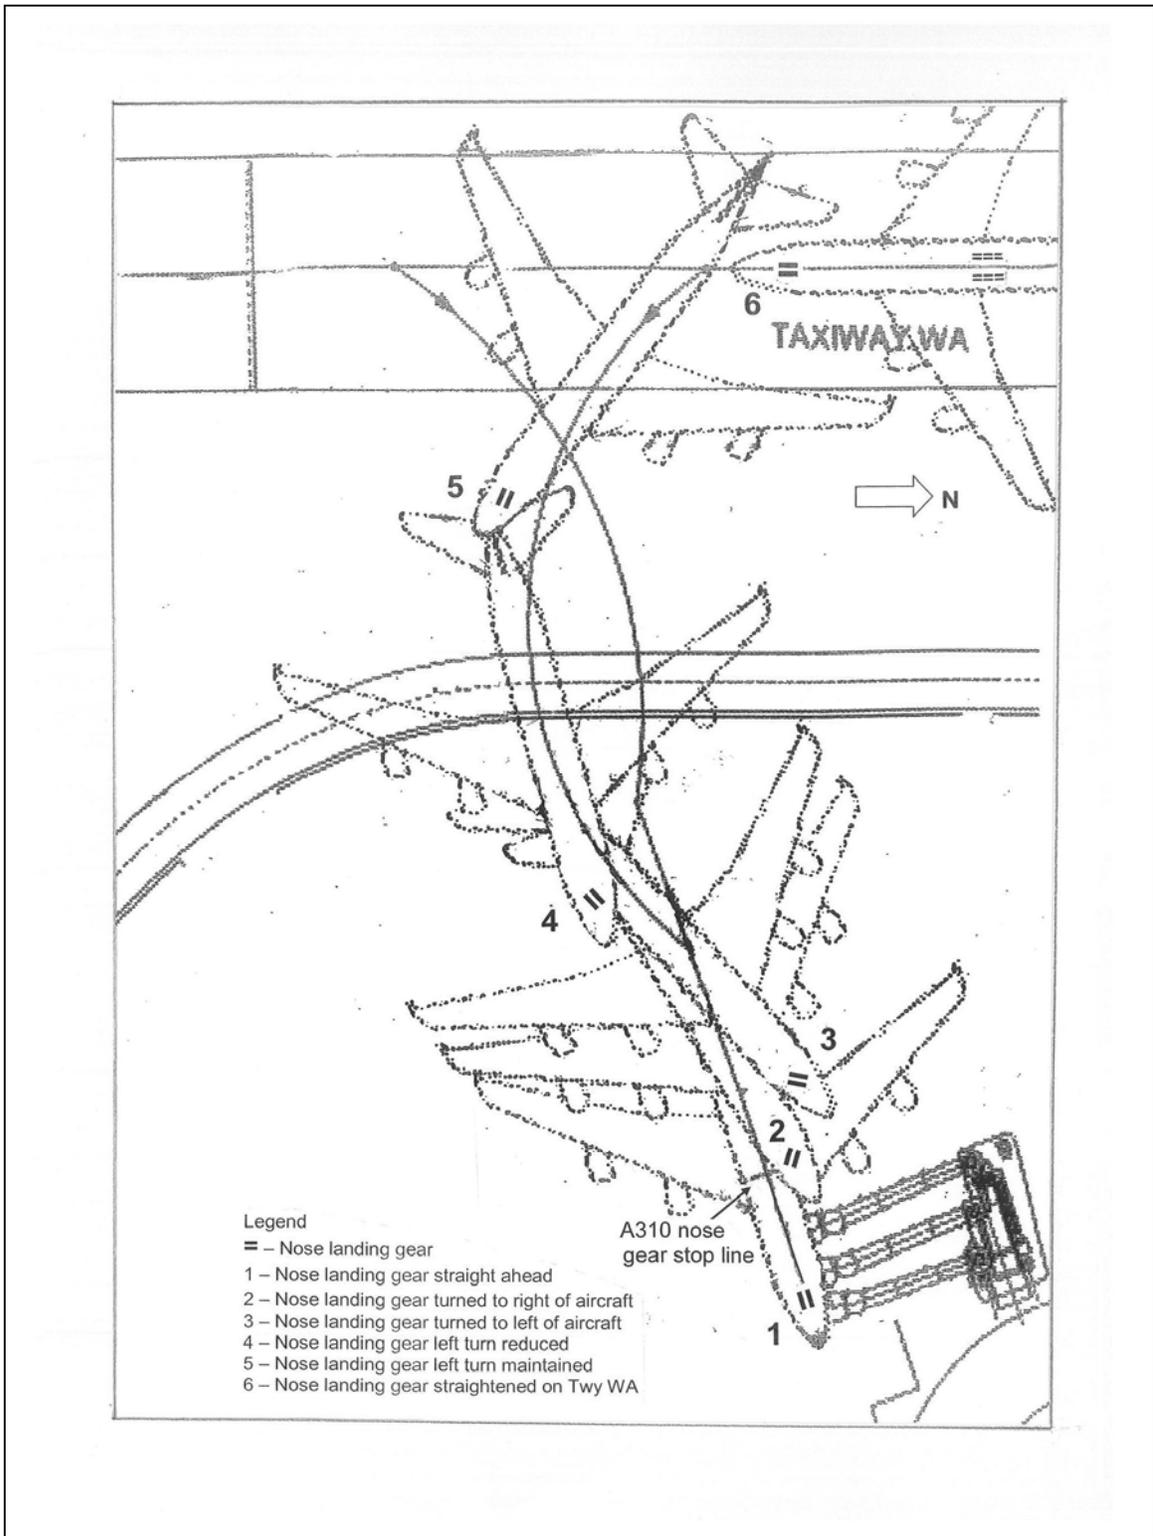
Sketch showing 'S - shape' trial pushback track

- 1.11.4 To accomplish the pushback from Bay A4 to the taxiway, the driver had to clear the aerobridges at Bay A4 and the B777 parked at Bay A3. Following that, he had to use his judgment when turning the nose wheels of the aircraft to position the body landing gears on the yellow lead-in line. This required the aircraft to be pushed in an 'S' shaped path. This is shown on the sketch at **Appendix 3**.
