**KOMITE NASIONAL KESELAMATAN TRANSPORTASI
REPUBLIC OF INDONESIA**

Aircraft Serious Incident Investigation Report

**PT. Batik Air Indonesia and PT. Lion Mentari Airlines
Airbus A320-200; PK-LUI and Boeing 737-900ER; PK-LPF**

6 January 2018

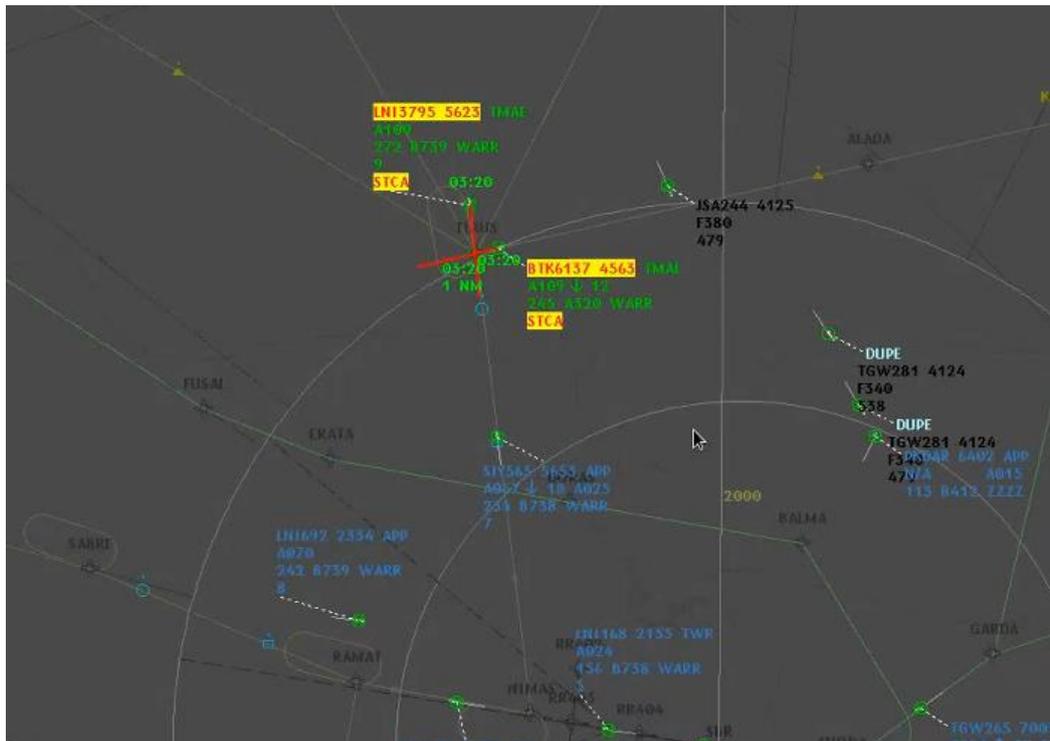
At 10:20:15 LT, the BTK passed altitude of 11,000 feet while the LNI was maintaining on altitude 10,000 feet and then the Short-Term Conflict Alert (STCA) of the controller radar system for LNI and BTK activated with aural and visual alert.

Figure 1: The STCA activated on the controller radar system at 10:20:15 LT

The STCA aural and visual alert did not trigger the controller to pay attention to the situation. This might be caused the vertical separation was still about 1,000 feet. The controller issued clearance to the BTK pilot when the LNI pilot confirming the traffic above. At 10:20:35 LT, when the LNI was still maintaining altitude of 10,000 feet, the LNI pilot received TCAS RA instruction “*DON'T CLIMB*”, while the BTK aircraft was continuing to descend. The vertical separation reduced to 400 feet while the horizontal reduced to 2.8 Nm. One second later, the BTK pilot received TCAS RA instruction “*DON'T DESCEND*”. The BTK pilot followed the TCAS RA and the aircraft maintained at altitude of 10,500 feet. At this time the vertical separation between aircraft was 400 feet while the horizontal was 2.7 Nm.

18. The STCA of the controller radar system activated with aural and visual alert for BTK and LNI when the BTK passed altitude of 11,000 feet. The STCA aural and visual alert did not trigger the controller to pay attention to the situation. This might be caused the vertical separation was still about 1,000 feet.
