07-001 Boeing 777 A6-EBC, incorrect power and configuration 22 March 2007
for take-off, Auckland International Airport

Report 07-001

incorrect thrust and configuration for take-off

22 March 2007

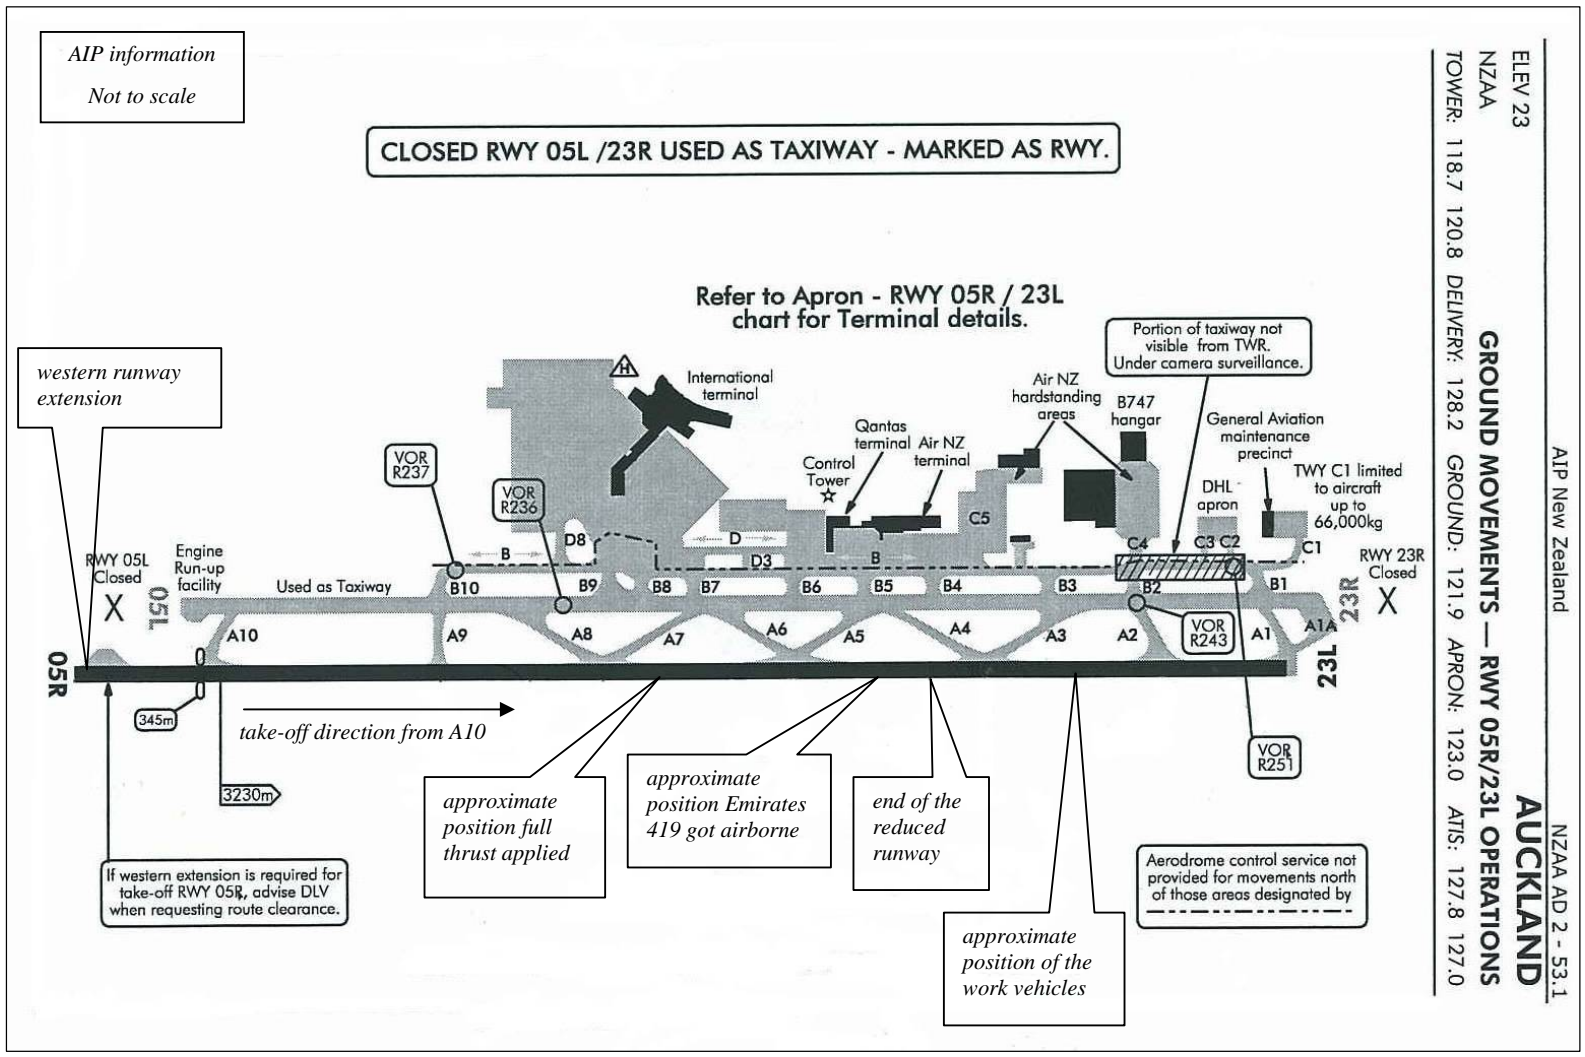
Figure 1
Auckland International Airport

- 1.1.7 At 1609 the first officer contacted the aerodrome ground controller for taxi instructions for Emirates 419’s return flight to Sydney. The controller gave the pilots instructions to taxi for runway 05R and to hold at taxiway A10 (see Figure 1). The first officer read back the

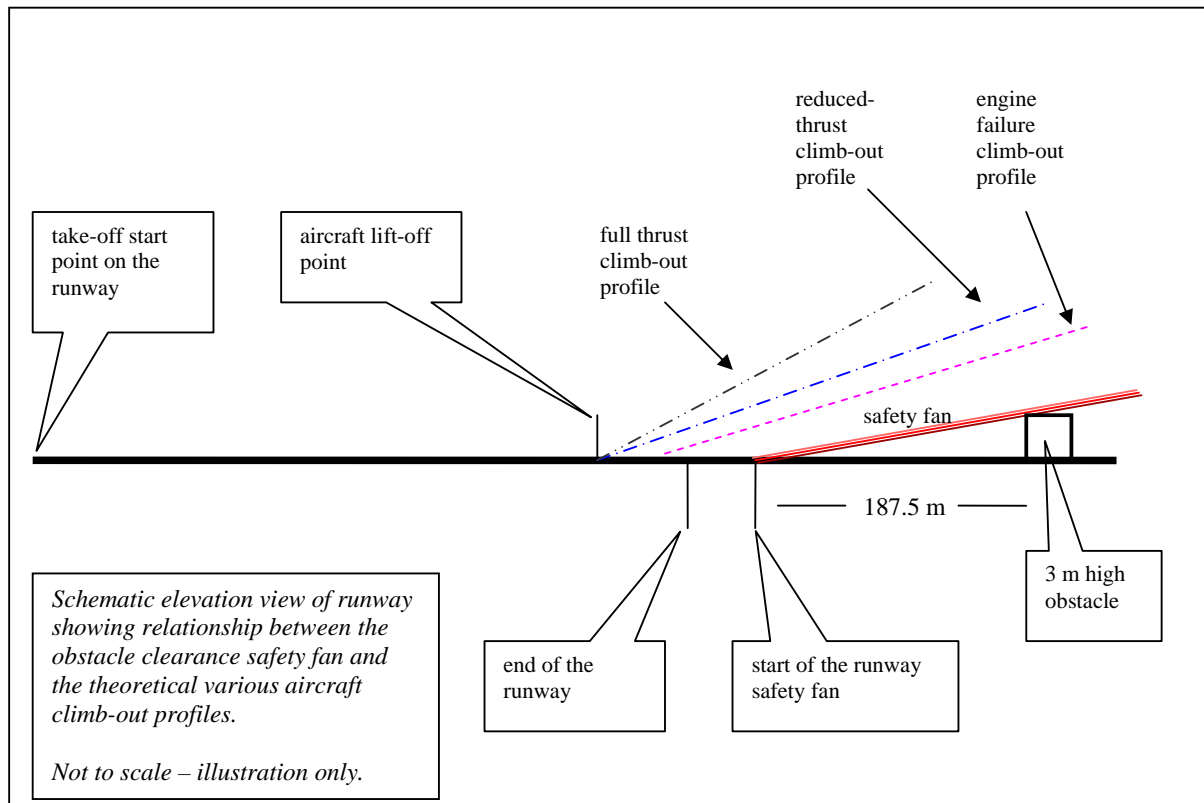
Figure 2
Illustration of aircraft runway performance

- 1.6.8 For take-off, to provide the obstacle clearance fan, no obstacle could be higher than 1 m at the first 62.5 m horizontally from the start of the fan. For each additional 62.5 m horizontally, obstacles could progressively be a further 1 m in height, e.g. at 125 m from the start of the fan no obstacle could be higher than 2 m. A 3 m obstacle such as the rubber-removal truck could be no closer than 187.5 m to the start of the fan, or 247.5 m to the end of the available runway. The obstacle clearance fan widened progressively as it extended out.
