Final Report No. 2244

concerning the serious incident (Airprox)

involving an Airbus A319 aircraft, registration G-EZAU
operated by EasyJet with the callsign EZY 899B,

on 26 May 2013

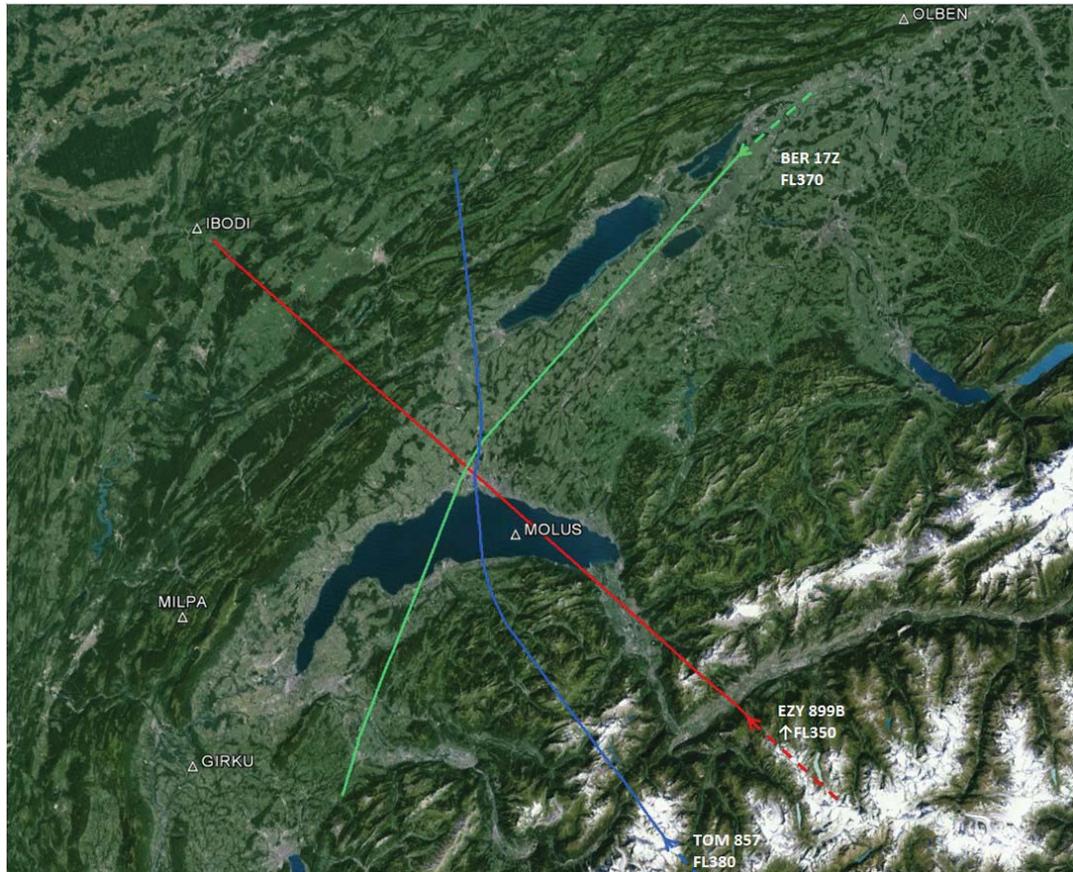
Figure 1: Trajectories of flights TOM 857, BER 17Z and EZY 899B and positions at 10:40 UTC

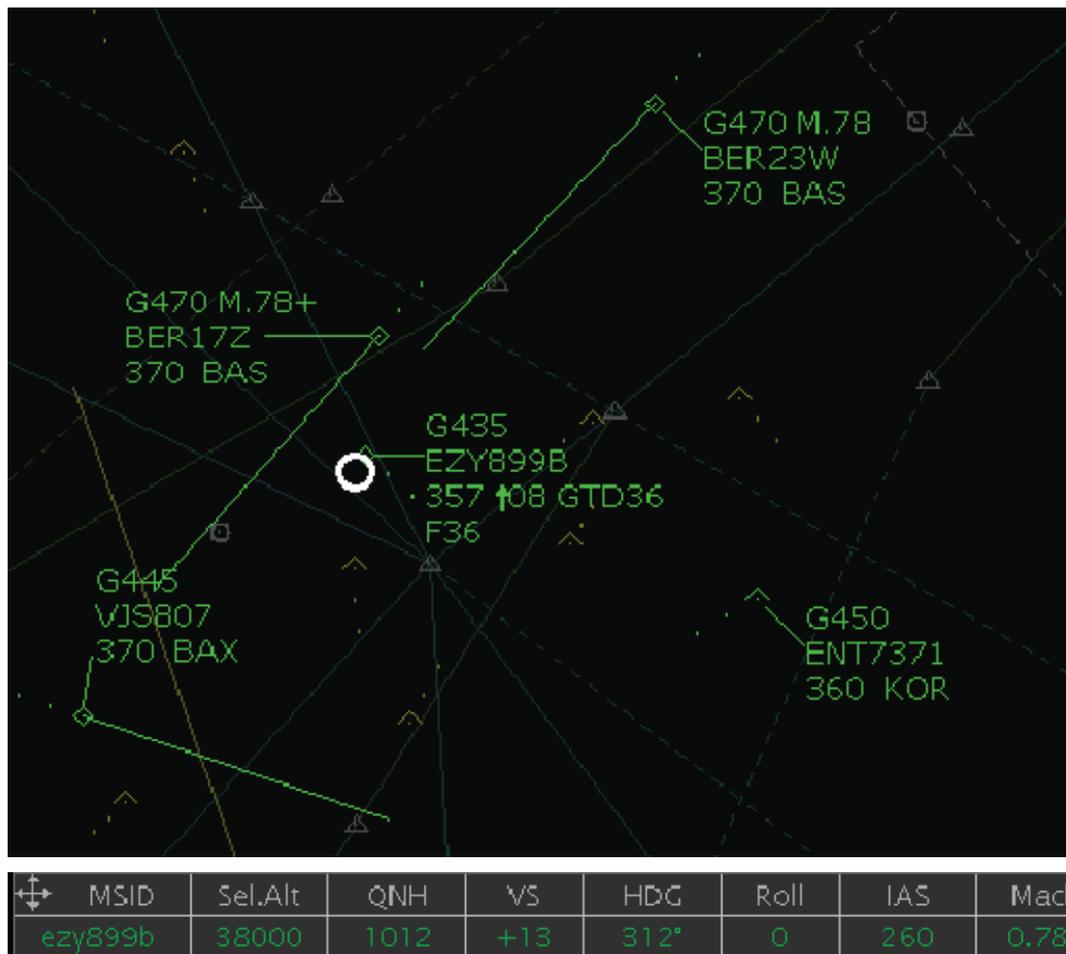
At 10:44:56 UTC the sector L5 RE (radar executive) controller was carrying out a scan of his radar data and noted that the value displayed in the "Sel.Alt" window of the EZY 899B label was "38000". This indication meant that the flight crew had entered the climb instruction to flight level FL 380 in the automatic flight control system.

Figure 2: Section of the radar image and the MSID (Mode S identification) window of EZY 899B at control sector L5, at 10:44:56 UTC

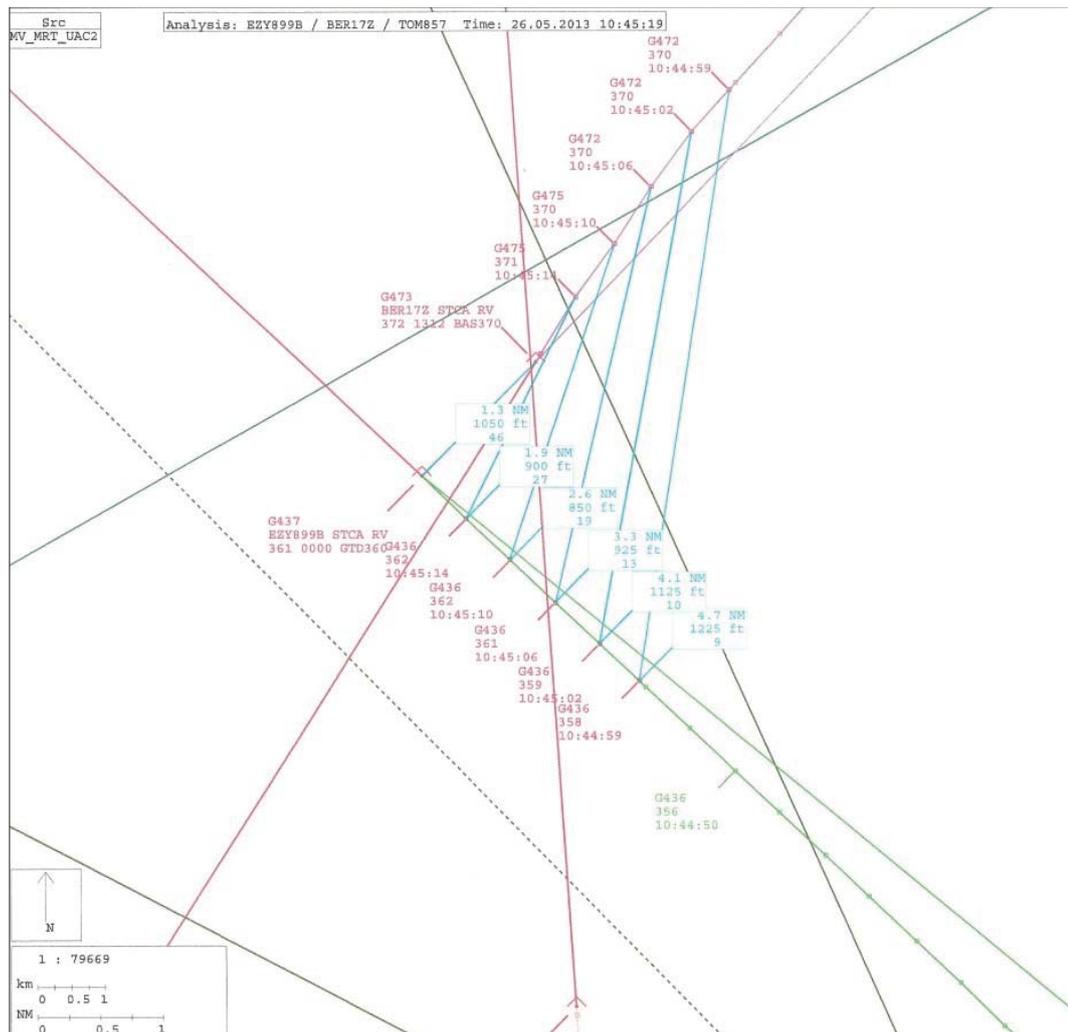
The loss of separation (simultaneously less than 5 NM lateral separation and 1000 ft altitude difference) between EZY 899B and BER 17Z occurred between 10:45:05 and 10:45:15 UTC. Their closest point of approach occurred at 10:45:10 UTC when the aircraft had a lateral separation of 2.6 NM and an altitude difference of 850 ft.

Figure 3: Vertical and horizontal distances during the STCA alert for EZY 899B and BER 17Z

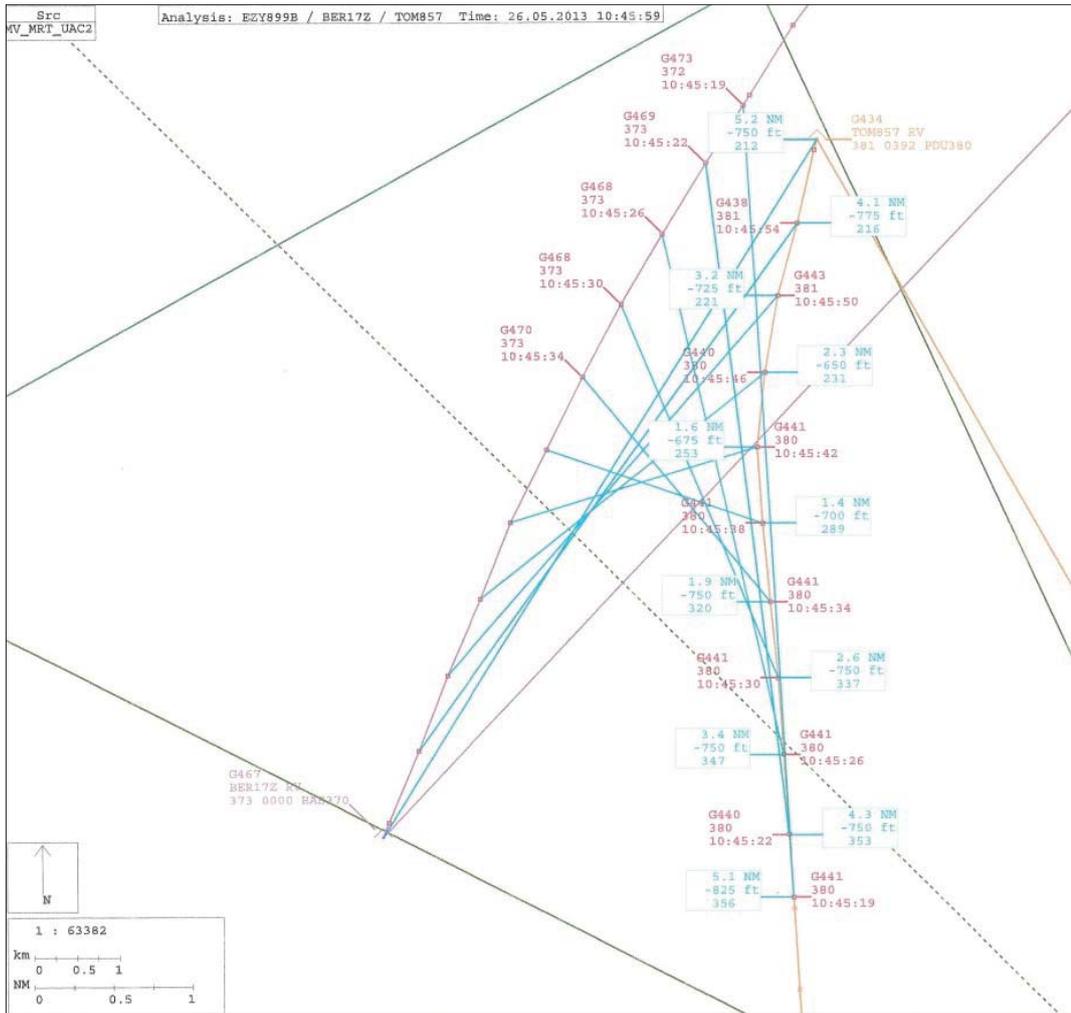
The loss of separation between BER 17Z and TOM 857 occurred between 10:45:19 and 10:45:57 UTC; however, the trajectories of the aircraft were diverging during the last 17 seconds of this period. During the convergence, the closest point of approach occurred at 10:45:40 UTC when the aircraft had a lateral separation of 1.5 NM and an altitude difference of 675 ft.

Figure 4: Vertical and horizontal distances during the STCA alert for BER 17Z and TOM 857

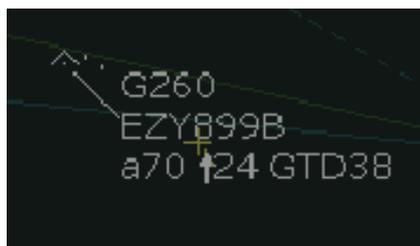
The label of flight EZY 899B after correlation. ATM links the data from the flight plan and the information transmitted by the aircraft's transponder. Its current altitude is 7000 ft (a70) and ATM assigns it the requested cruising level, FL 380 (38).

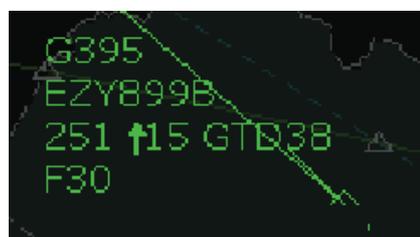
Flight EZY 899B is in contact with a sector below sector L5. It is cleared to climb to flight level FL 300 (F30).

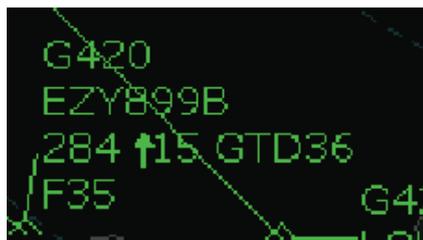
Flight EZY 899B is in contact with a sector below sector L5. It is cleared to climb to flight level FL 350 and the value of its assigned cruising level is now FL 360.

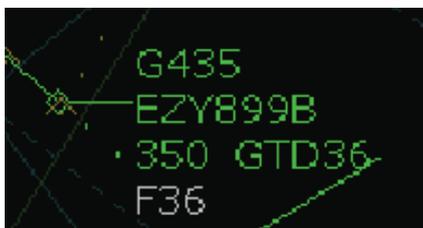
Flight EZY 899B is in contact with sector L5. It has received clearance to climb to flight level FL 360 (F36). The “close the loop” manipulation by the RP controller has not yet been carried out (F36 in white). When it has been carried out, “F36” will change to green.

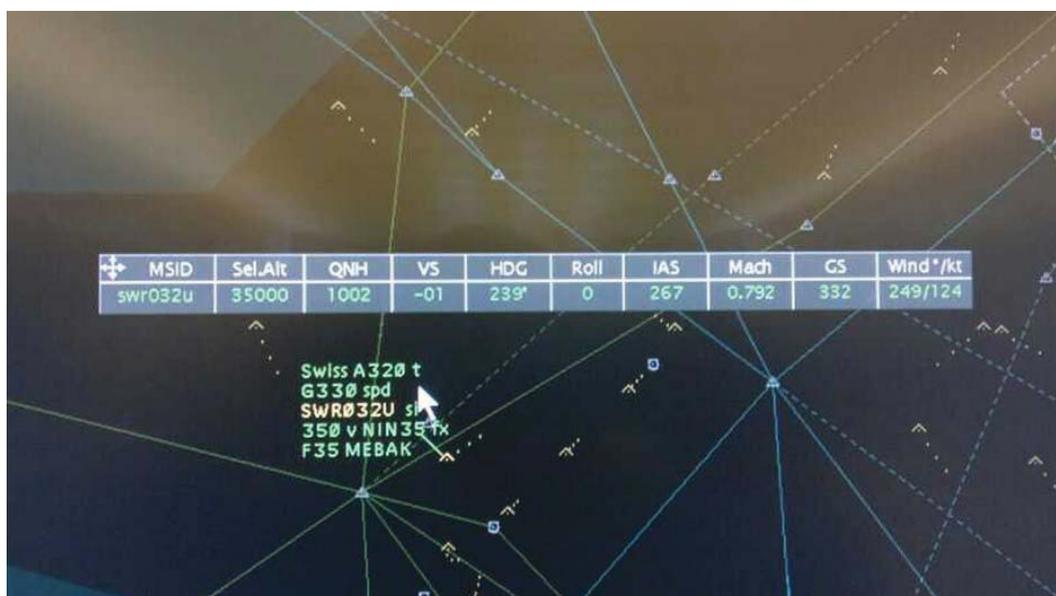
Figure 5: Example of the MSID window display

On the radar screen, the downlink aircraft parameters (DAPS) can be displayed at the controller's request in a window dedicated for this purpose.

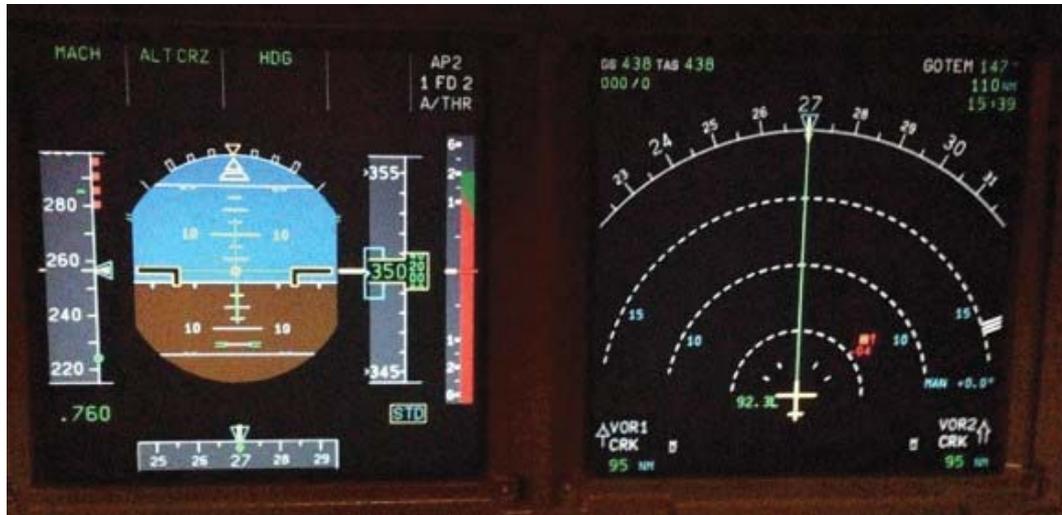
For the Airbus A320, the avoidance instructions are indicated on the display screen of the main flight parameters (primary flight display - PFD) by strips of grey/green/red colours on the scale of the vertical speed indicator. The red sector is the one which it is essential to exit, by means of a manoeuvre in the vertical plane.

Figure 6: Visualization of a “CLIMB” resolution advisory on the PFD and ND of the A320 in the left-hand position

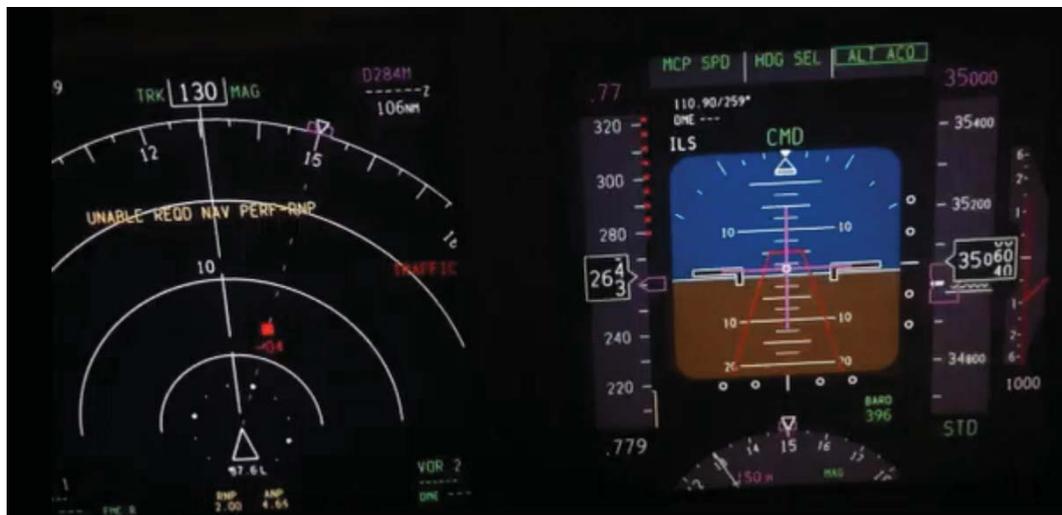
For the Boeing 737-800, the avoidance instructions are visualised on the PFD by a red trapezoid delimiting the zone from which it is essential to exit by means of an attitude correction. They are additionally indicated by strips of red/black colours on the scale of the vertical speed indicator.

Figure 7: Visualisation in the right-hand position of a “CLIMB” on the PFDs and NDs of the Boeing 737-800

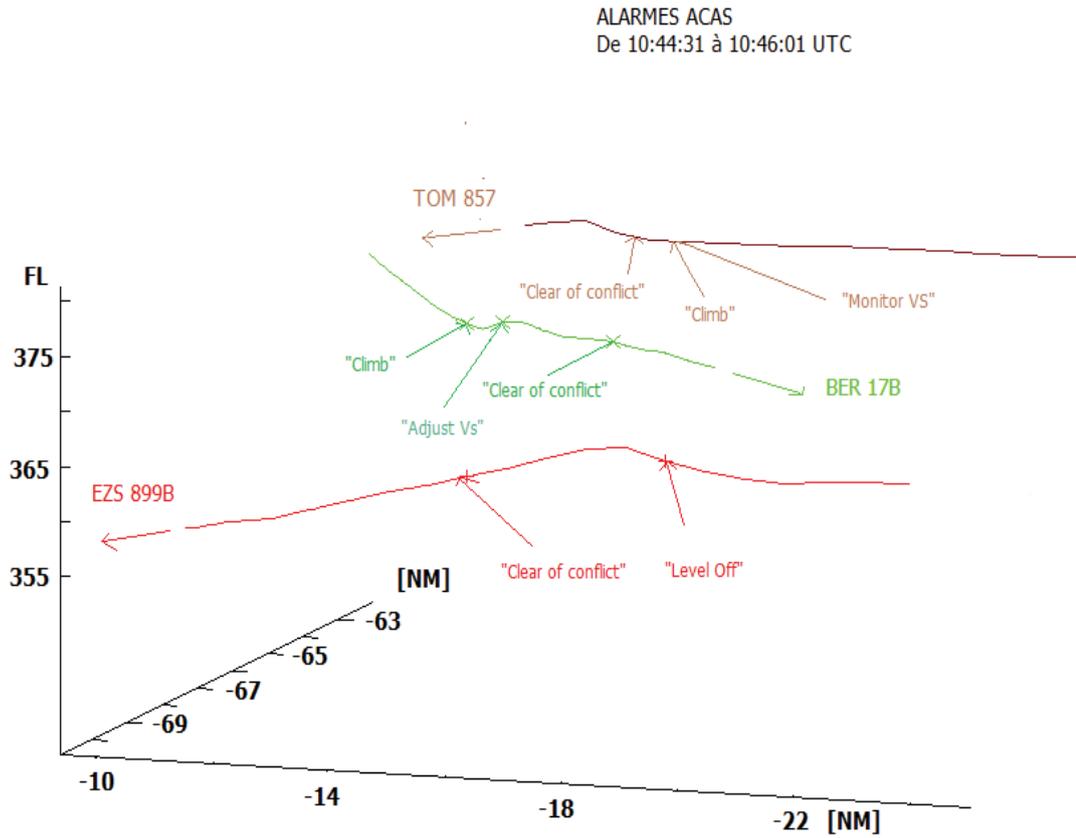
On the basis of the recordings of the radar tracks, the 3D trajectories of the aircraft involved in the serious incident were reconstructed in the ARTAS co-ordinates reference (ATM surveillance tracker and server) at the 5 second refresh rate of la Dôle radar. Projections on the horizontal and vertical planes on which the resolution advisories are marked make it possible to highlight the dynamics of the conflict.

Figure 8: 3D representation of the trajectories with TCAS alerts

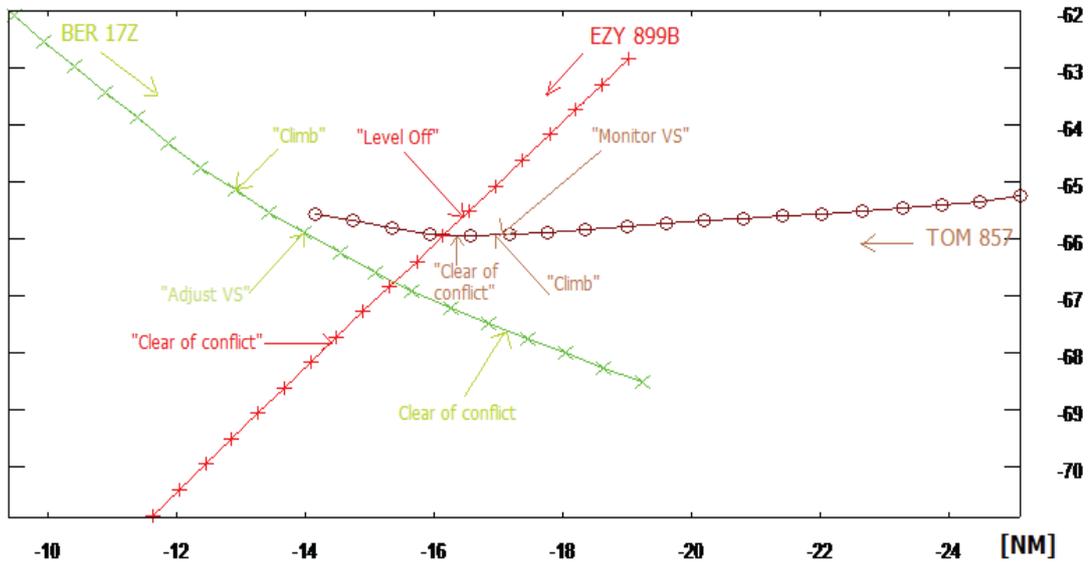
Figure 9: Projection of the trajectories in the horizontal plane with TCAS alerts

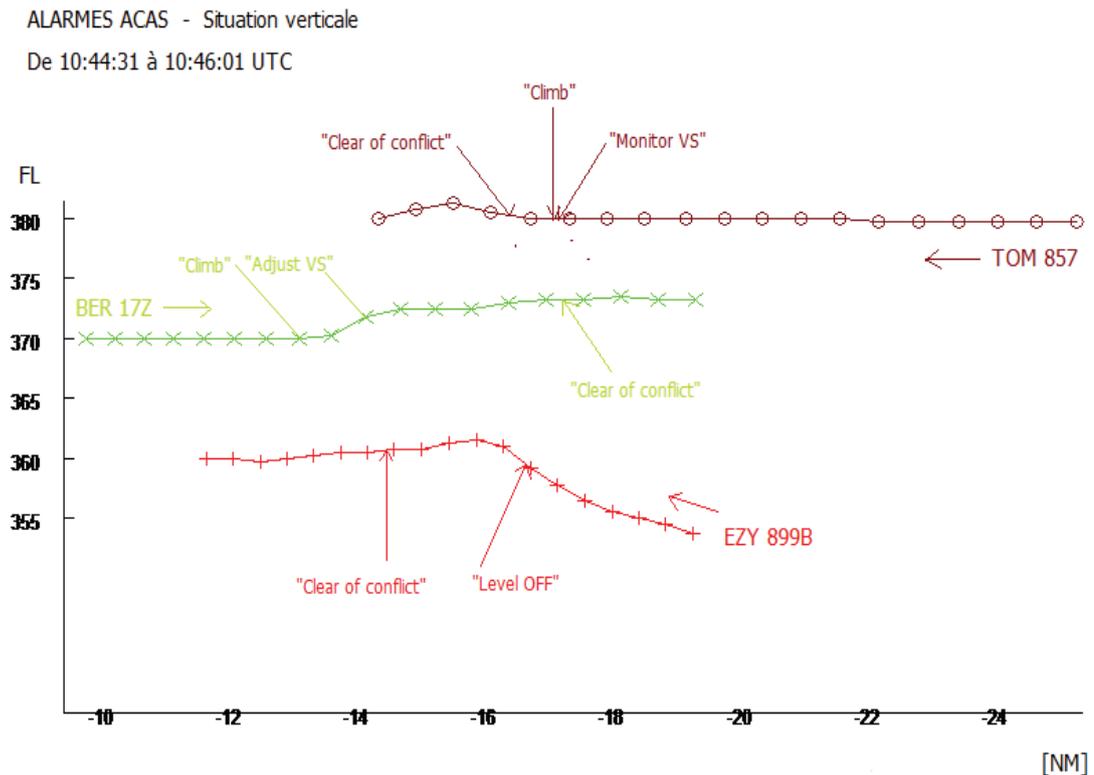
Figure 10: Projection of the trajectories in the vertical plane with TCAS alerts

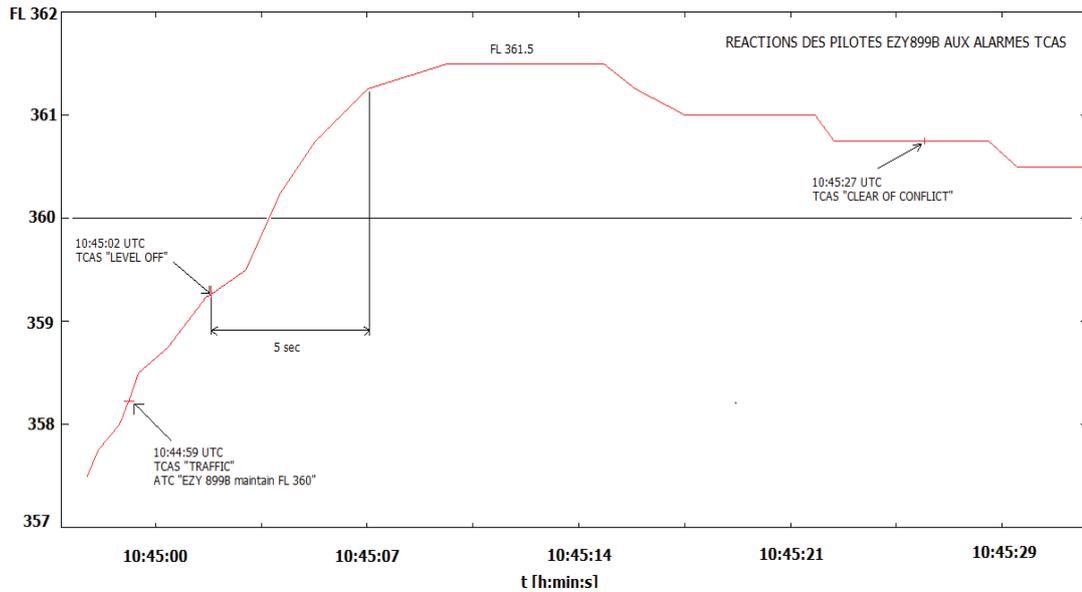
The flight crew of flight EZY 899B entered flight level FL 380 into the automatic flight control system at 10:44:05 UTC, i.e. during the read back of the clearance to climb to this level. The preceding instruction “*Easy eight niner niner bravo, climb flight level three six zero*” did not elicit a response from the pilots. It is coherent that it was not followed by operation of the automatic flight control system.

At 10:44:59 UTC, the sector L5 RE controller instructed the flight crew of flight EZY 899B to maintain flight level FL 360. At the same moment, the traffic advisory issued by the airborne collision-avoidance system reported that the intruder BER 17Z represented a possible threat. The “LEVEL OFF” resolution advisory occurred three seconds later, also during the radiotelephony message. This simultaneous occurrence represented a disturbing element in terms of the reaction of the flight crew to the alerts. Nevertheless and despite the short notice of traffic advisory, the latter was in conformity with the standard pilot model of the collision-avoidance logic, since the avoidance manoeuvre proposed was initiated 5 seconds after the corrective resolution advisory. The trajectory of the aircraft then exhibited a constant reduction in the rate of climb, from 2200 ft/min to approximately -300 ft/min, in accordance with the TCAS indications reported on the vertical speed indicator. The aircraft exceeded flight level FL 360 by only 150 ft.

Figure 11: Flight level of EZY 899B as a function of time: reaction of the pilots to the TCAS alerts

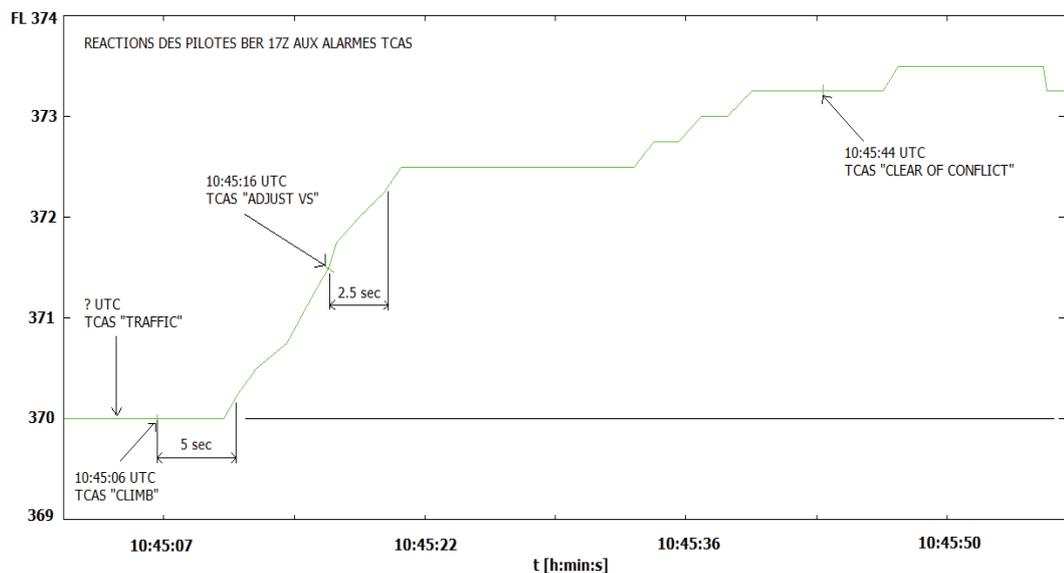
During the reaction time of the pilots of EZY 899B to the “LEVEL OFF” alert, the aircraft was on its climb trajectory with a rate of climb of approximately 2200 ft/min; this contributed to the triggering of a traffic advisory on-board BER 17Z followed immediately by the resolution advisory “CLIMB”. Its flight crew reacted within 5 seconds and adopted the vertical climb speed required by the TCAS. This avoidance manoeuvre positioned the aircraft in a conflict situation with TOM 857, causing the “ADJUST VERTICAL SPEED” resolution advisory to be issued, this time in the downwards direction. The pilots of BER 17Z reacted correctly to this change of direction, since after 2.5 seconds the rate of climb was gradually reduced towards 0 ft/min. These TCAS manoeuvres must be carried out in manual flight, as on the aircraft types involved in the serious incident the automatic flight control system is not designed to react sufficiently rapidly. The minimal variations in trajectory noted just before the end of the conflict “CLEAR OF CONFLICT” are due to the difficulty in accurately maintaining the flight parameters at high altitudes and speeds.

Figure 12: Flight level of BER 17Z as a function of time: reaction of the pilots to the TCAS alerts

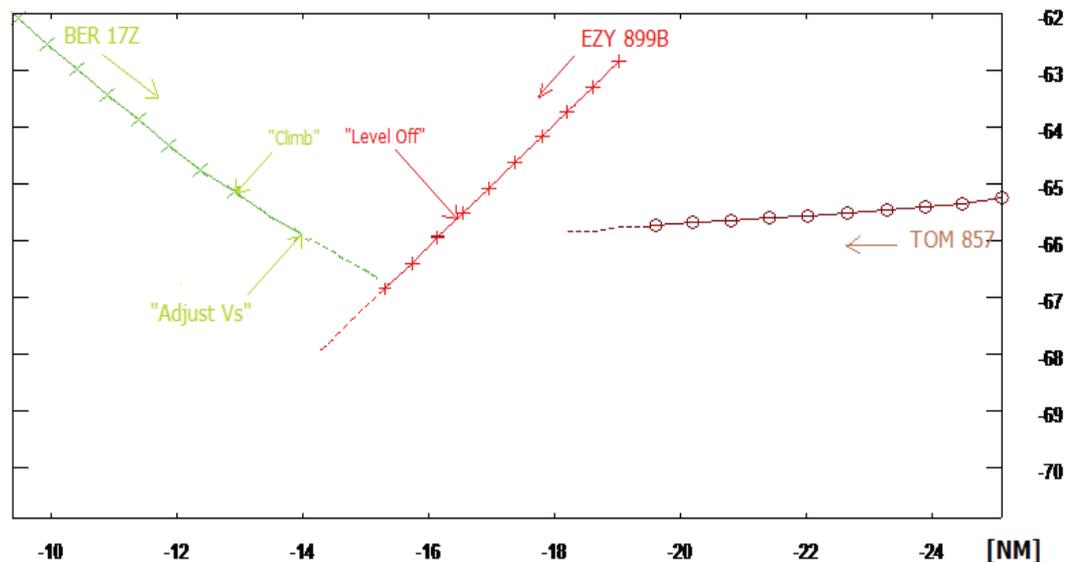
Instant 10:45:16 UTC

With regard to the TCAS alerts, the ASR completed by the pilots of BER 17Z mentions only the “CLIMB” resolution advisory triggered by an intruder located at their 9 o'clock position, at a distance of 4 NM and 700 ft lower. It is unlikely that the flight crew realised that a second intruder, TOM 857, had become involved in the encounter geometry, triggering the “ADJUST VERTICAL SPEED” resolution advisory. This alert was certainly interpreted as the attenuation of the first “CLIMB” instruction whose intruder (EZY 899B) was located at this time at twelve o'clock on the NDs of BER 17Z. The latter, at a distance to the rear right, would still remain symbolised as such for 11 seconds, diverting the attention of the pilots from the new intruder TOM 857, located on the left on the navigation screen.

Figure 13: 10:45:16 UTC: intruders EZY 899B and TOM 857 for BER 17Z

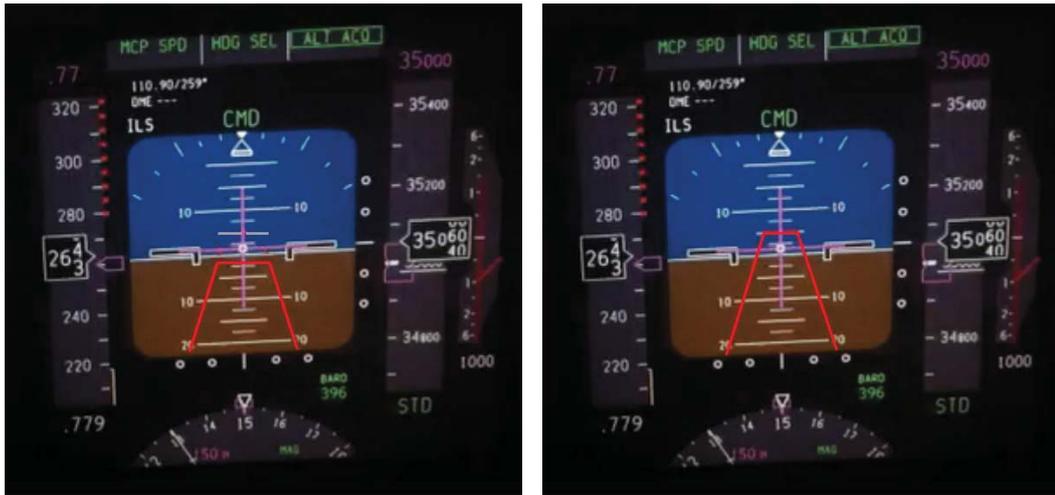
On the PFDs, since it is preventive, the “MONITOR VERTICAL SPEED” advisory presents a situation where the model of the aircraft is outside the red trapezoid relating to the vertical avoidance manoeuvre. On the other hand, for the corrective “CLIMB, CLIMB” advisory it is on the inside, indicating to the pilots that an upward change of pitch must be carried out.

Figure 14: Preventive resolution advisory “MONITOR VERTICAL SPEED” on the left and corrective advisory “CLIMB, CLIMB” on the right

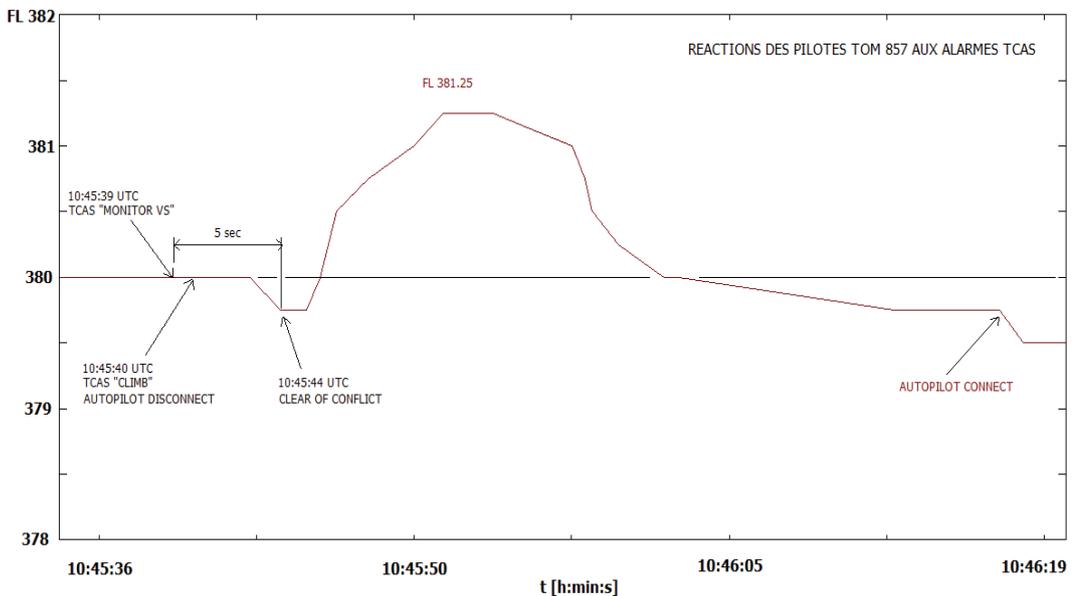
On-board flight TOM 857, the succession of these two alerts and the end-of-conflict notification lasted only 5 seconds, i.e. the equivalent of the response time of the standard pilot model used in the performance evaluation of the collision-avoidance logic. The pilots reacted 5 seconds after the appearance of the first advisory, at the very moment of the notification of the end of the conflict. Whereas it therefore no longer applied, the reaction consisted of an upward movement of approximately one hundred feet, with an extension of the right turn ordered a few seconds earlier by the air traffic controller. It responds to the last vertical avoidance manoeuvre instruction “CLIMB” which appeared on the PFDs and can be explained by the effect of stress on the pilots caused by the TCAS alerts.

The reaction time of the pilots was in conformity with that envisaged by the collision-avoidance logic and the variation in trajectory was minimal.

Figure 15: Flight level of TOM 857 as a function of time: reaction of the pilots to the TCAS alerts
