# AIR ACCIDENT INVESTIGATION SECTOR

## ACCIDENT INVESTIGATION REPORT

### SEVERE TURBULENCE ENCOUNTER

Boeing 777-300

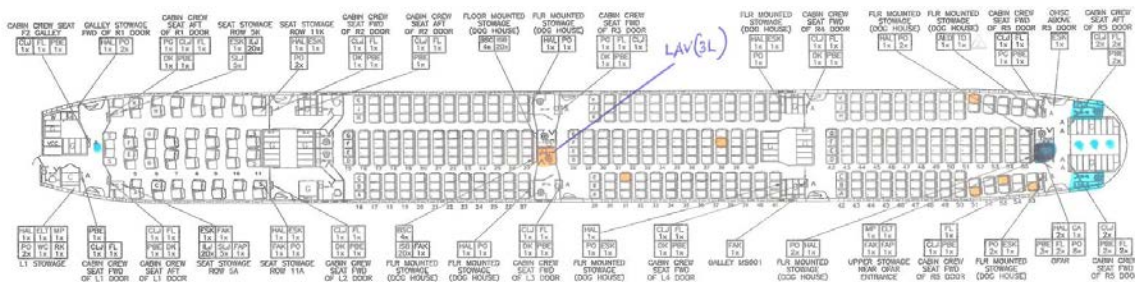
Figure 1: Cabin Configuration Diagram – Passenger seating, Lavatories and Galley Locations

Most of the injured passengers were seated with seat restraints fastened. The seriously injured passenger was in the amenities/lavatory during the severe turbulence encounter.

- Injured Cabin Crew
- Injured Passengers

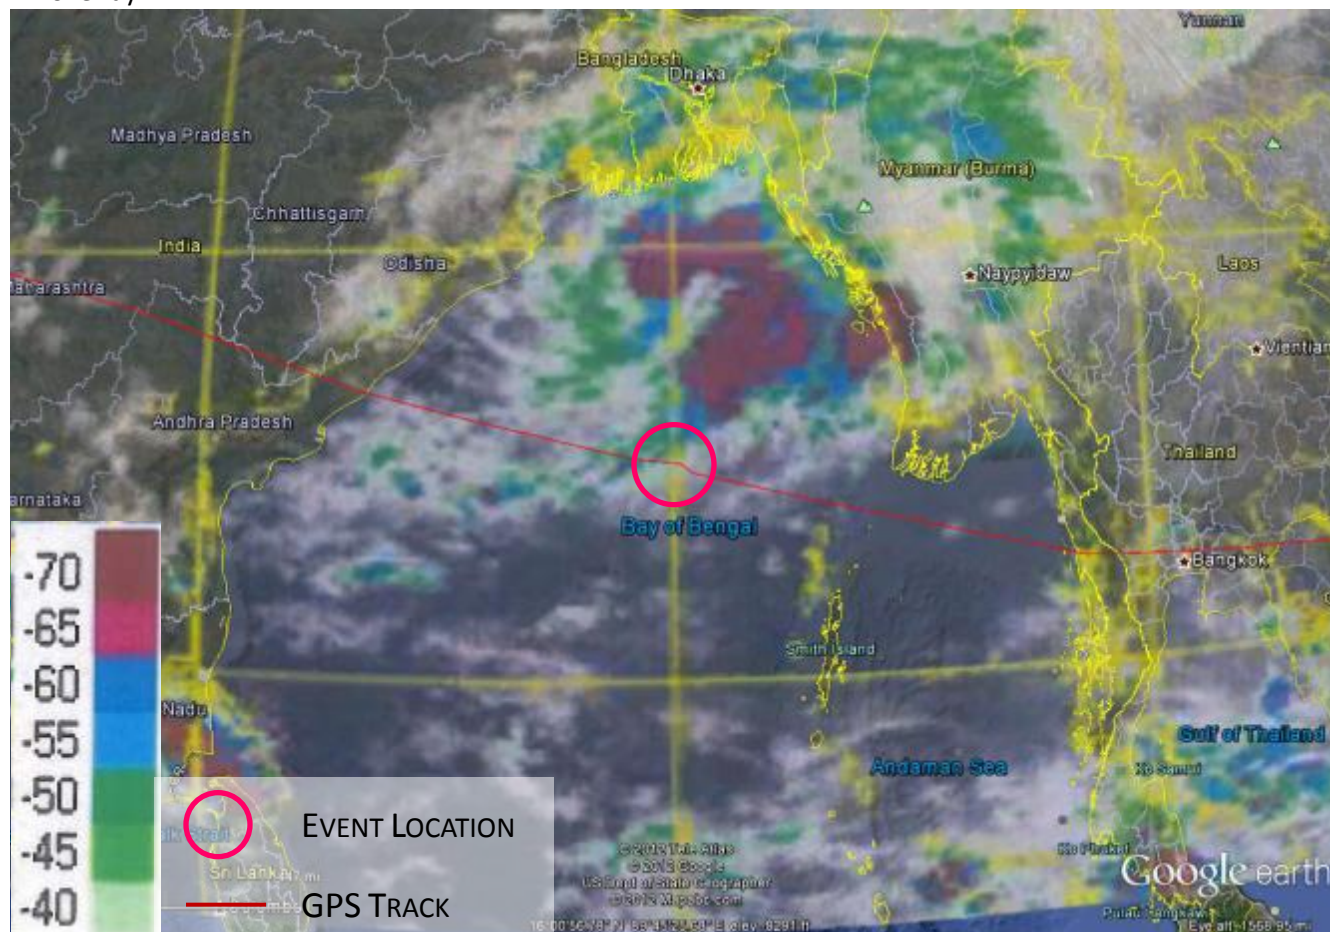
Figure 4: Enroute Briefing Prognostic Charts: Bay of Bengal – 14:00 UTC Prognostic Chart

The image indicated an area of intense convective activity in the Bay of Bengal from approximately 15°N up to the southern coast of Bangladesh.

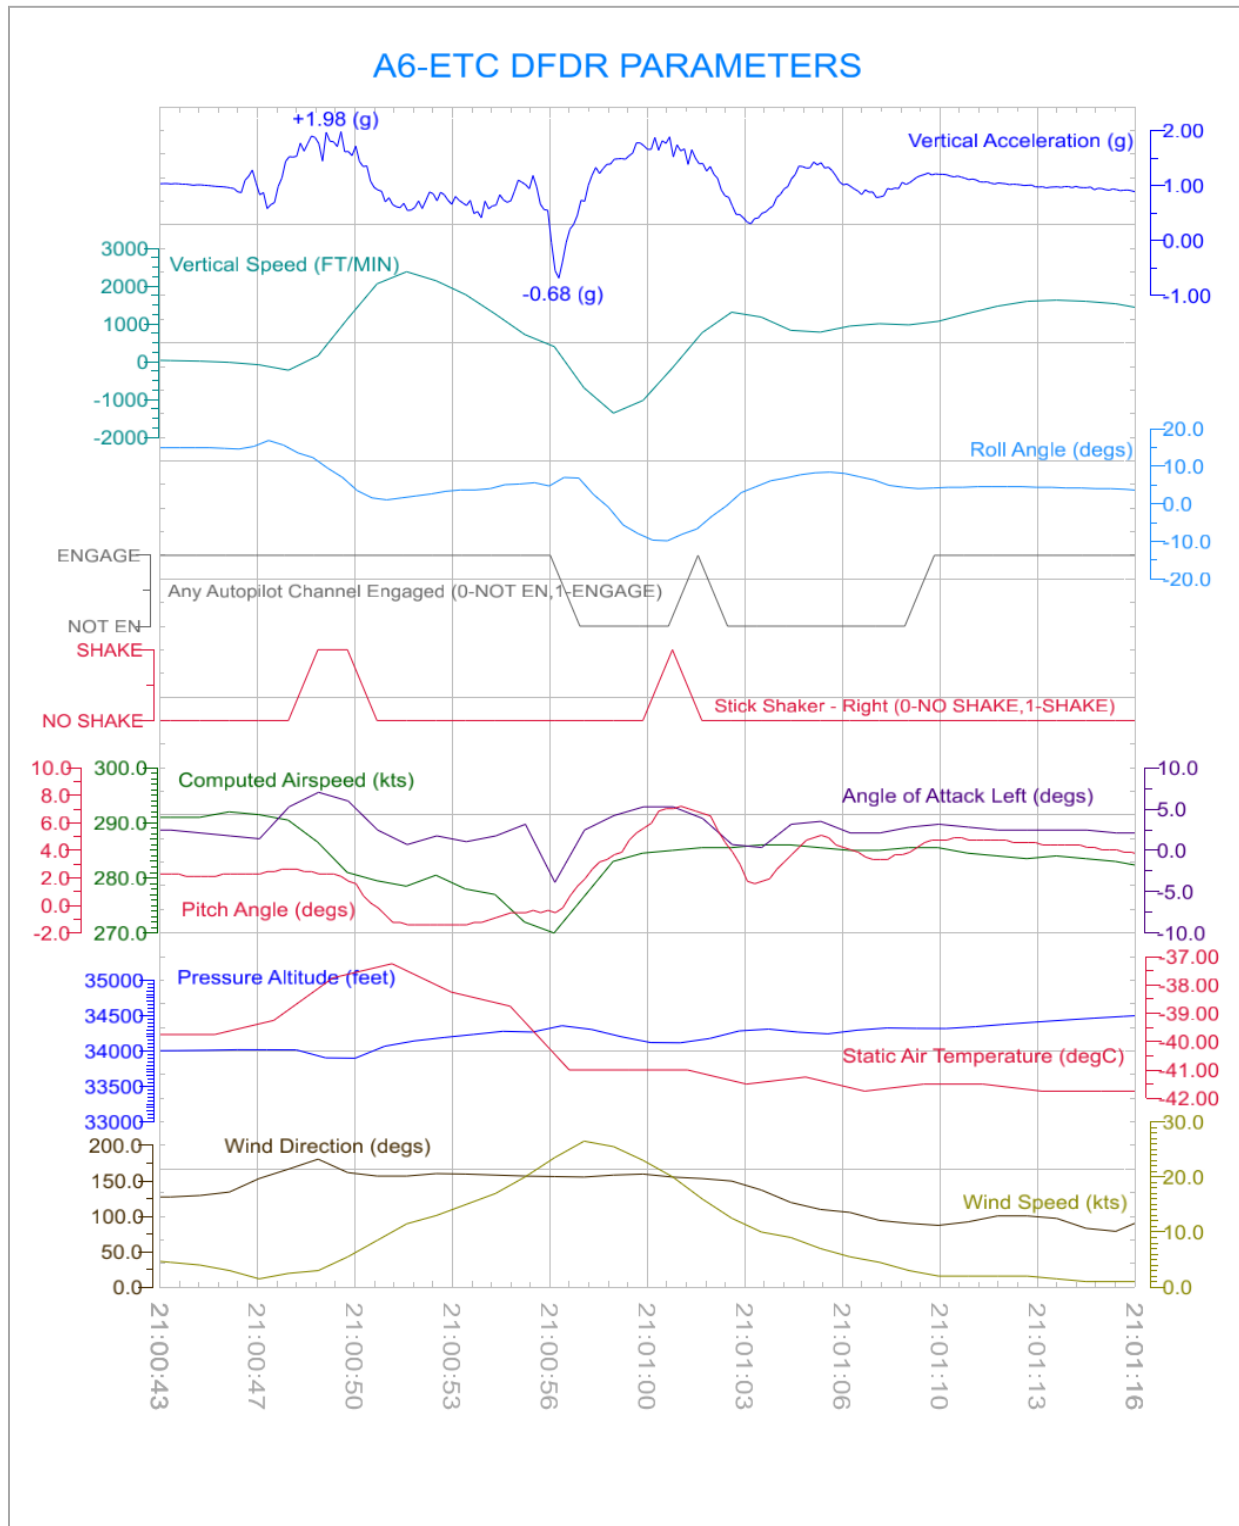
Analysis - DFDR Data Derived Event Sequence Parameters

DIGITAL FLIGHT DATA PARAMETERS/TIME STAMP - UTC 21:00:43 TO 21:01:16
