Statens haverikommission
Swedish Accident Investigation Board

Report RL 2003:19e

Incident involving aircraft OH-SAT and a passenger car at Stockholm/Arlanda airport, AB County, Sweden on the 18th of December 2001

Case L-002/02

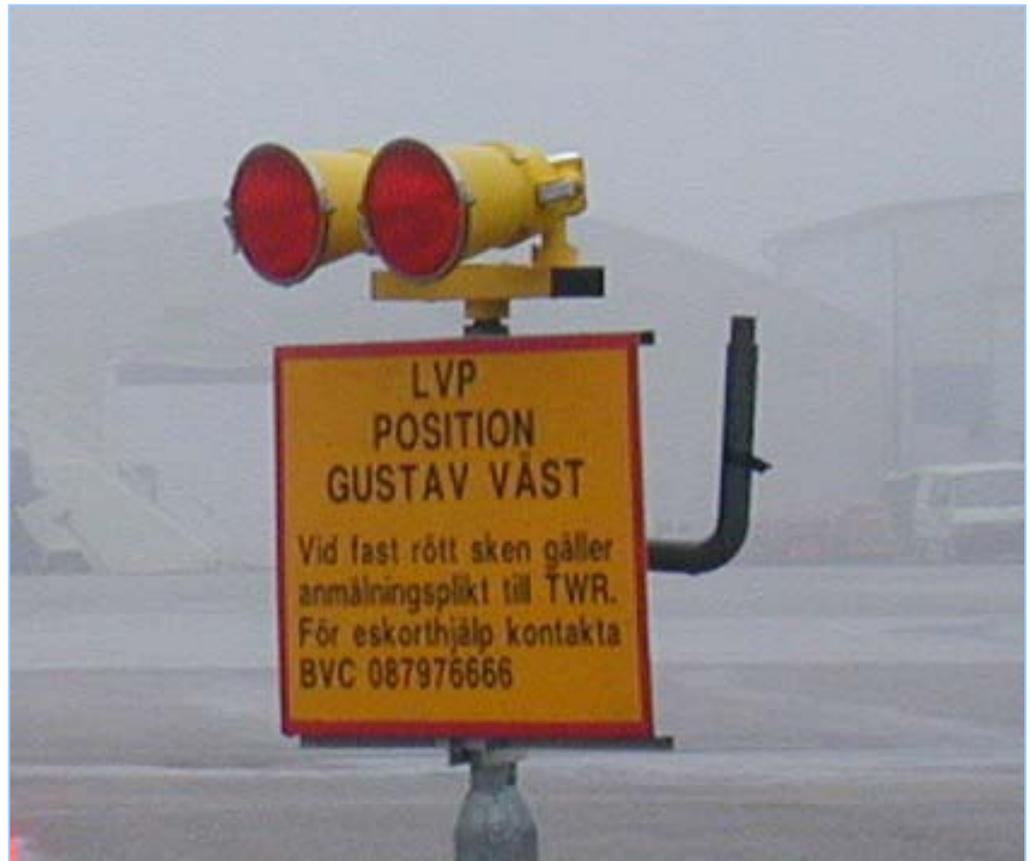
In haze or fog conditions, when the horizontal visibility decreases to less than 600 meters, the TWR can decide to implement LVP. This is indicated by a

steady red light from double lamps on the signal poles, which are positioned on each side of the affected road section.

This indicates to vehicle traffic that certain rules change. Vehicle traffic that intends to drive along a LVP section must have radio contact with ATC (GND). The vehicle shall indicate its presence through the use of a blinking/ rotating yellow/ orange beacon. Vehicles that are not equipped with a radio and a blinking beacon can pass under the escort of a vehicle with the requisite equipment.

LVP-sign with warning lamps

- The stop signs have been replaced with a type of sign that is used in the public road network.
- The sign prohibiting right hand turns has been removed.
- LVP-signs/lamps have been complimented with booms that lower manually with LVP conditions.
- During LVP, all vehicle traffic is prohibited on sections of the Inner Transport Route that is regulated by LVP.
- During LVP conditions, contingency for driving around the whole of Ramp G has been created.
