Vibrations, failure of the right main landing gear torsion link during landing roll

Aircraft	Boeing B737-300 registered G-CELD
Date and time	23 July 2011 at 8 h10 UTC ⁽¹⁾
Operator	Jet2.com
Place	Paris Charles de Gaulle Airport
Type of flight	Scheduled international transport of passengers
Persons on board	Captain; Co-pilot; 3 cabin crew; 128 passengers
Consequences	Right main landing gear damaged

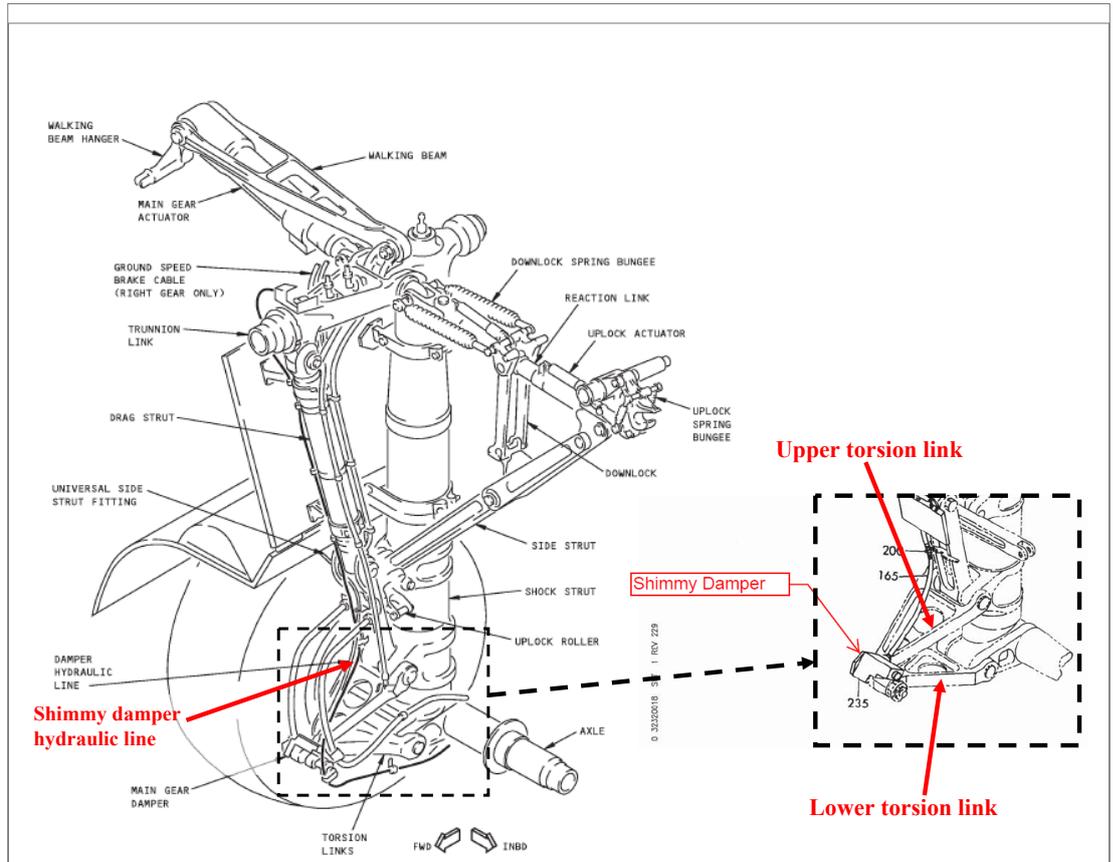
Figure 1 – Overall view of main landing gear

The aeroplane left the runway via taxiway Z3 and came to a stop before being towed to the ramp. Significant damage was observed on the right main landing gear, especially on the lower torsion link.

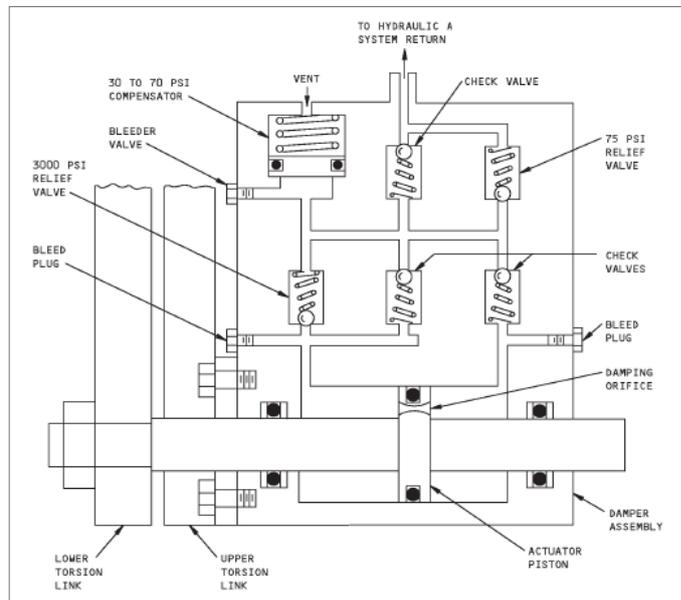
Figure 2 – Schematic of the shimmy damper

The shimmy damper was thus not supplied by the aeroplane's hydraulic system. It could not then function normally. During the landing, the vibrations caused by the high speed of the wheels and the heavy braking could not be damped down. The strong vibrations quickly weakened the lower torsion link until it failed suddenly.

The accident was caused by the failure, undetected by the maintenance personnel, to reconnect the right main landing gear shimmy damper hydraulic line to the aeroplane's hydraulic system. The vibrations caused during landing rollout could not be damped down and weakened the torsion link until it failed suddenly.
