ENGLISH TRANSLATION OF MAIN TEXT OF VENEZUELAN ACCIDENT REPORT

JIAAC-9-058-2005

SYNOPSIS

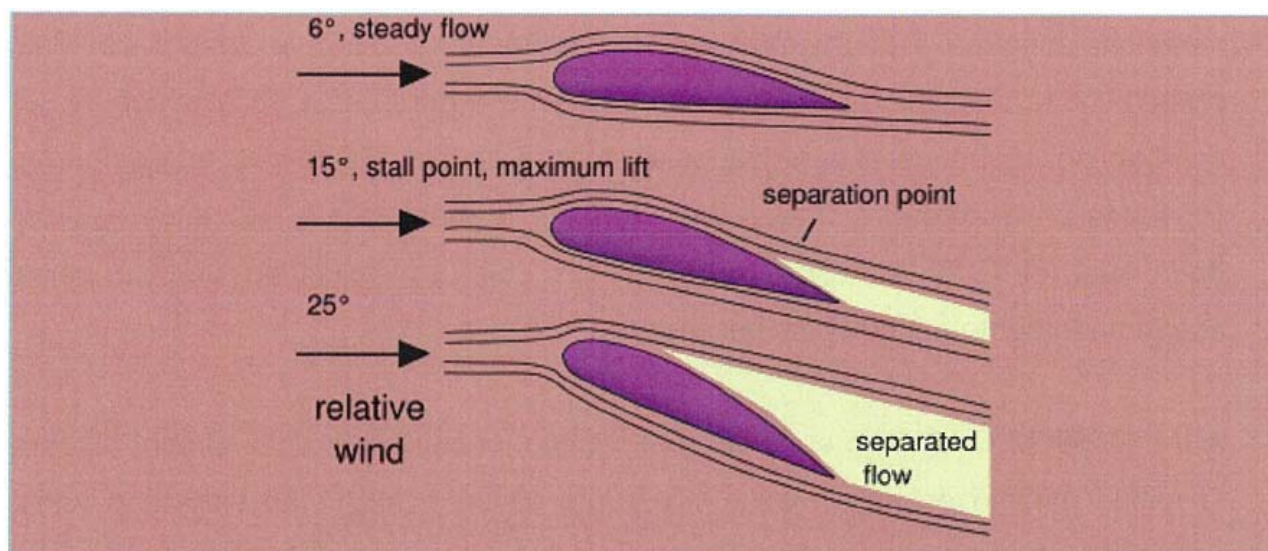
Between **06:57:44 UTC** and **06:57:54 UTC**, the EPR fell from 1.89 to 1.16.

At **06:57:46 UTC**, the stabiliser trim started to gradually increase to -5° until the maximum nose up value was reached. The wings of the aircraft, owing to the angle of attack, contributed to producing an effect on the entry of air into the engines, causing the reductions in EPR.
