ACCIDENT

Aircraft Type and Registration:	Gulfstream III (G-1159A), N103CD	
No & Type of Engines:	2 Rolls-Royce Spey Mk511-8 turbofan engines	
Year of Manufacture:	1984 (Serial no: 418)	
Date & Time (UTC):	24 November 2014 at 2030 hrs	
Location:	Biggin Hill Airport, Kent	
Type of Flight:	Private	
Persons on Board:	Crew - 2	Passengers - 5
Injuries:	Crew - None	Passengers - None
Nature of Damage:	Aircraft damaged beyond economic repair	
Commander's Licence:	Airline Transport Pilot's Licence	
Commander's Age:	36 years	
Commander's Flying Experience:	4,120 hours (of which 3,650 hours were on type) Last 90 days - 60 hours Last 28 days - 19 hours	
Information Source:	AAIB Field Investigation

Synopsis

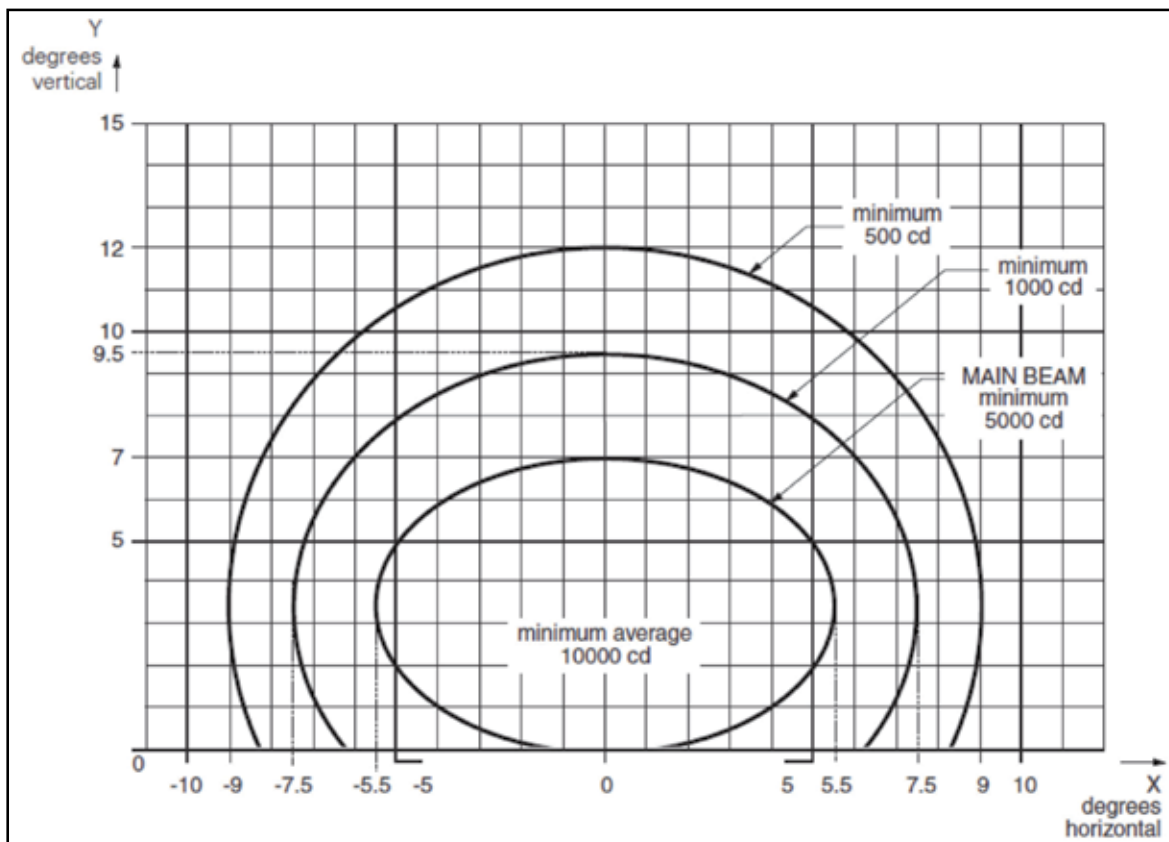
Figure 7

The white runway edge lights in use at the aerodrome have an omni-directional element and a bi-directional element and are raised above the ground. The minimum intensity of the omni-directional element is stipulated as 200 cd⁴. The intensity minimums for the bi-directional element depend on the angle it is being observed from, both laterally and vertically, and are shown in Figure 77 for a 45 m wide runway. The intensity of runway lighting is adjusted depending on ambient light levels but the intensity settings are not logged by the aerodrome authority.

Requirements for the directional element of runway edge lights
(extracted from Figure 6A.9 of CAP 168)
