**AVIATION INVESTIGATION REPORT  
A14W0177**

**RIGHT MAIN LANDING GEAR COLLAPSE**

**JAZZ AVIATION LP (DBA AIR CANADA EXPRESS)  
DHC-8-402, C-GGBF  
EDMONTON INTERNATIONAL AIRPORT, ALBERTA  
06 NOVEMBER 2014**

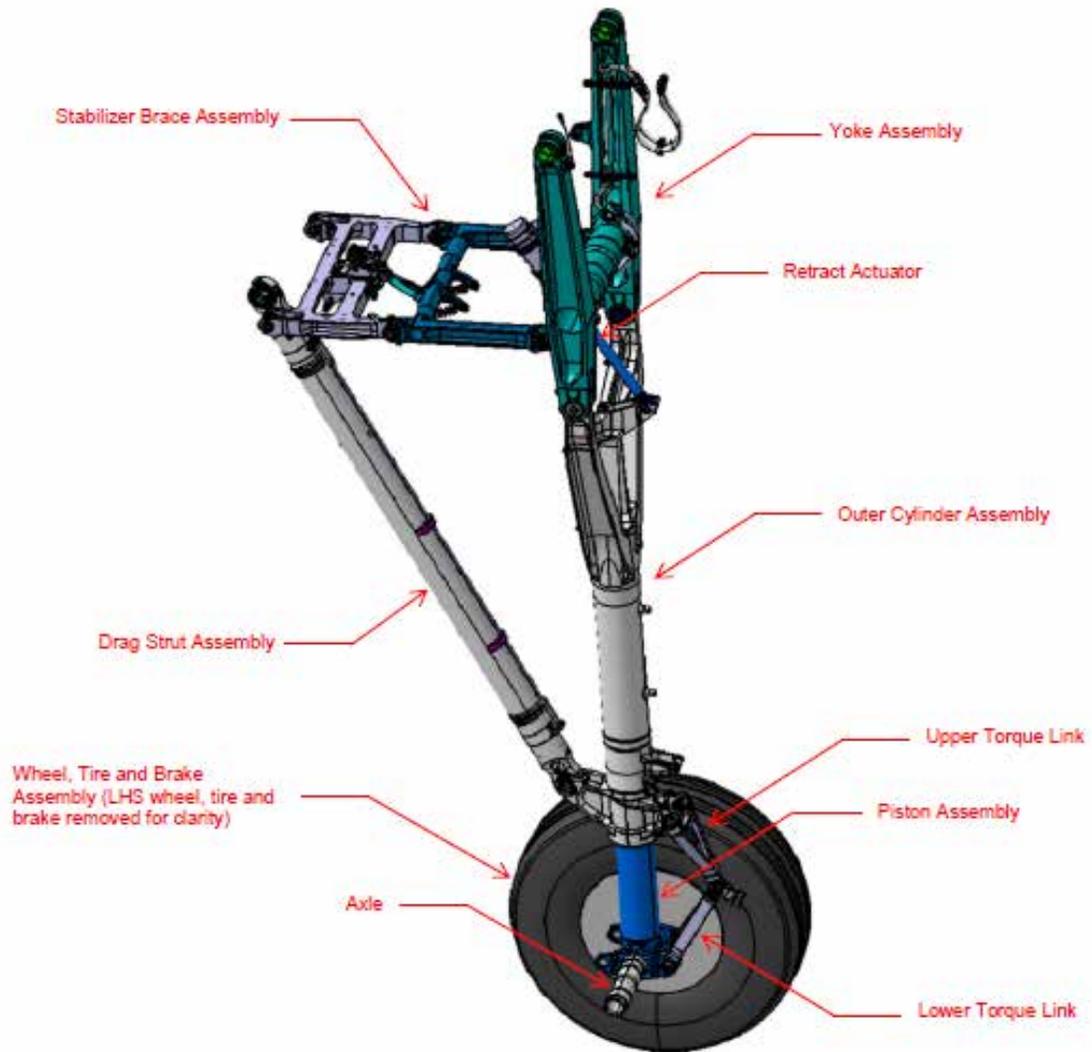
### Appendix A – DHC-8-Q400 main landing gear and major sub-assemblies

Zoomed view of the main landing gear stabilizer brace assembly (part no. 46400-27/-29) (Source: UTC Aerospace Systems)
